WY2014 ANNUAL MONITORING SUMMARY

**THE BIOLOGICAL OPINION FOR THE OPERATION
AND MAINTENANCE OF THE CACHUMA PROJECT
ON THE SANTA YNEZ RIVER
IN SANTA BARBARA COUNTY, CALIFORNIA**

**CACHUMA OPERATION AND MAINTENANCE BOARD
FISHERIES DIVISION**

APRIL 10, 2018

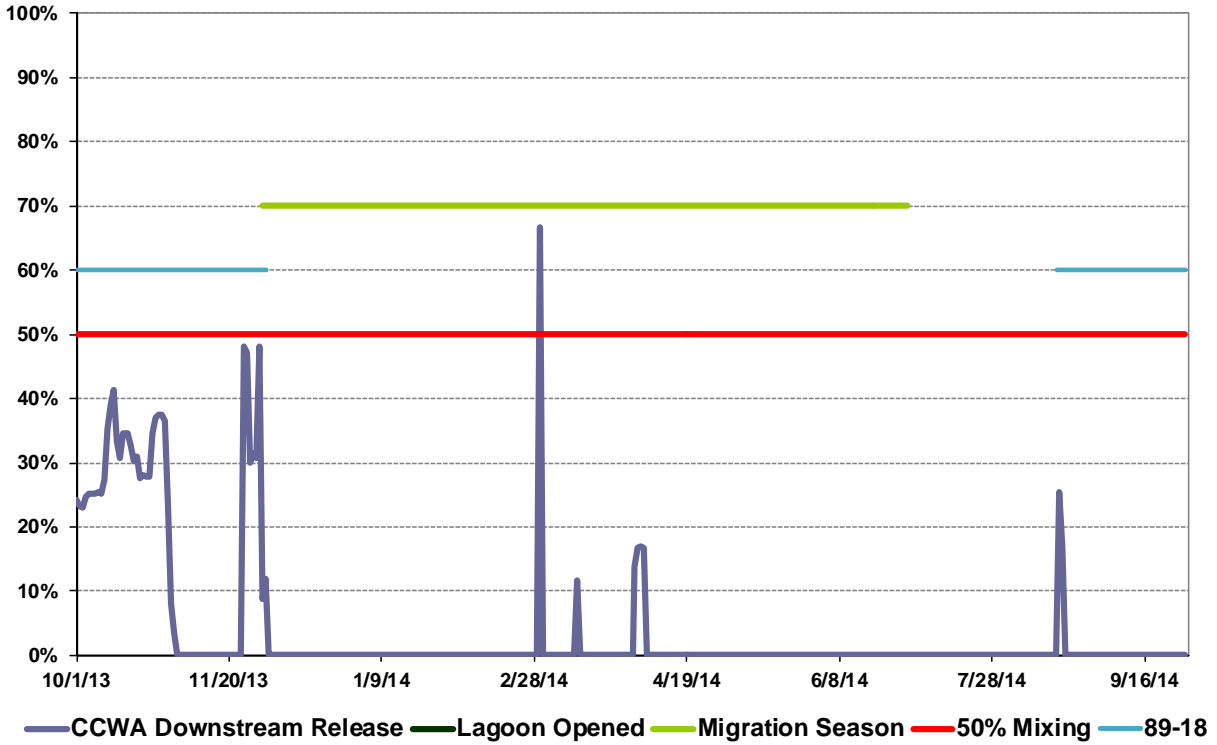
Figure 4: Percentage of CCWA water released from Bradbury Dam downstream to the Long Pool and the Lower Santa Ynez River during the WY2014 migration season; the lagoon was not open throughout the monitoring period.

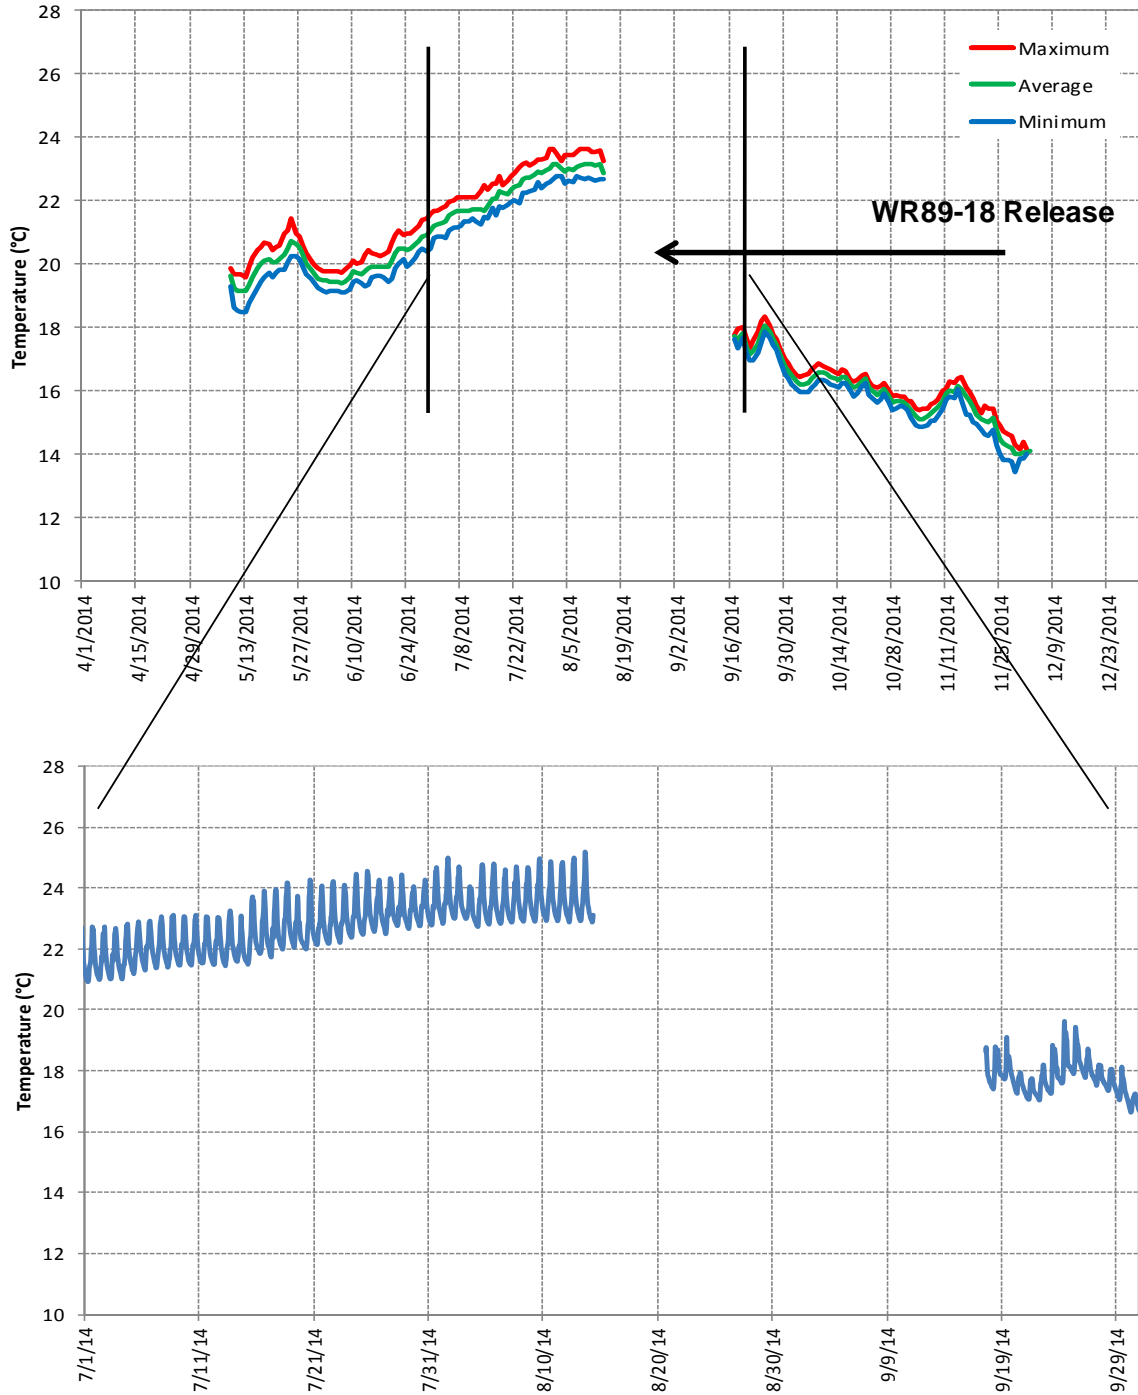
Figure 6: 2014 LSYR-0.10 (Stilling Basin tailout) surface (1.0 foot) water temperatures for (a) daily maximum, average, and minimum for the entire period of deployment and (b) hourly measurements for the period July 1-October 1.

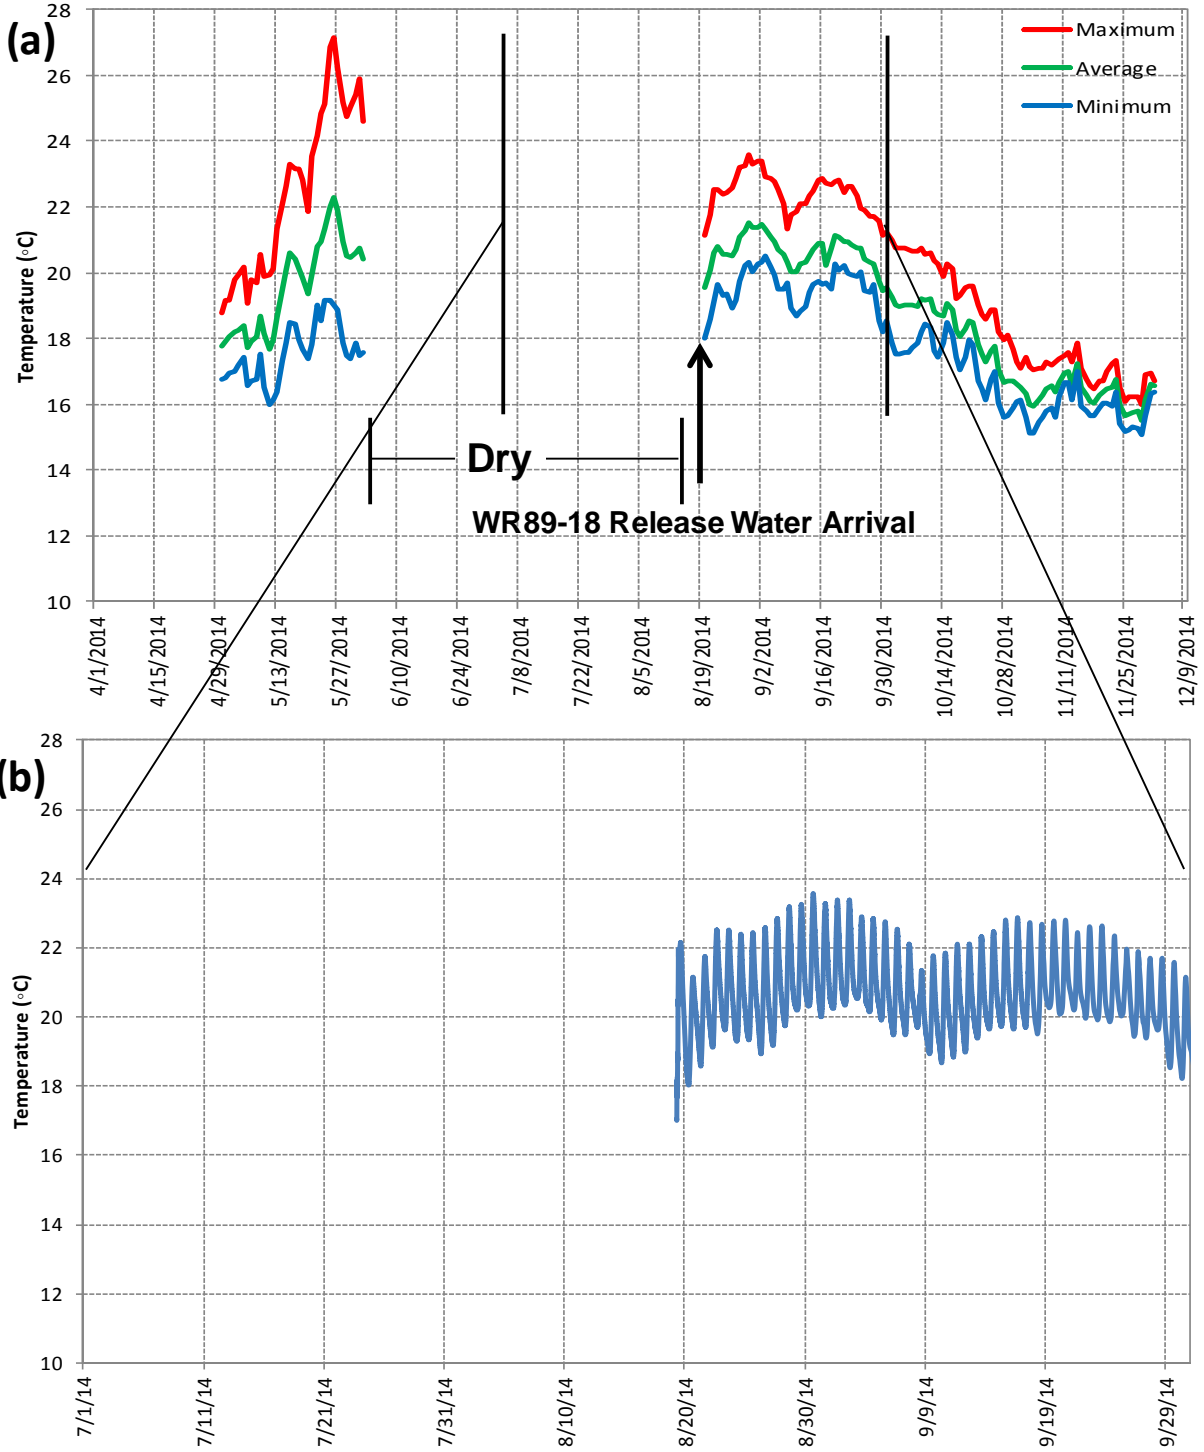
Figure 15: 2014 LSYR-4.95 (Encantado Pool) middle (3.5 feet) thermograph for (a) daily maximum, average, and minimum daily values and (b) hourly data for the period of July 1-October 1; WR89-18 reached the site on 8/19/14.

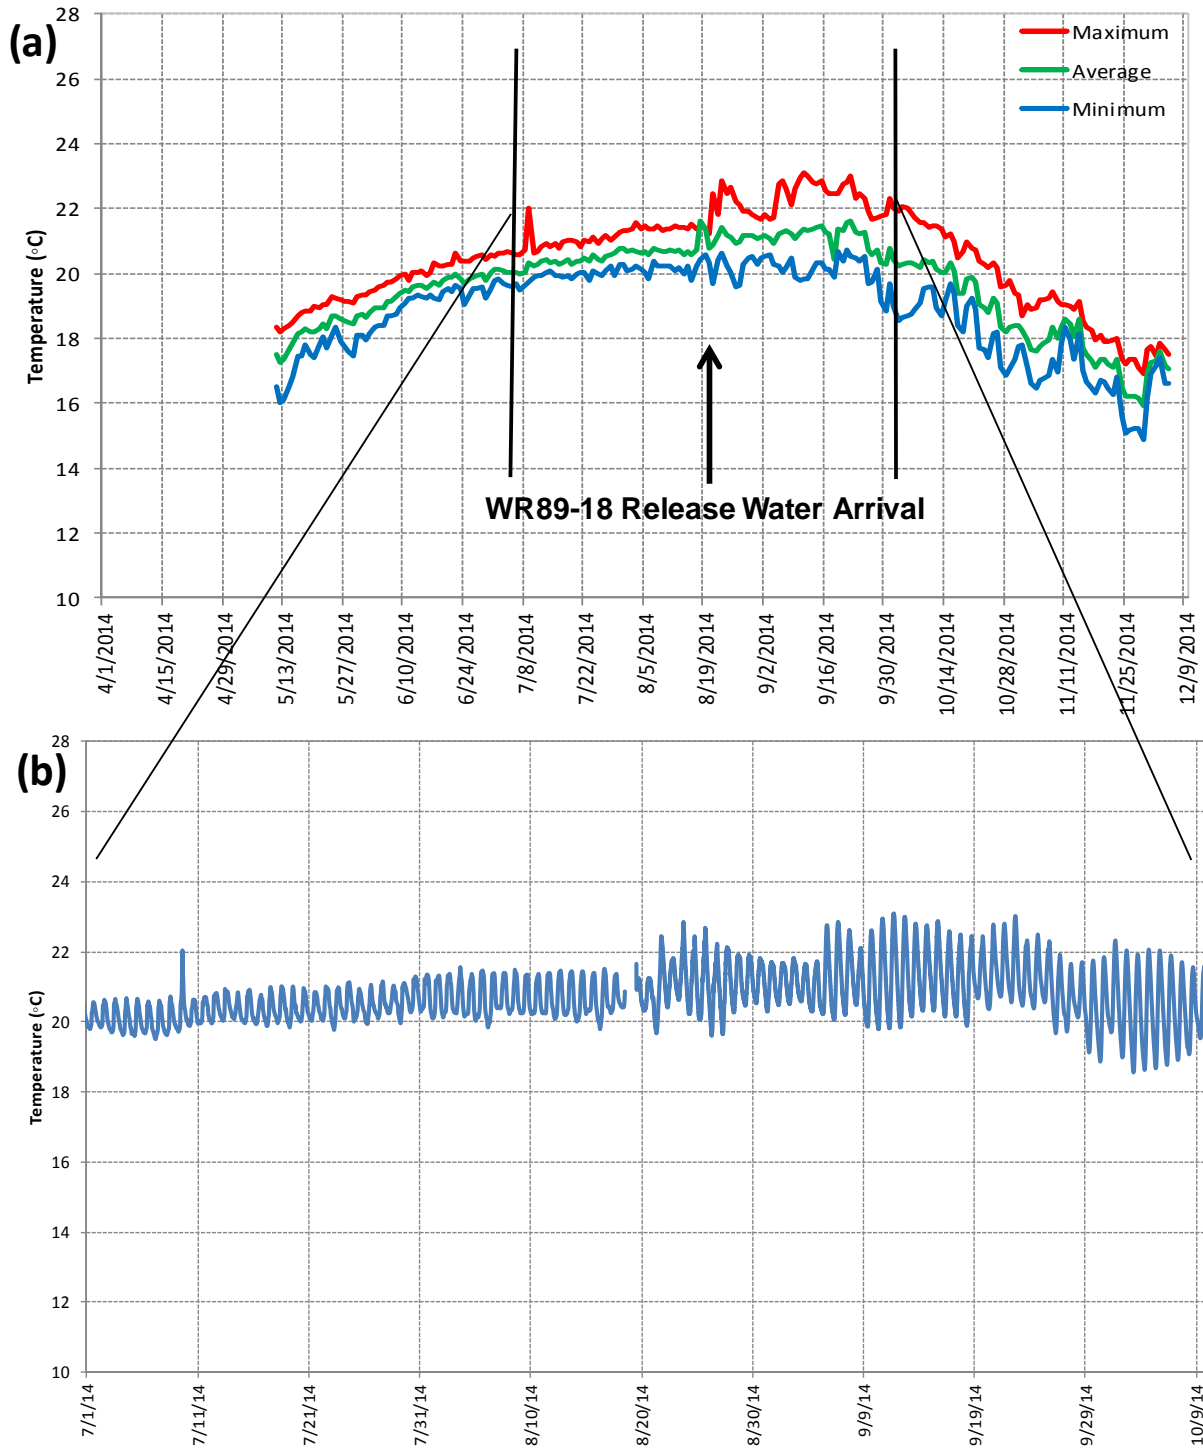
Figure 19: 2014 LSYP-7.65 (Double Canopy Pool) bottom (4.0 feet) thermograph for (a) daily maximum, average, and minimum daily values and (b) hourly data for the period July 1-October 1.

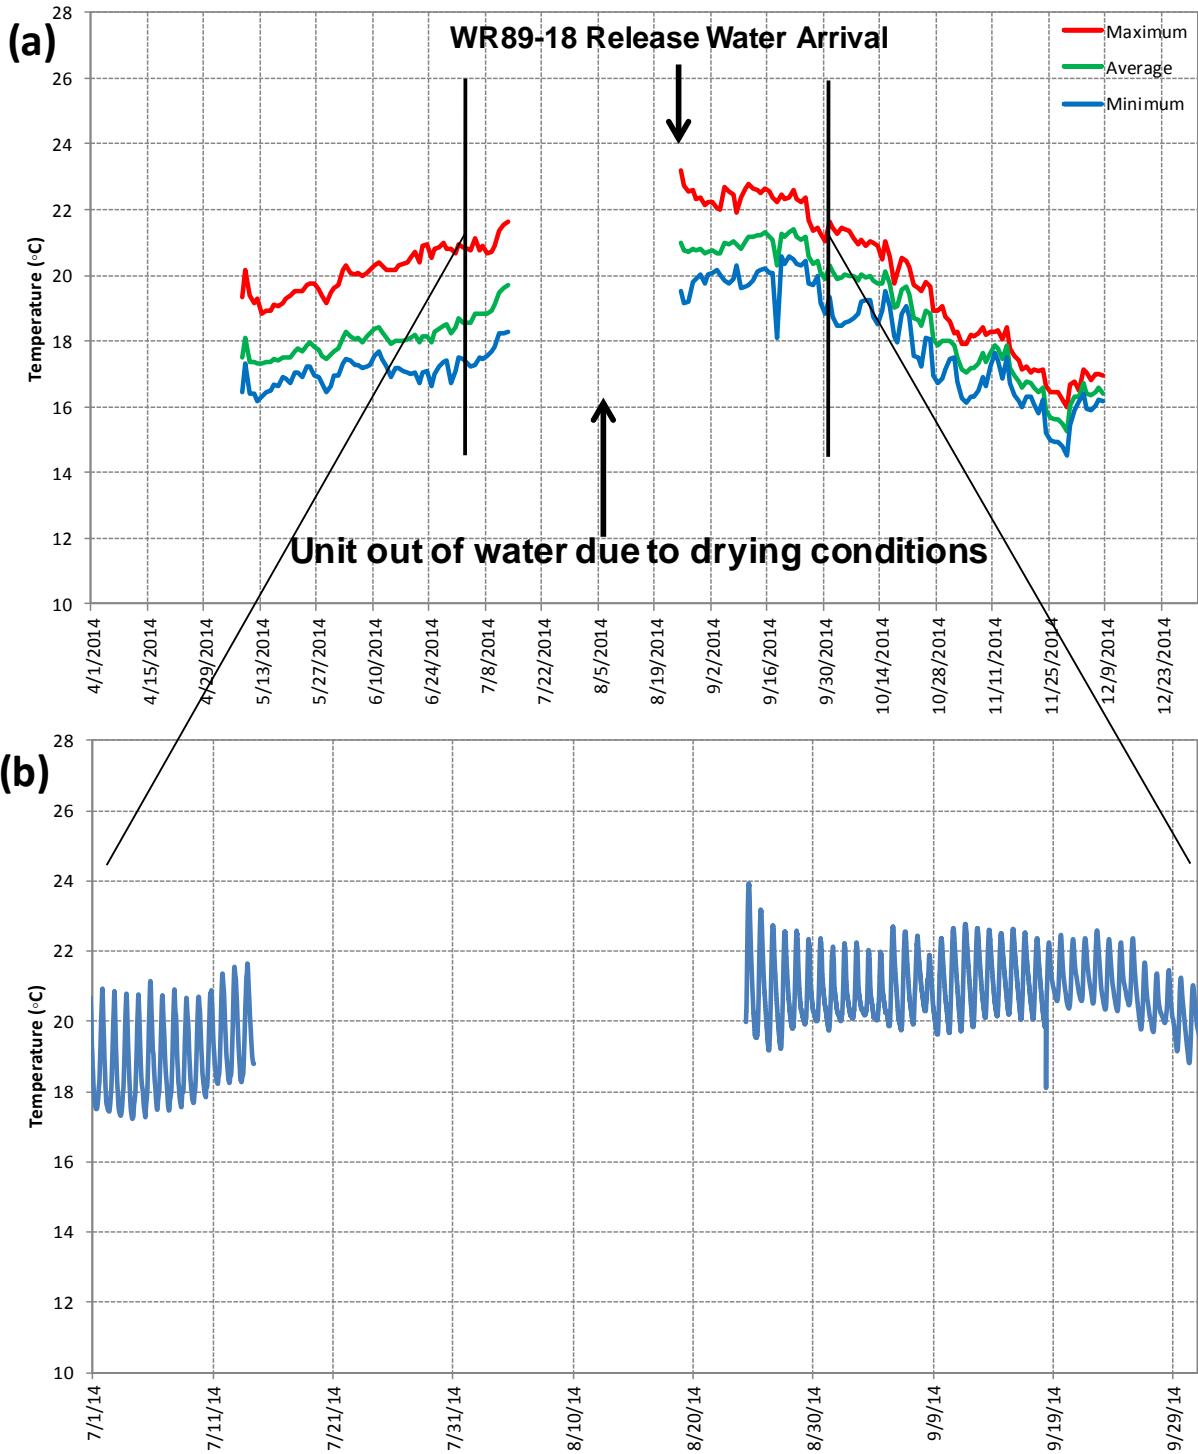
Figure 21: 2014 LSYR-8.7 (Head of Beaver Pool) middle (3.5 feet) thermograph for (a) daily maximum, average, and minimum daily values and (b) hourly data for the period July 1-October 1.

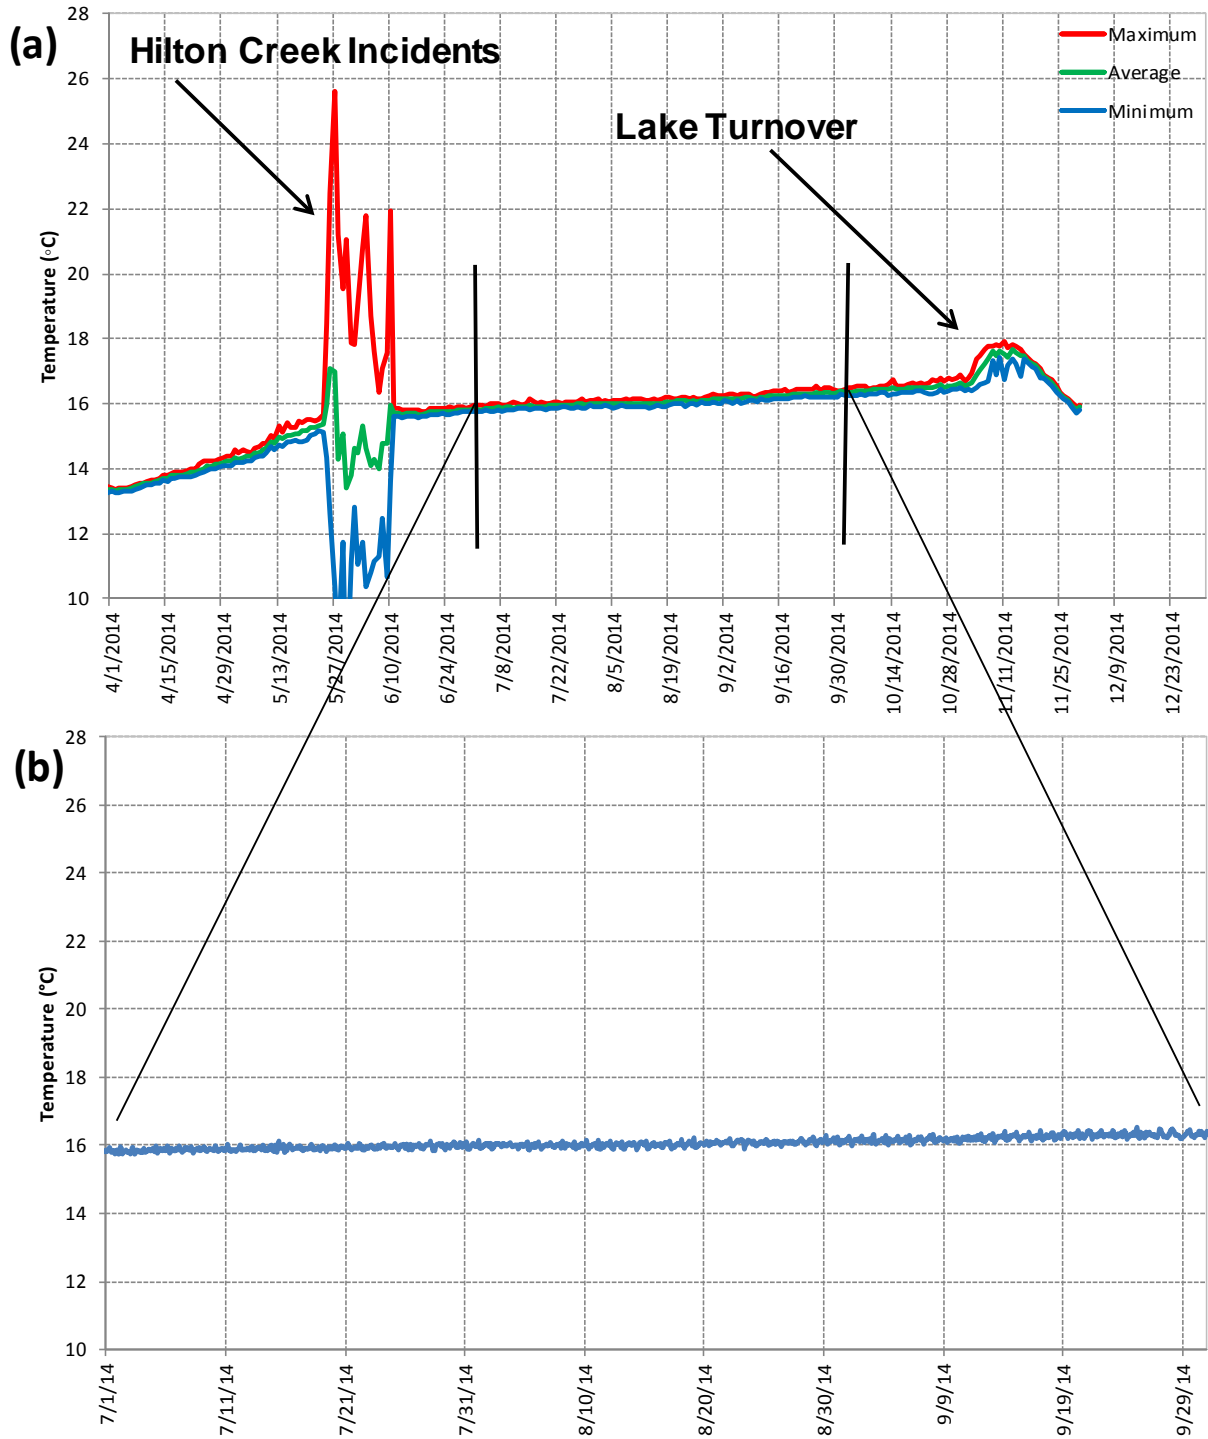
Figure 32: 2014 HC-0.54 (Upper Hilton Creek) bottom (2.5 feet) thermograph for (a) daily maximum, average, and minimum daily values and (b) hourly data for the period July 1-October 1. Included in the graph is a Hilton Creek dewatering incident where the thermographs was exposed to air.
