WY2021 ANNUAL MONITORING SUMMARY

THE BIOLOGICAL OPINION FOR THE OPERATION AND MAINTENANCE OF THE CACHUMA PROJECT ON THE SANTA YNEZ RIVER IN SANTA BARBARA COUNTY, CALIFORNIA

**CACHUMA OPERATION AND MAINTENANCE BOARD
FISHERIES DIVISION**

MARCH 1, 2022

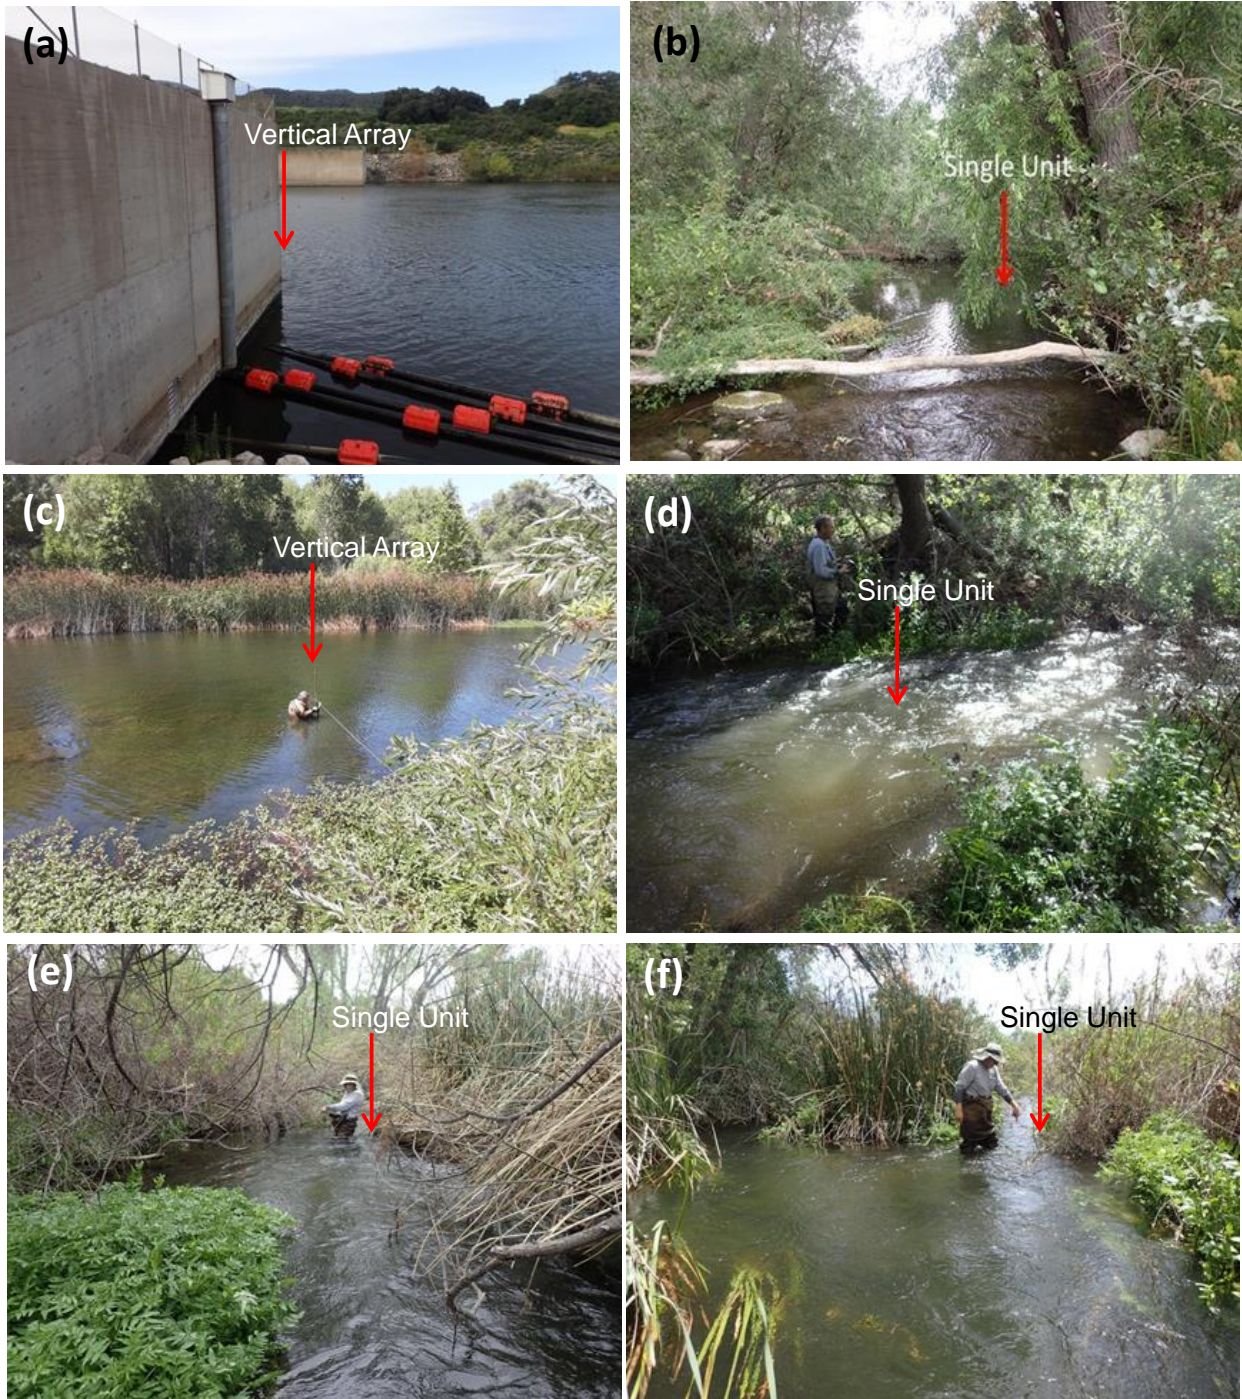
Figure 6: 2021 LSYR mainstem temperature unit deployment locations at: (a) LSYR-0.01, (b) LSYR-0.25, (c) LSYR-0.51, (d) LSYR-0.68, (e) LSYR-1.09, and (f) LSYR-1.54.

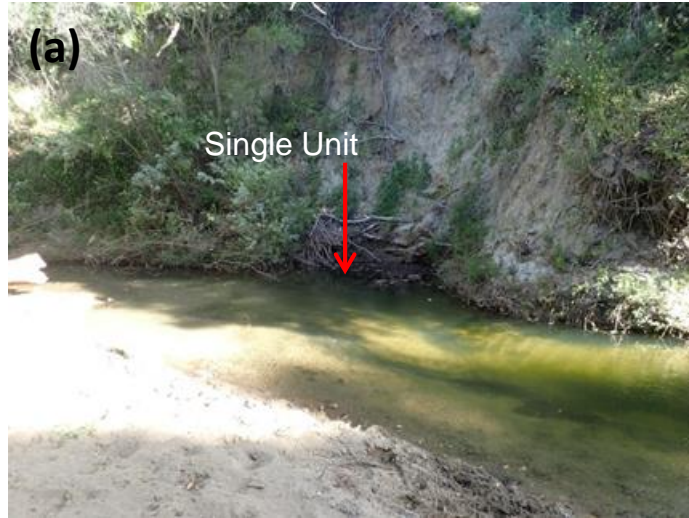
Figure 10: 2021 Tributary temperature unit deployment location at: a) LAC-7.0.

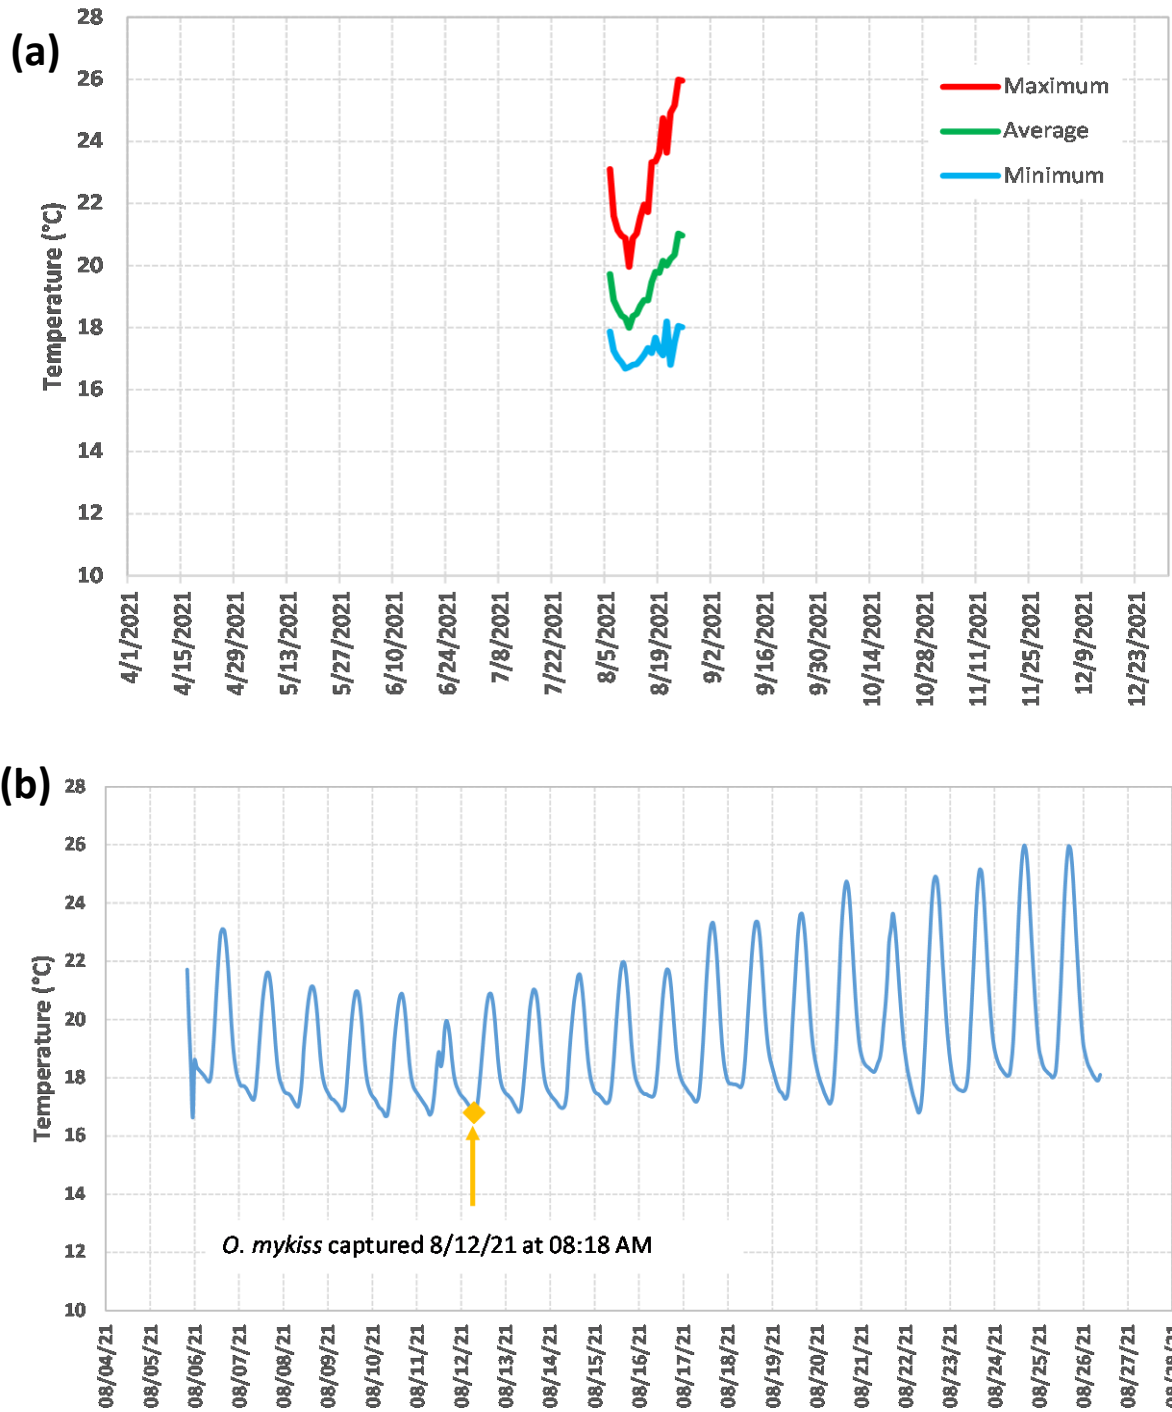
Figure 28: 2021 LSYR-6.08 (Mainstem Trap Site) bottom (3.0 foot) water temperature for (a) daily maximum, average, and minimum for the entire period of record and (b) hourly measurements for the entire period of record; unit deployed to monitor water temperature conditions during trapping of the WR89-18 release; one 88 mm (3.5 inch) *O. mykiss* was captured moving downstream on 8/12/21.

Figure 28: 2021 LSYR-6.08 (Mainstem Trap Site) bottom (3.0 foot) water temperature for (a) daily maximum, average, and minimum for the entire period of record and (b) hourly measurements for the entire period of record; unit deployed to monitor water temperature conditions during trapping of the WR89-18 release; one 88 mm (3.5 inch) *O. mykiss* was captured moving downstream on 8/12/21.

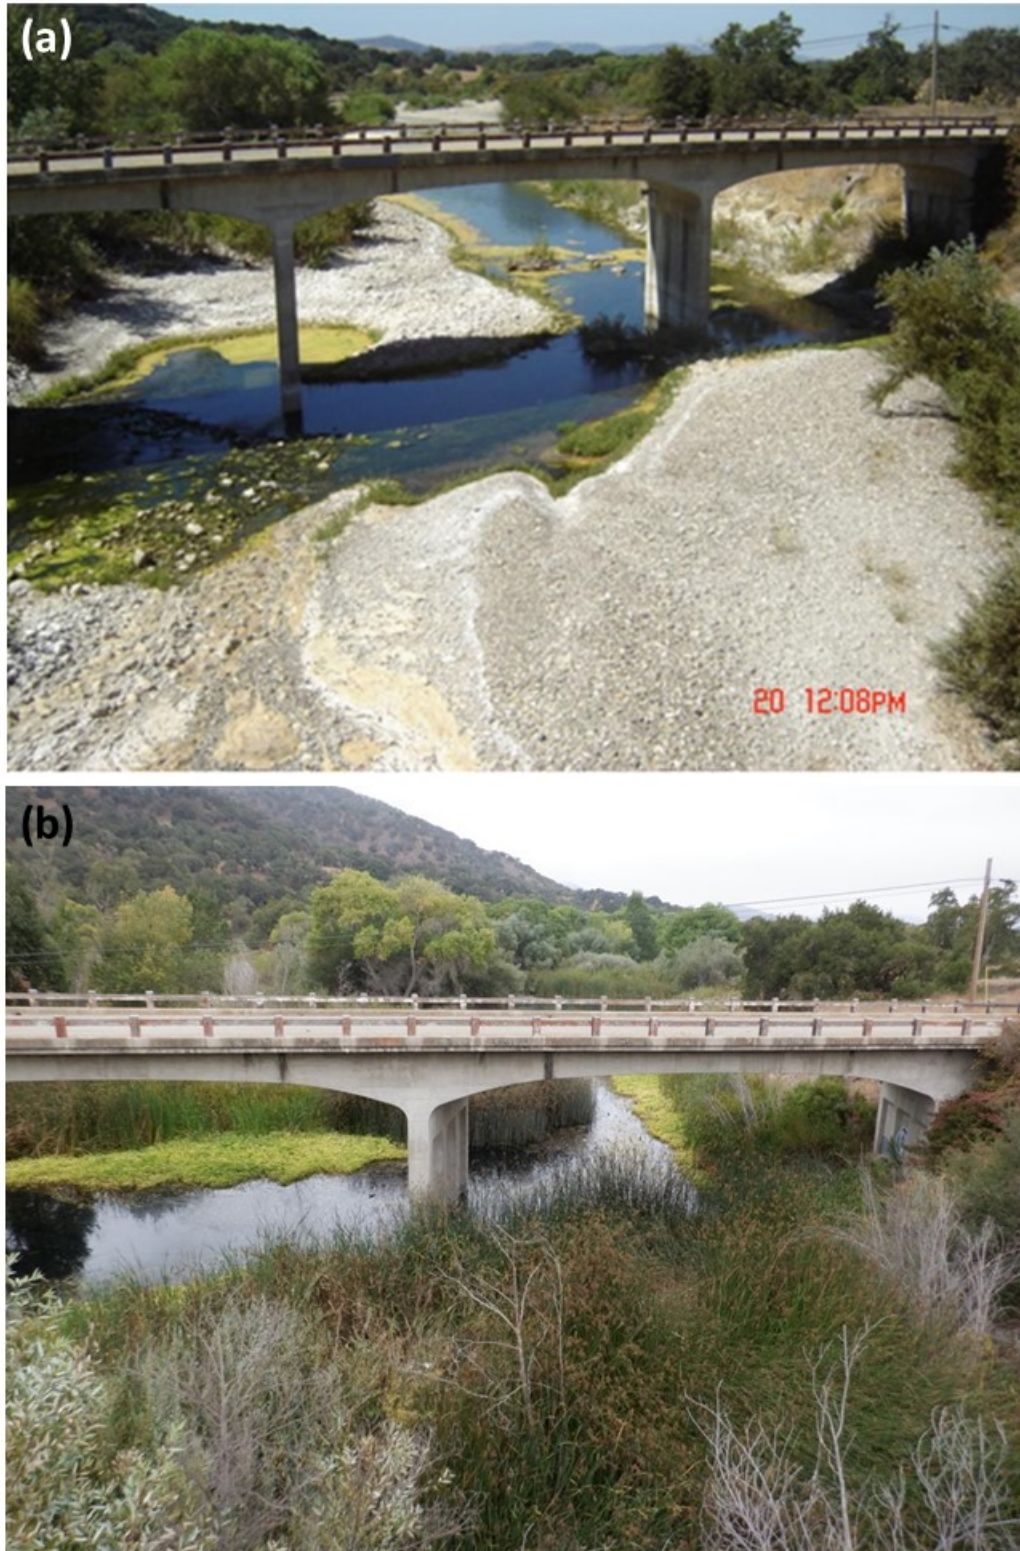
Figure 58: Photo points (M-6) collected at Highway 154 Bridge looking downstream in (a) September 2005 and (b) September 2021.

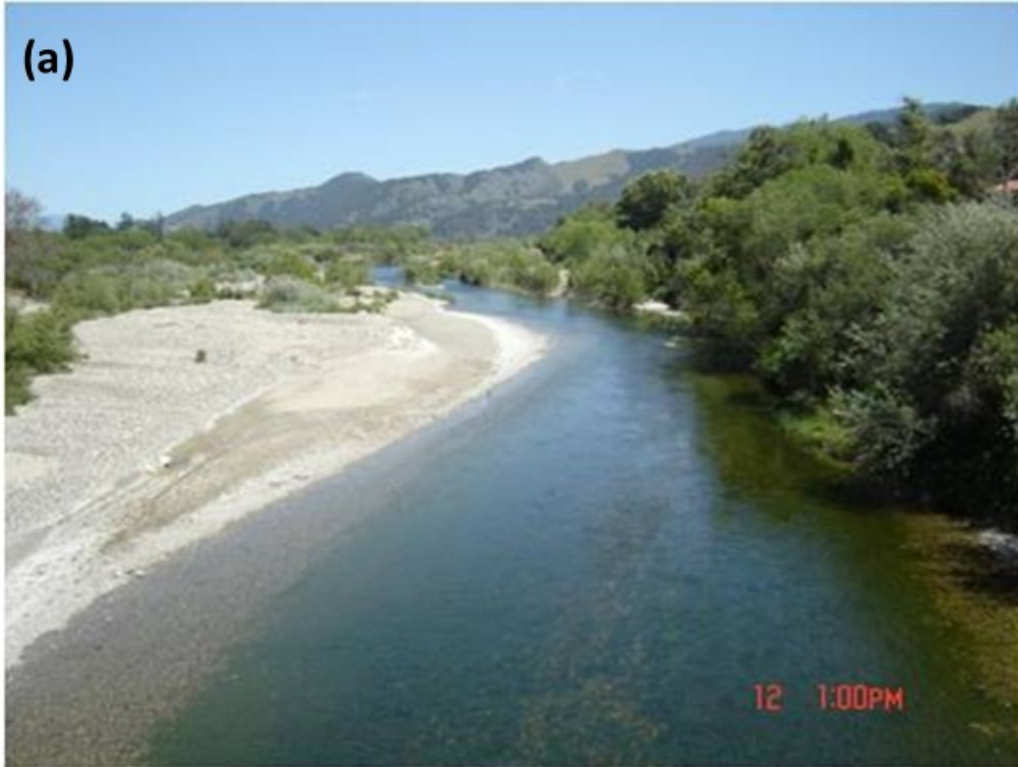
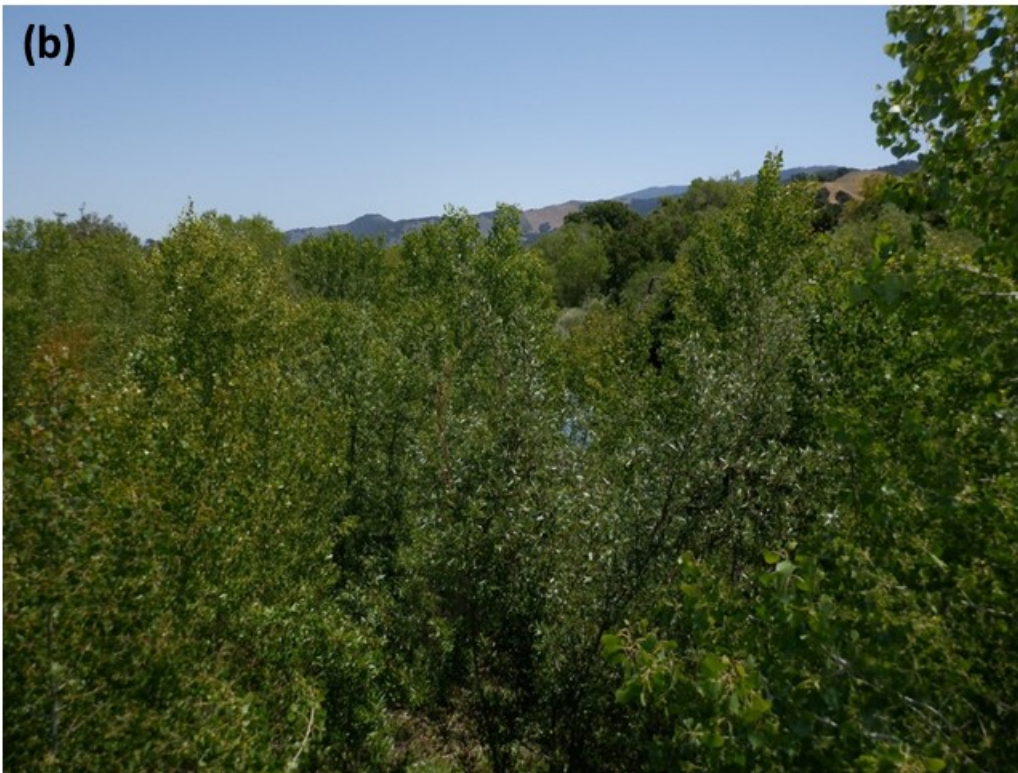
Figure 59: Photo point (M-12) collected at Refugio Bridge looking upstream in (a) May 2005, and (b) September 2021.

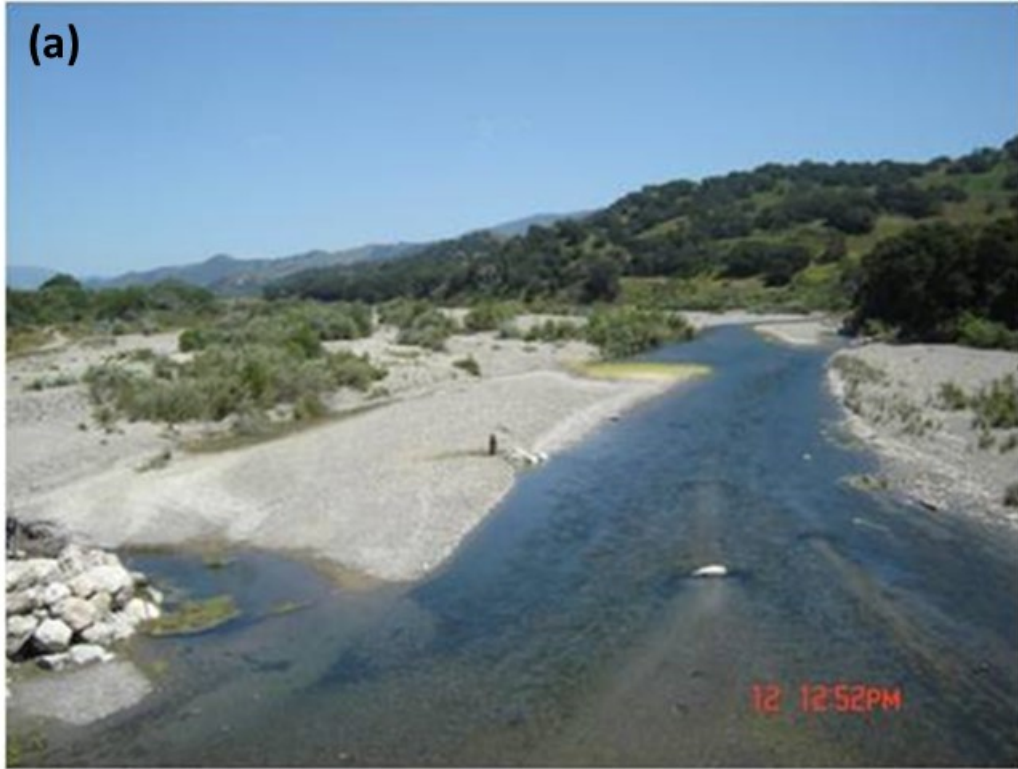
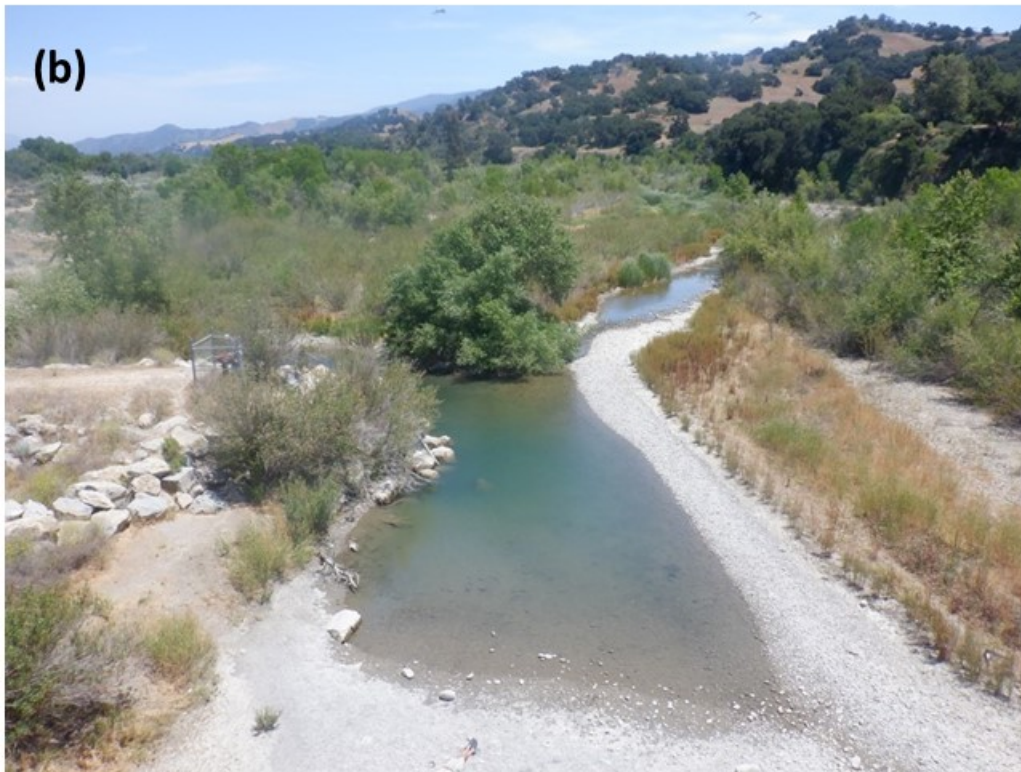
Figure 60: Photo point (M-14) collected at Alisal Bridge looking upstream in a) May 2005, and b) June 2021.

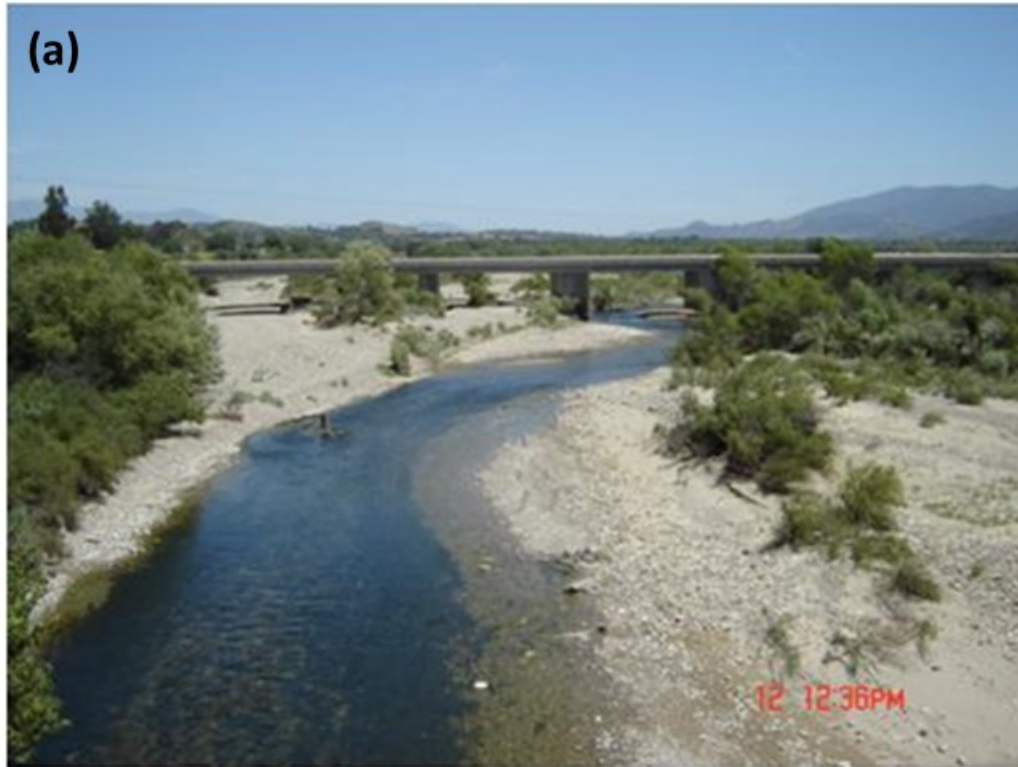
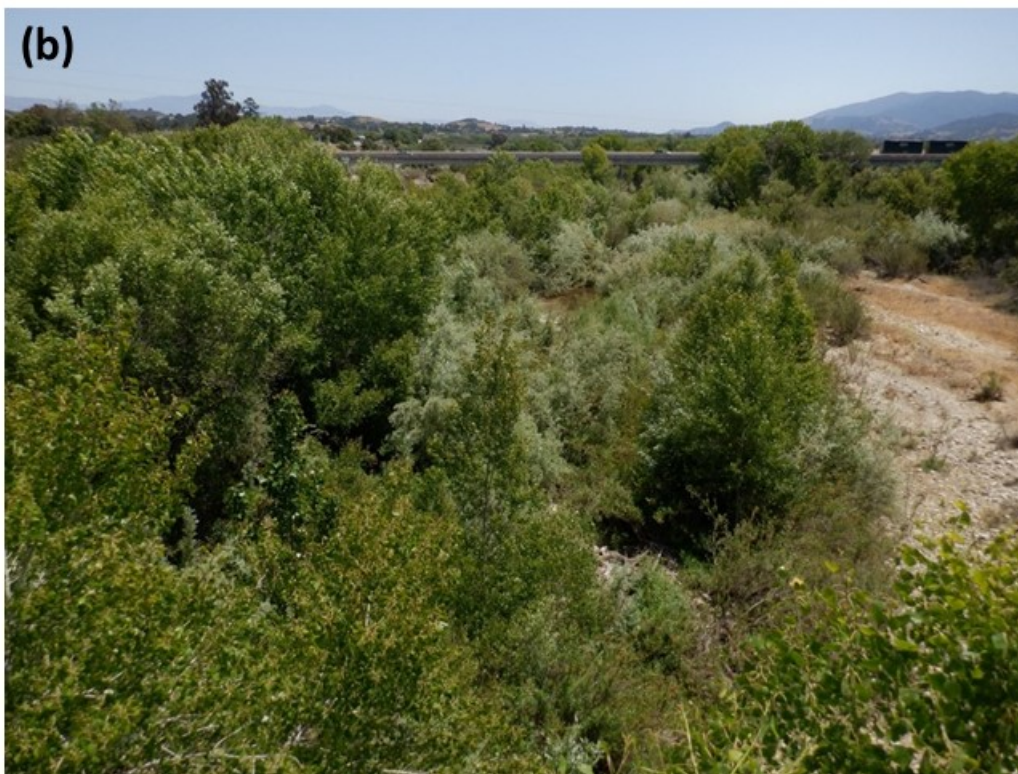
Figure 61: Photo point (M-19) collected at Avenue of the Flags Bridge looking upstream in (a) May 2005, and (b) May 2021.

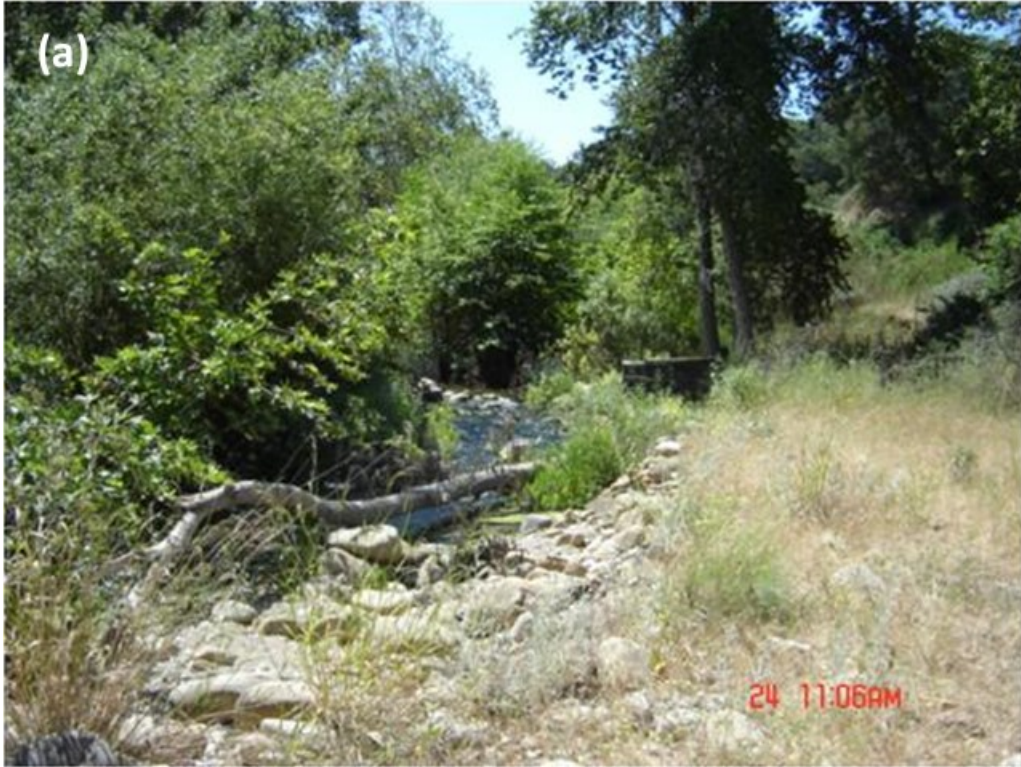
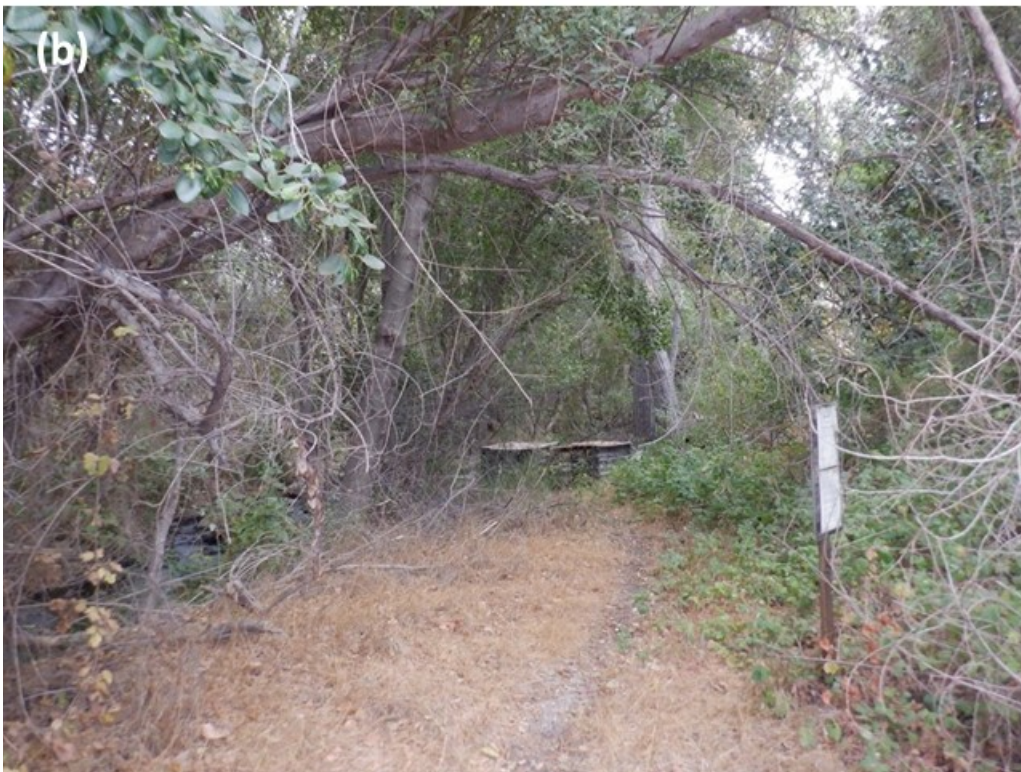
Figure 63: Photo point (T-1) collected at Hilton Creek looking upstream towards the trap site on (a) May 2005, and (b) September 2021.

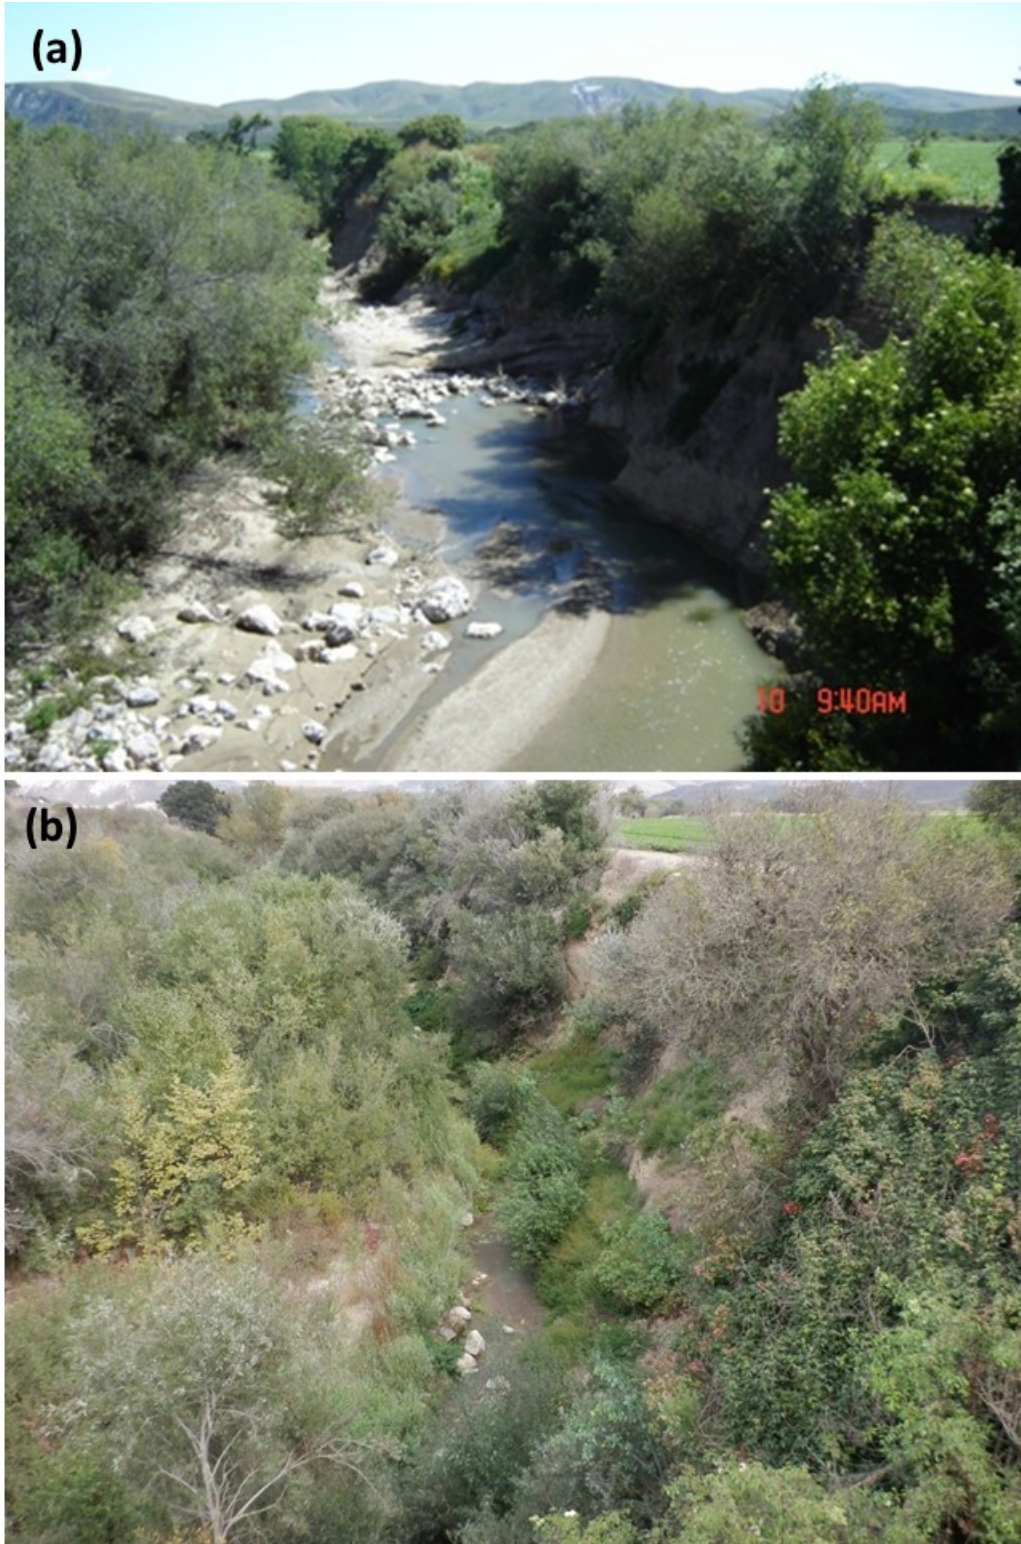
Figure 65: Photo point (T-28) collected at Salsipuedes Creek at Santa Rosa Bridge in (a) May 2005 and (b) September 2021.

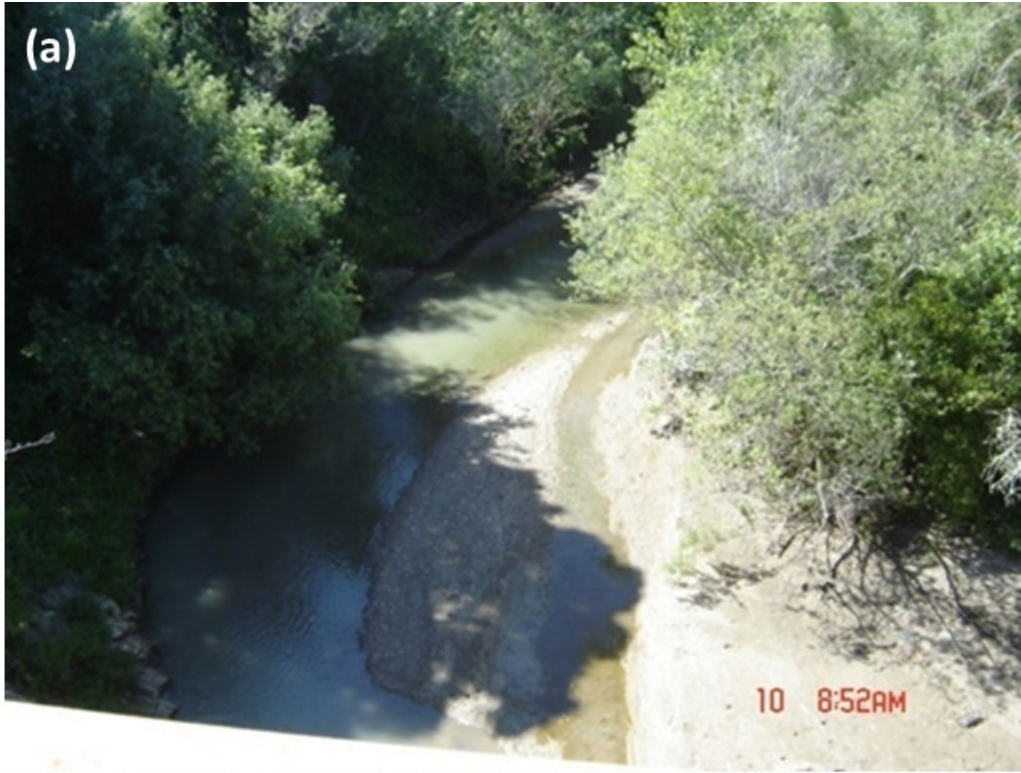
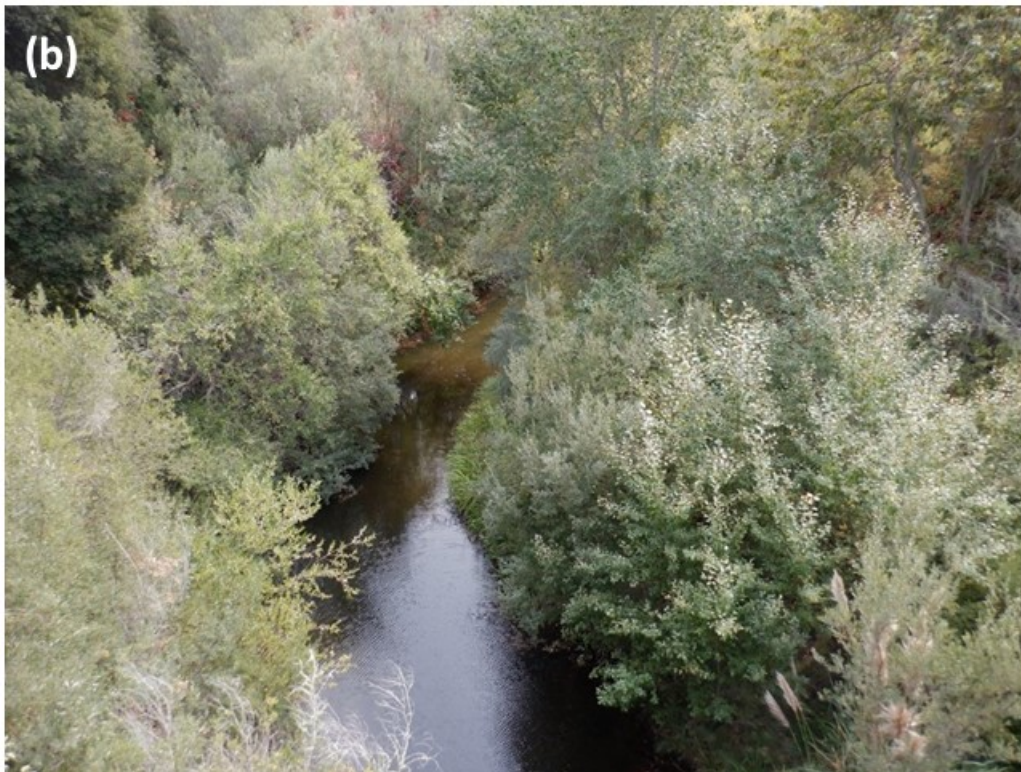
Figure 67: Photo point (T-42) collected at Salsipuedes Creek at Jalama Road Bridge in May 2005 and (b) September 2021.

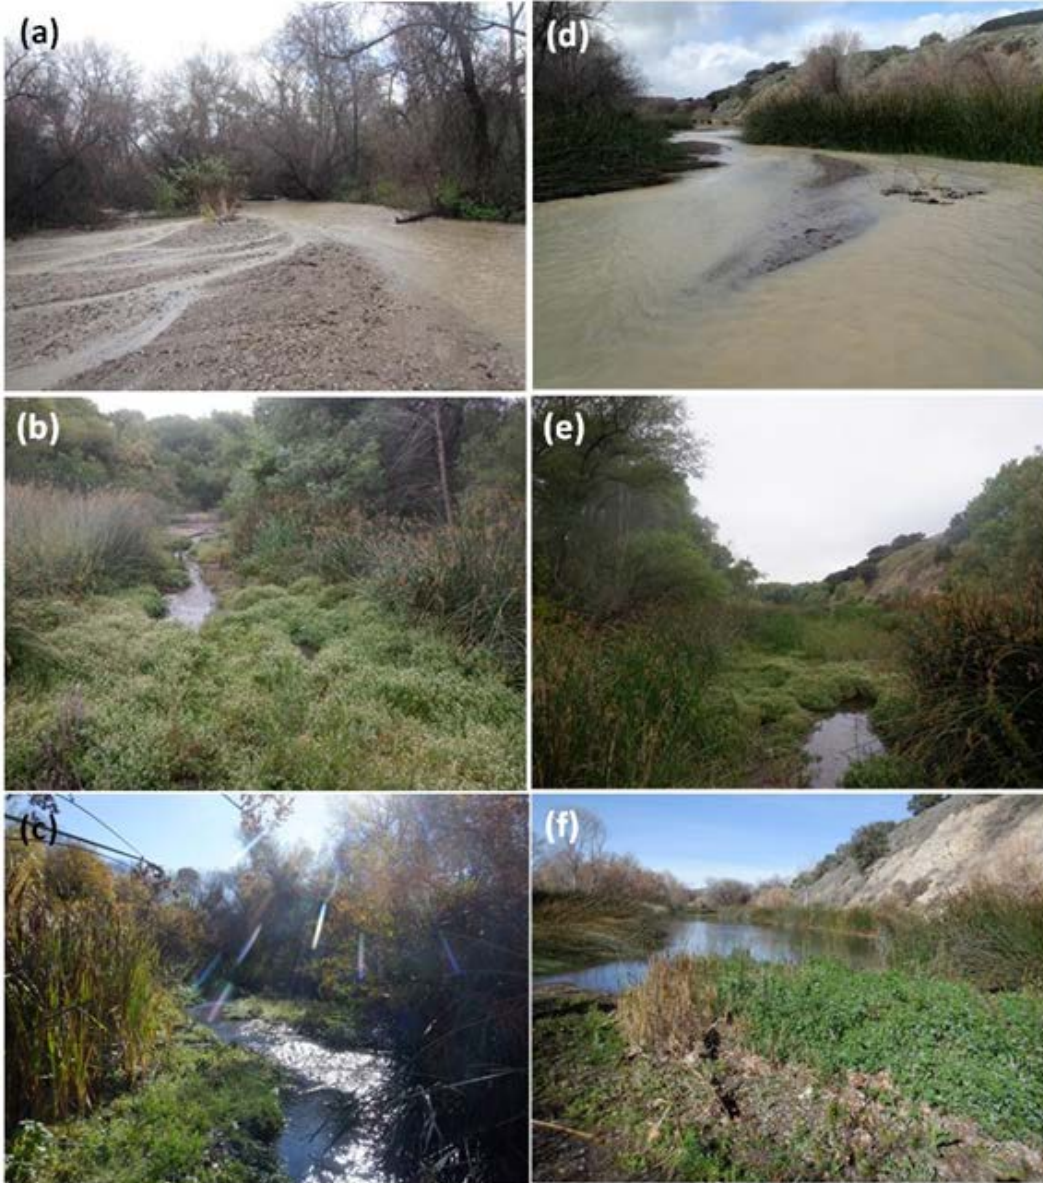
Figure 91: Delta formation at head of Long Pool along the LSYS mainstem looking up towards the Hilton Creek confluence on (a) 2/4/19, (b) 5/29/20, and (12/3/21; and looking downstream towards the Long Pool on (d) 2/5/19, (e) 11/16/20, and (f) 12/3/21 showing a newly defined and evolving channel.

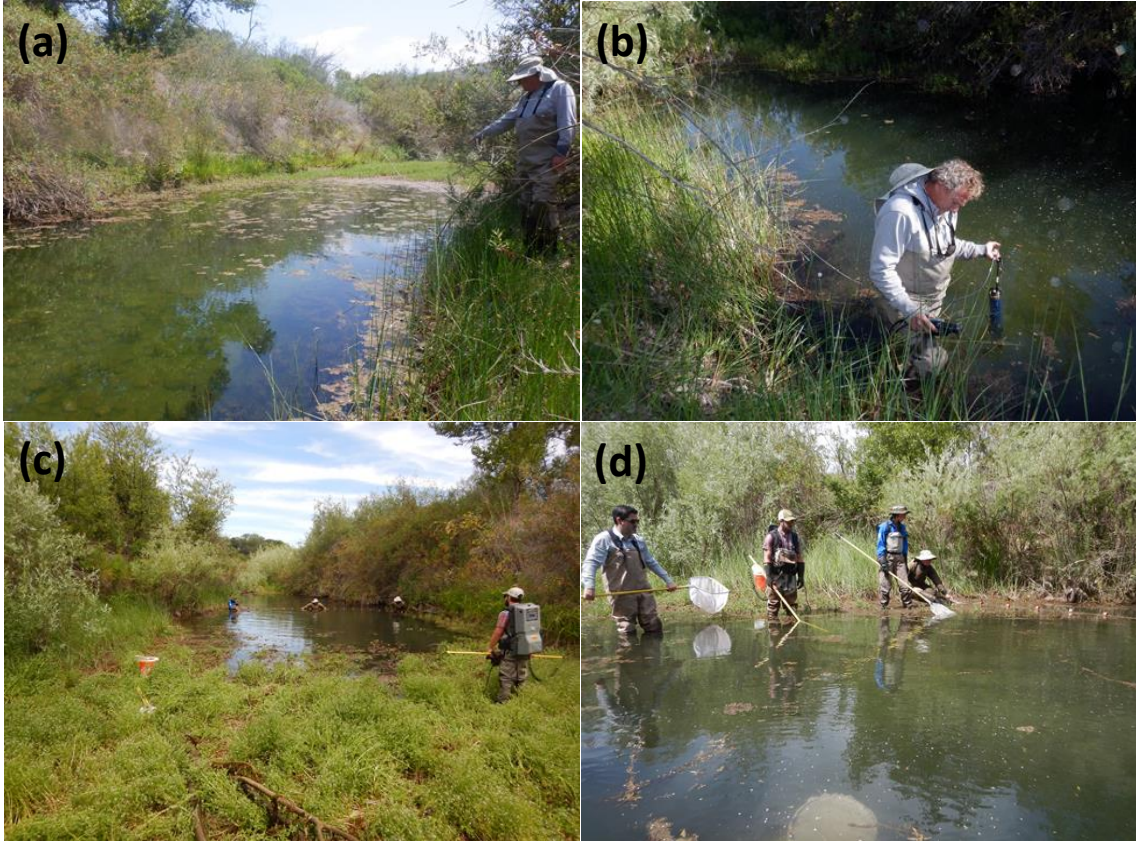
Flow and water quality conditions were carefully monitored in the Narrows Reach in April and May. Reduced flow and poor water quality (low DO in particular), prompted coordination by the resource agencies (CDFW and NMFS) to conduct a fish rescue operation on 5/15/21. The Fish Rescue Team (CDFW and COMB-FD) attempted to seine (and e-fish the shallower areas) and capture the 5 observed *O. mykiss* from that pool (Figure 97). Several attempts were made with the seine but the habitat remained too deep and too complex to be successful with the seine or potential use of the e-fisher.

Figure 97: The large pool habitat with 5 observed *O. mykiss* within the Narrows Reach where the Fish Rescue Team attempted a rescue by seining and e-fishing in the shallower areas, specifically (a) where the fish were located, (b) taking water quality, and (c + d) seining and e-fishing.

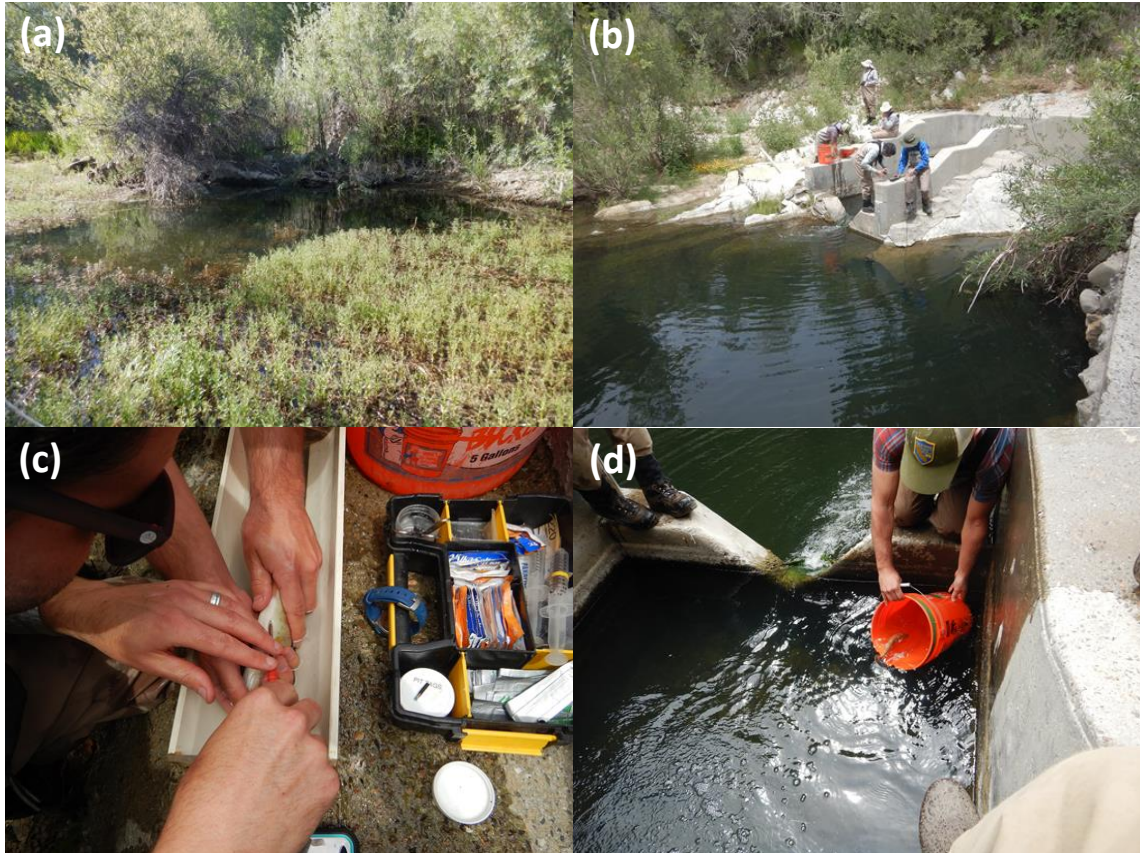
That same day the team scouted additional habitats downstream in need of potential fish rescue. A deep and narrow pool habitat located just downstream (34.589357, -120.408858) was electrofished and two *O. mykiss* were successfully removed from that drying habitat (Figure 96). Those fish measured 213 mm and 242 mm. Both *O. mykiss* were quickly transported to Salsipuedes Creek at Jalama Bridge (SC-3.5) where they were measured, photographed, fin clipped for genetics analyses, PIT tagged by CDFW, and released in good condition. COMB-FD staff revisited the release site and several hundred yards downstream over the next couple of days looking for any mortalities with none found.

Figure 98: The second fish rescue site within the Narrows Reach showing (a) the location of the rescued fish under the overhanging willow tree, (b) the release point of the captured fish at the Jalama Road Bridge fish ladder, (c) CDFW PIT tagging captured fish, and (d) the release of the tagged fish in the downstream pool of the fish ladder.

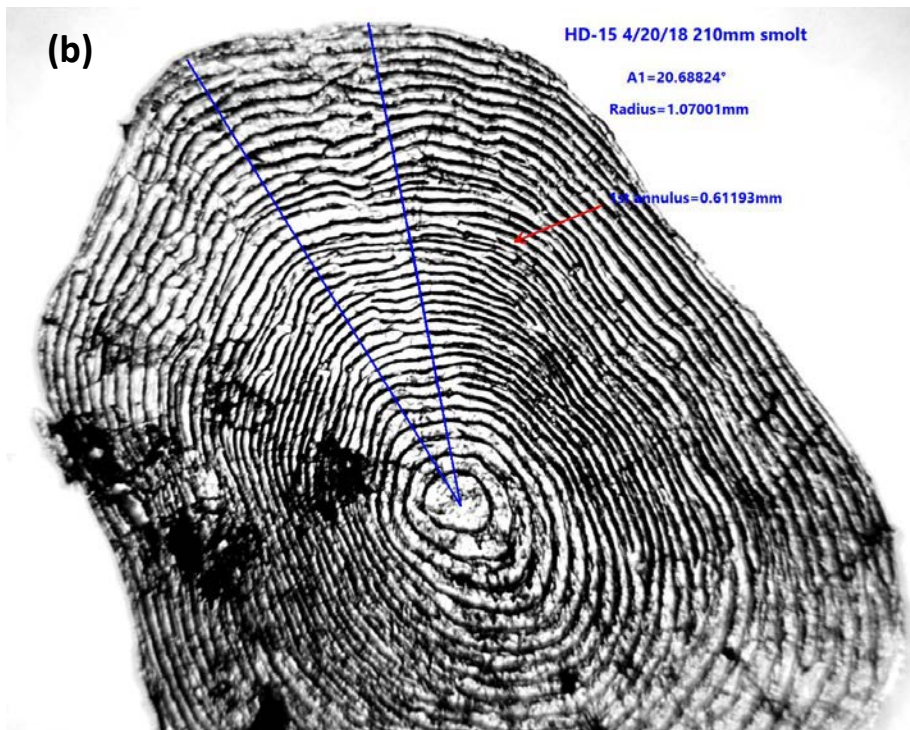
Figure 105: Two WY2018 Hilton Creek downstream migrating smolts (1+) showing similar growth pattern and annulus location; (a) HD-10 217 mm and (b) HD-15 210 mm fish.

Scales were taken and analyzed on 17 of 27 total migrant captures at 2 trap sites (Hilton Creek and Salsipuedes Creek, there were no LSYR mainstem captures) over the WY2018 reporting period. Minimum fish size for tissue sampling was again set at 120 mm and some fish could not be sampled due to their size or the scales were not legible. The age range was from 0+ to 1+ years old with a size range of 132 mm to 210 mm (Table 30). Scales were read from 17 fish of which near all were 1+ year old fish. Scale analyses are valuable and insightful regarding growth patterns, environmental changes, and differences between one stream and another. For example, Hilton Creek with continuous favorable rearing conditions from lake releases result in rapid and consistent growth (Figure 104). It is common to see smolt out-migration in Hilton Creek after just one (1+) age (Figure 105).

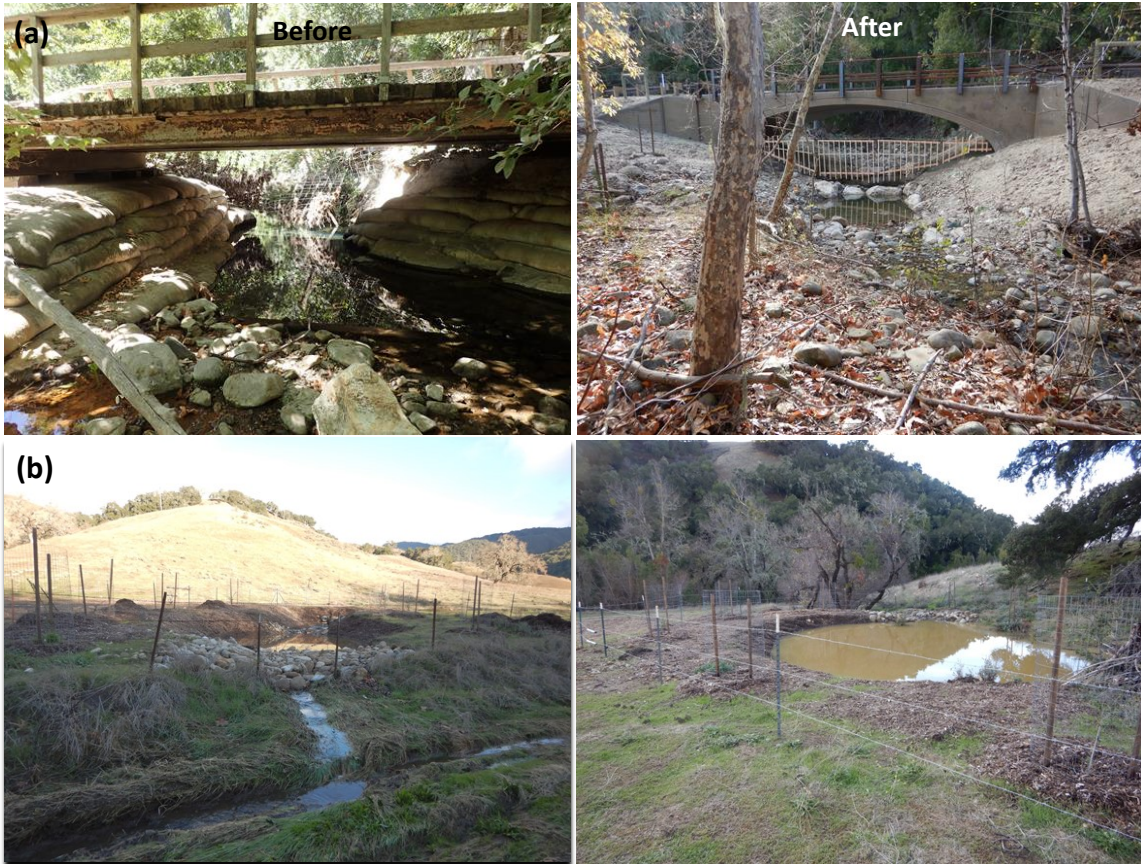
Figure 111: Fish passage and habitat restoration at (a) Quiota Creek Crossing 8 completed in 2019 and (b) South Side Erosion Control and Reforestation Project at Crossing 8 (completed in 2020).

The South Side Erosion Control and Reforestation Project was an enhancement to the completed Quiota Creek Crossing 8 Project by addressing observed erosion problems to the south in two small tributaries. The project was successfully completed at the end of September in WY2020 (Figure 111). Two small settling basins were constructed in each of the two intermittent drainages to reduce sediment delivery to Quiota Creek, a culvert was installed under the ranch road to reduce the erosion potential, ten native Coast Live oak trees (*Quercus agrifolia*) were planted in close proximity to each of the settling basins for reforestation (totaling 20 trees), and all disturbed areas were seeded/mulched within the project footprint. Each basin allows for slowing of the streamflow so that sediments can settle out during high flow events when the tributaries are running that results in reduced sediment delivery to the perennial channel of Quiota Creek.

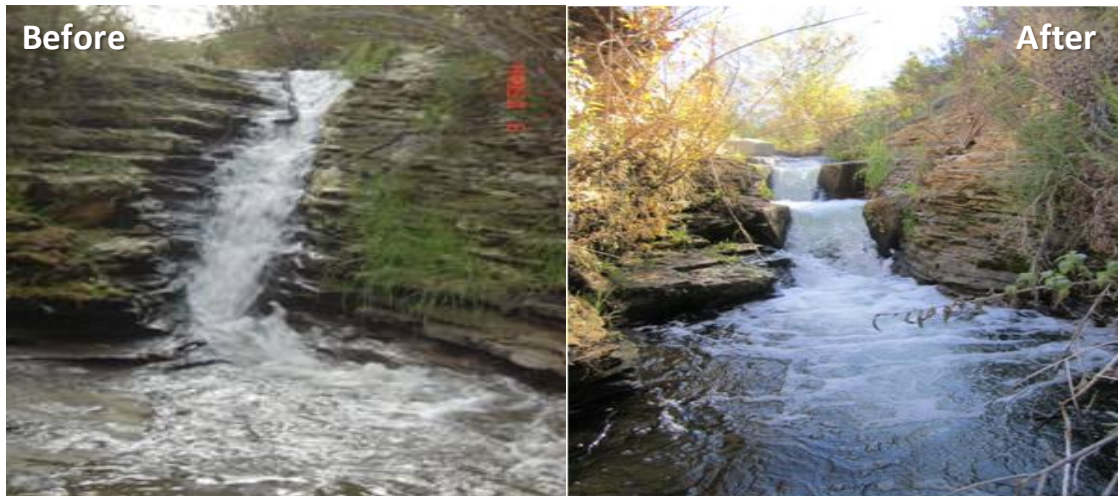
Figure 112: Fish passage and habitat restoration at Hilton Creek at the Cascade Chute Project that was completed in 2005.

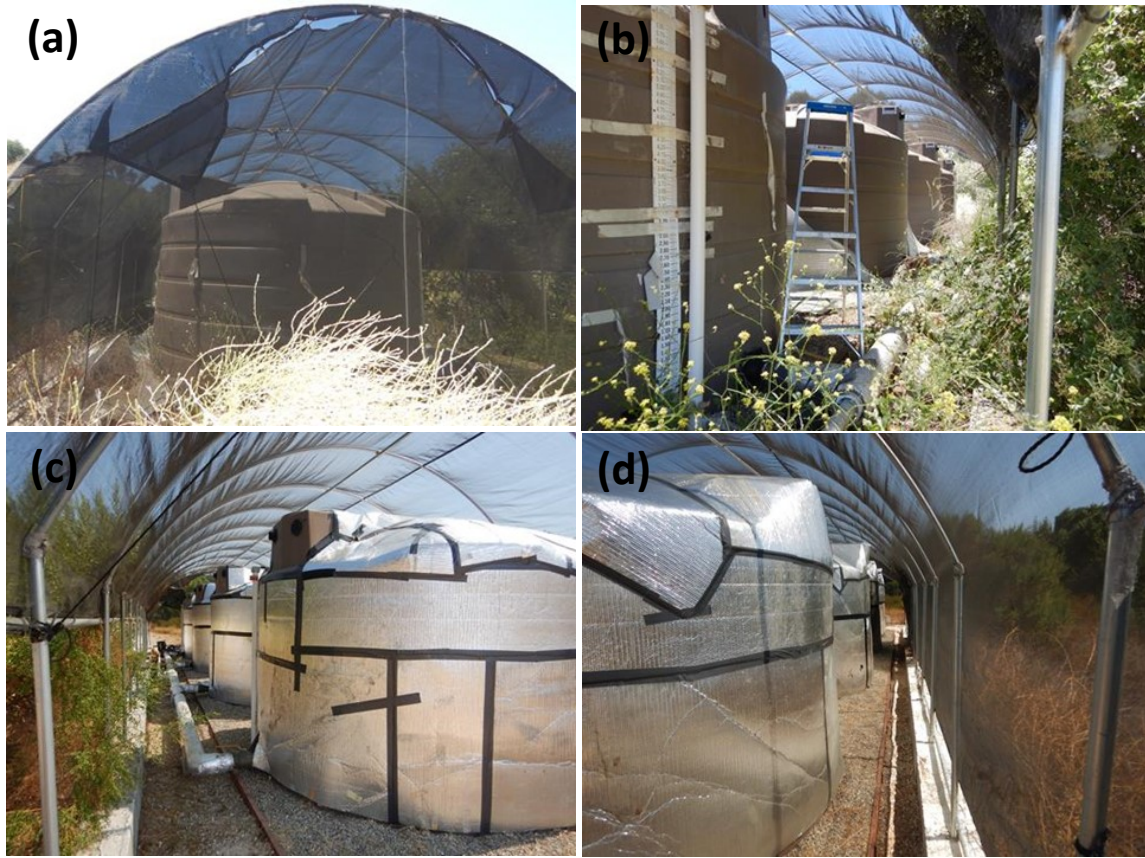
Figure 114: Hilton Creek water tanks (a+b) before and (c+d) after COMB-FD repairs.

Figure 114: Hilton Creek water tanks (a+b) before and (c+d) after COMB-FD repairs.
