2011 ANNUAL MONITORING SUMMARY AND TREND ANALYSIS

THE BIOLOGICAL OPINION FOR THE OPERATION AND MAINTENANCE OF THE CACHUMA PROJECT ON THE SANTA YNEZ RIVER IN SANTA BARBARA COUNTY, CALIFORNIA

**CACHUMA OPERATION AND MAINTENANCE BOARD
FISHERIES DIVISION**

JUNE 28, 2013

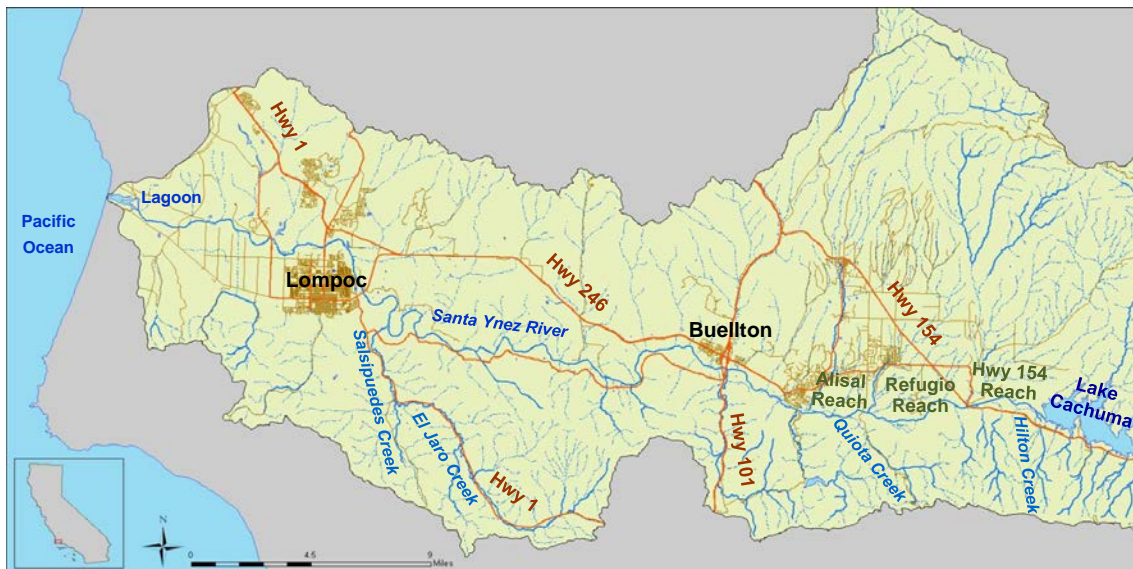
Figure ES-1: LSYR from Bradbury Dam and Lake Cachuma to the Pacific Ocean to the west of Lompoc showing tributary creeks and management reaches of interest for the LSYR Fisheries Monitoring Program.

The monitoring tasks completed in WY2011 were performed below Bradbury Dam in the LSYR watershed or in Lake Cachuma, which is approximately half the area (450 square miles) and stream distance (48 miles) to the ocean compared to the entire watershed. The area is within the Southern California Steelhead Distinct Population Segment (DPS). Monitoring focused on three management reaches (Highway 154, Refugio, and Alisal reaches) on the LSYR mainstem and tributaries (Hilton, Quiota, El Jaro, and Salsipuedes creeks) known to support suitable habitat for *O. mykiss* (Figure ES-1).

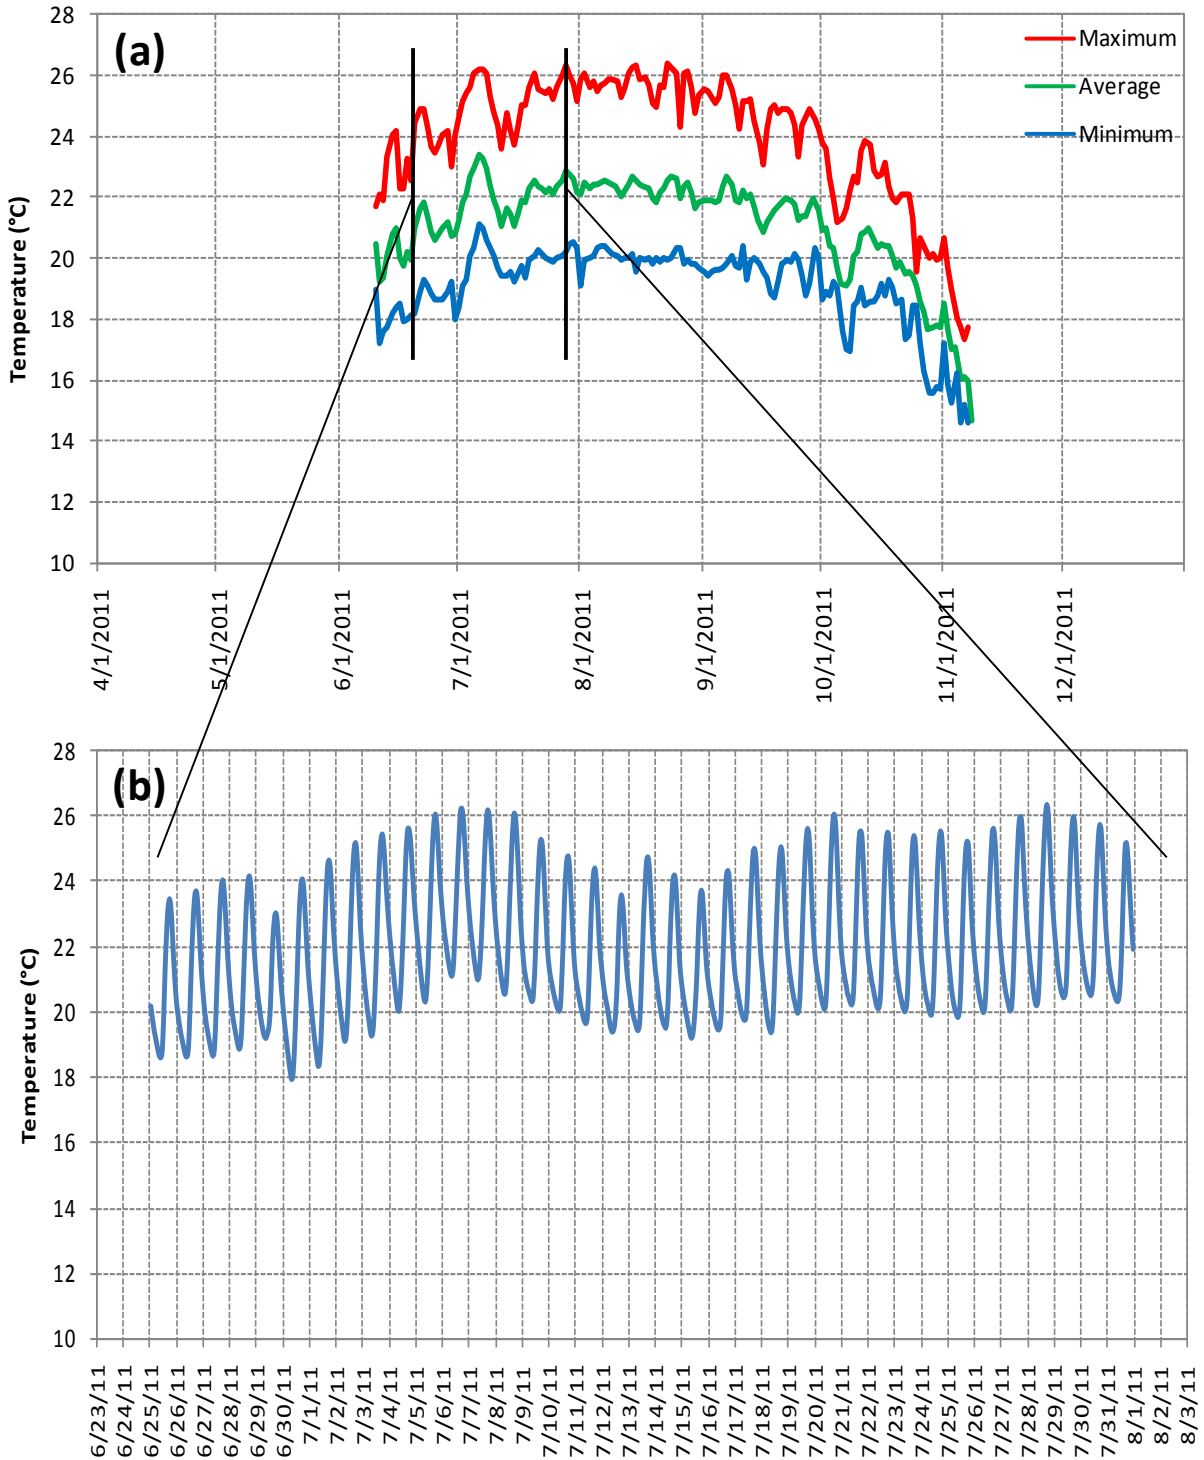
Figure 17: 2011 9.7 Pool (LSYR-9.7) middle (2.0 foot) thermograph for (a) daily maximum, average, and minimum daily values and (b) hourly data for the period 6/25/11-7/31/11.

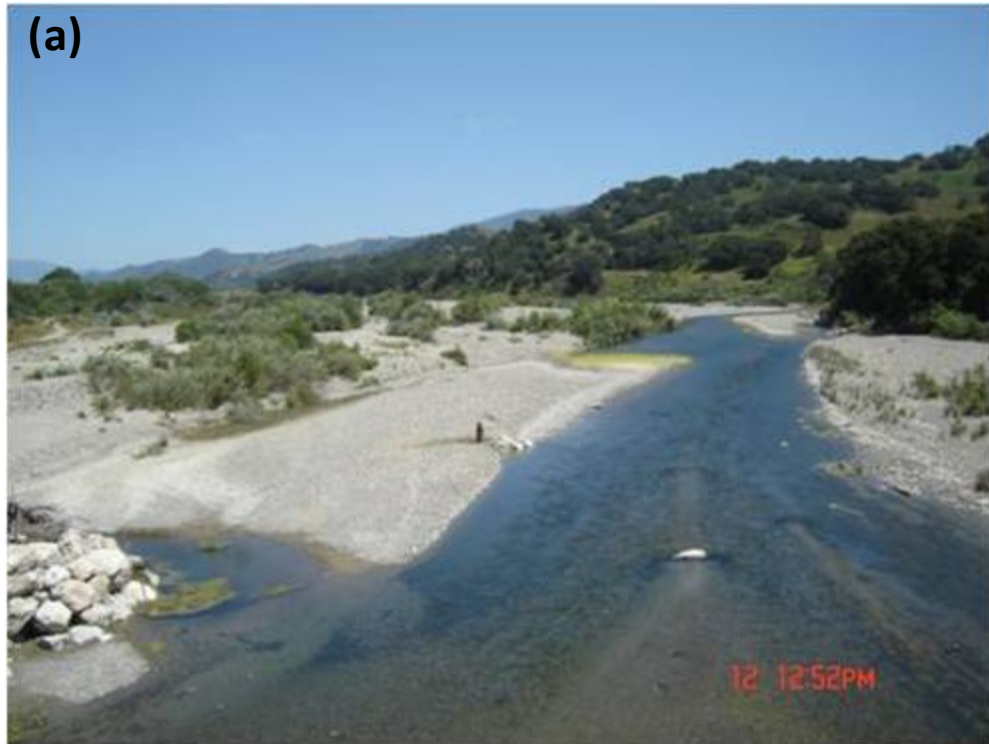
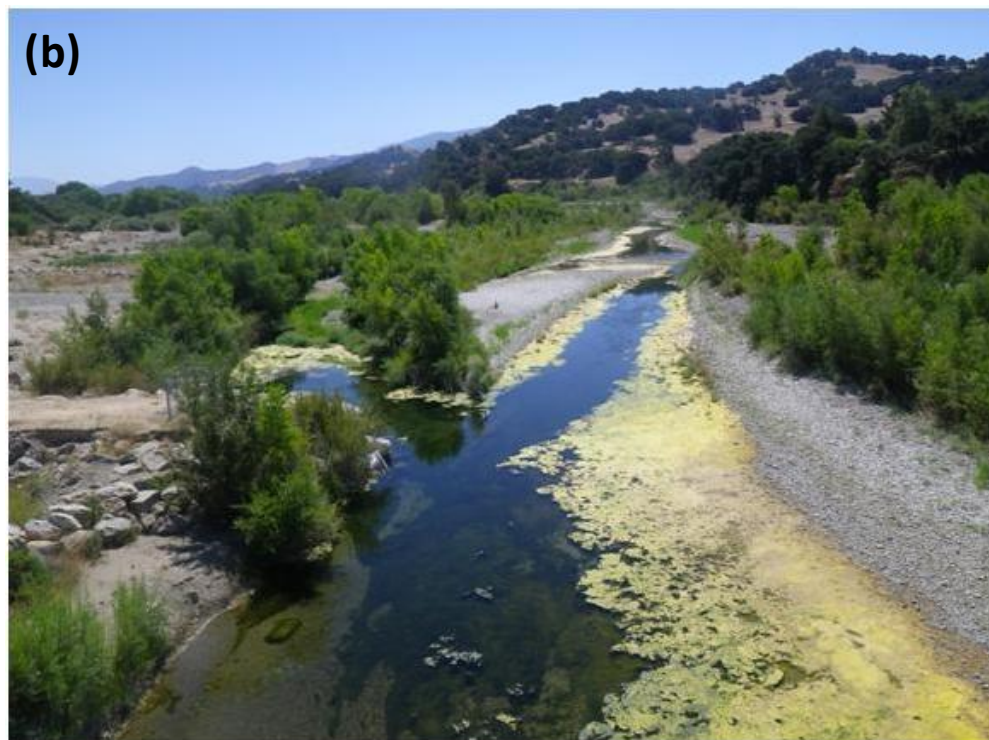
Figure 44: Photo point (M-12) collected at Refugio Bridge looking upstream in (a) May 2005, and (b) July 2011.

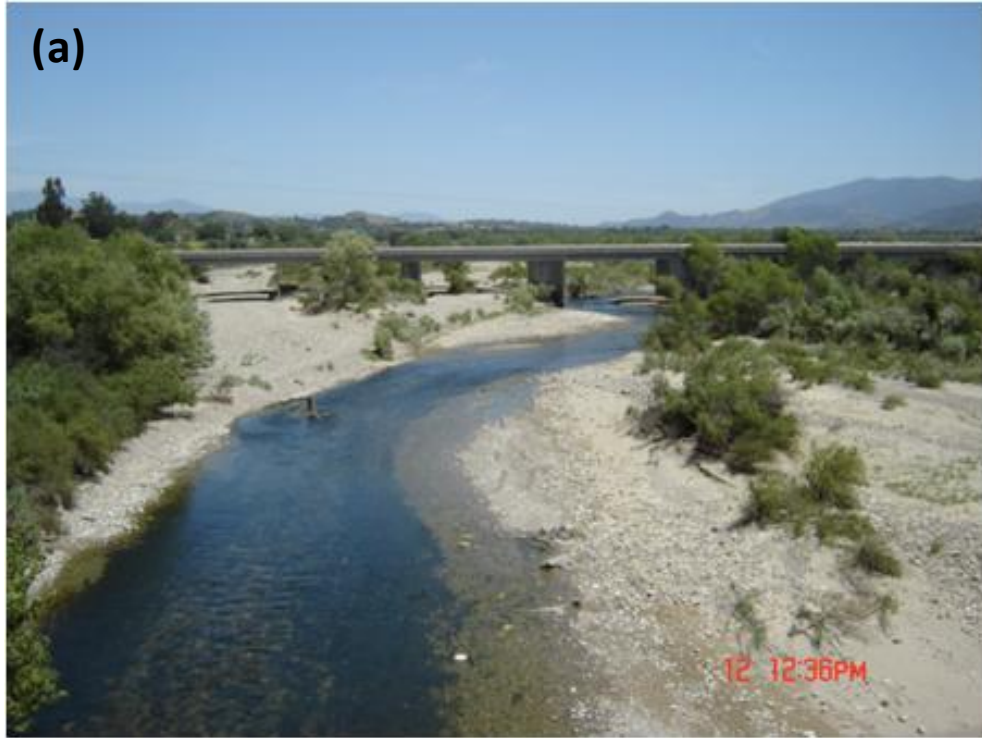
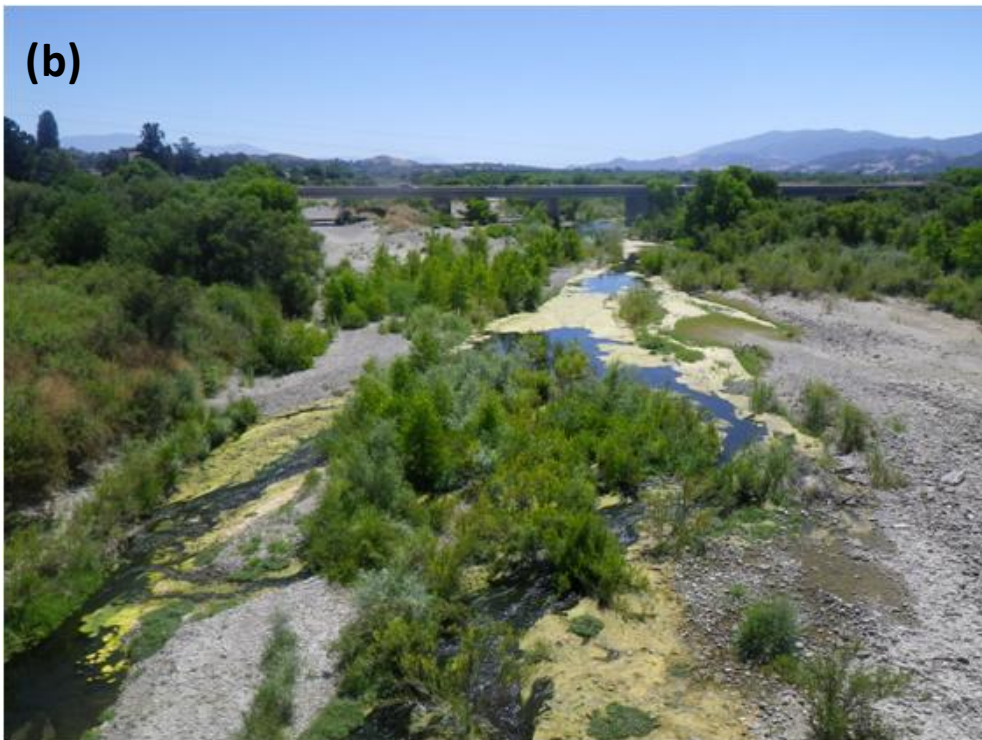
Figure 45: Photo point (M-14) collected at Alisal Bridge looking upstream in a) May 2005, and b) July 2011.

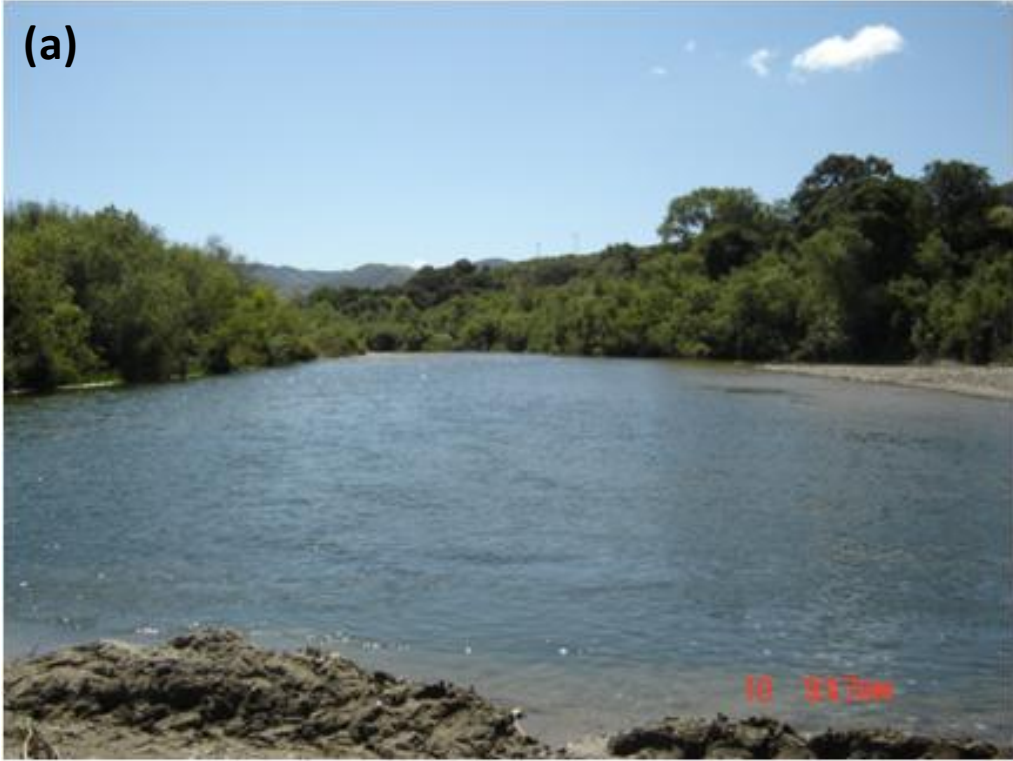
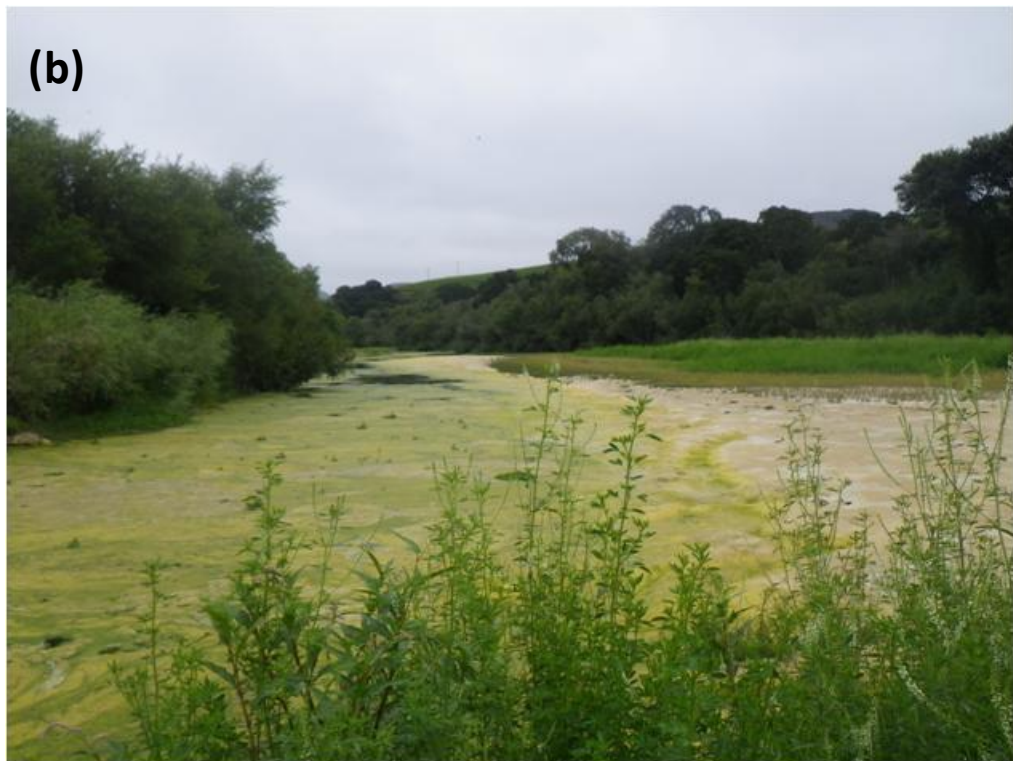
Figure 46: Photo point (M-19) collected at Avenue of the Flags Bridge looking upstream in (a) May 2005, and (b) July 2011.

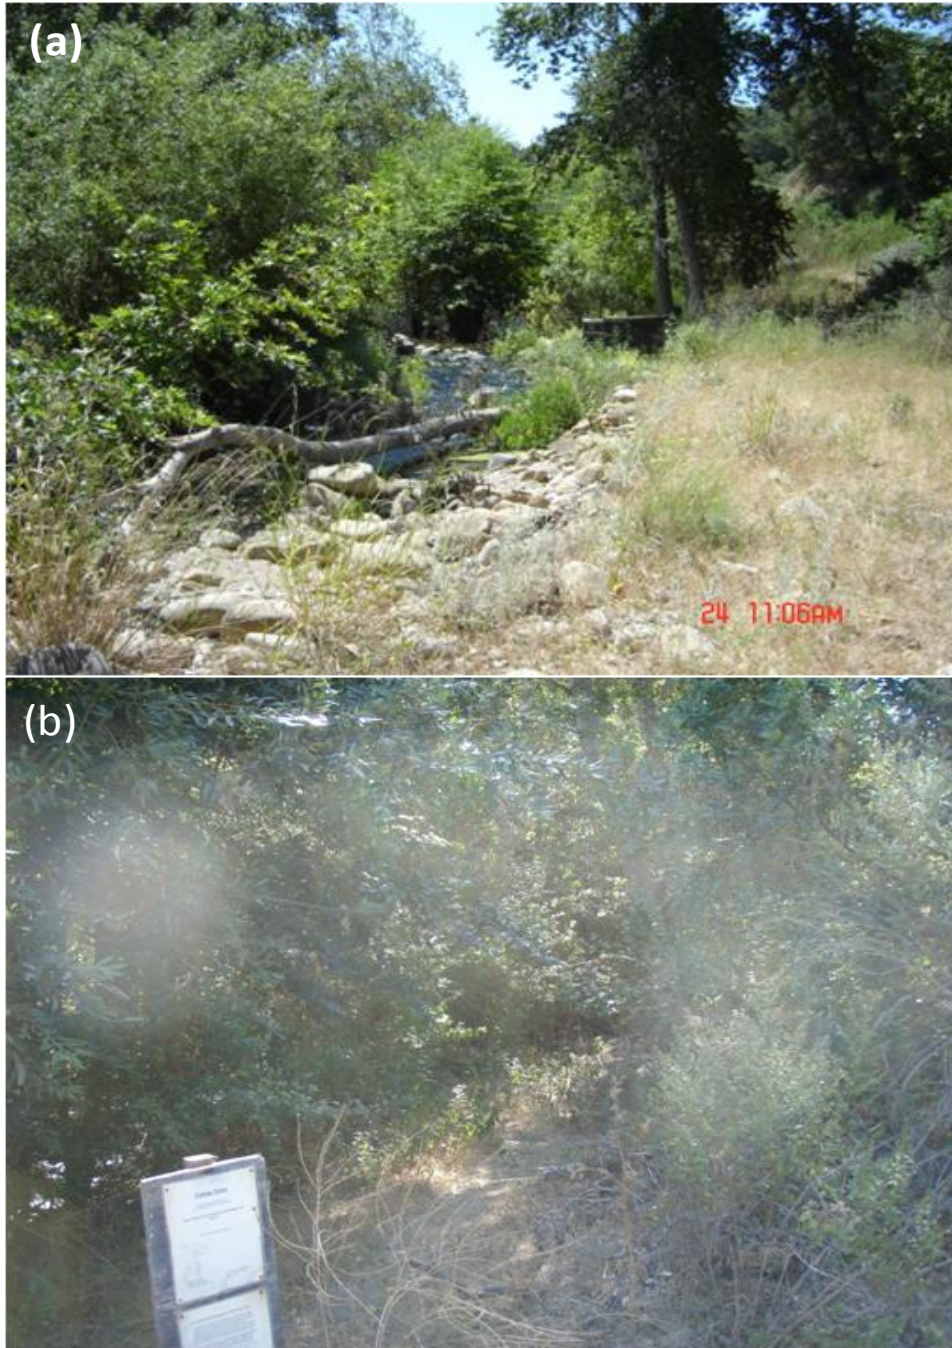
Figure 47: Photo point (M-21) collected at Sweeney Road Crossing looking upstream in (a) May 2005, and (b) August 2011.

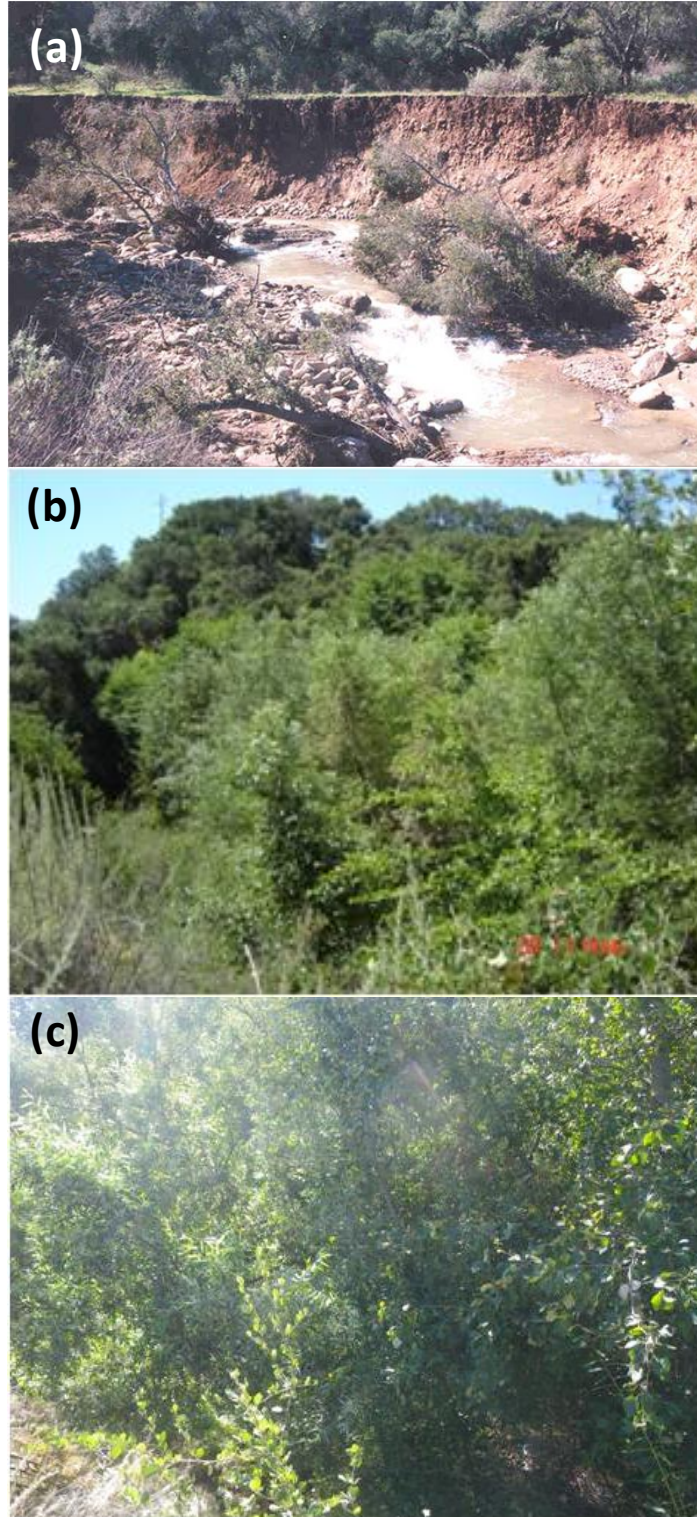
Figure 48: Photo point (T-1) collected at Hilton Creek looking upstream towards the trap site on (a) May 2005, and (b) September 2011.

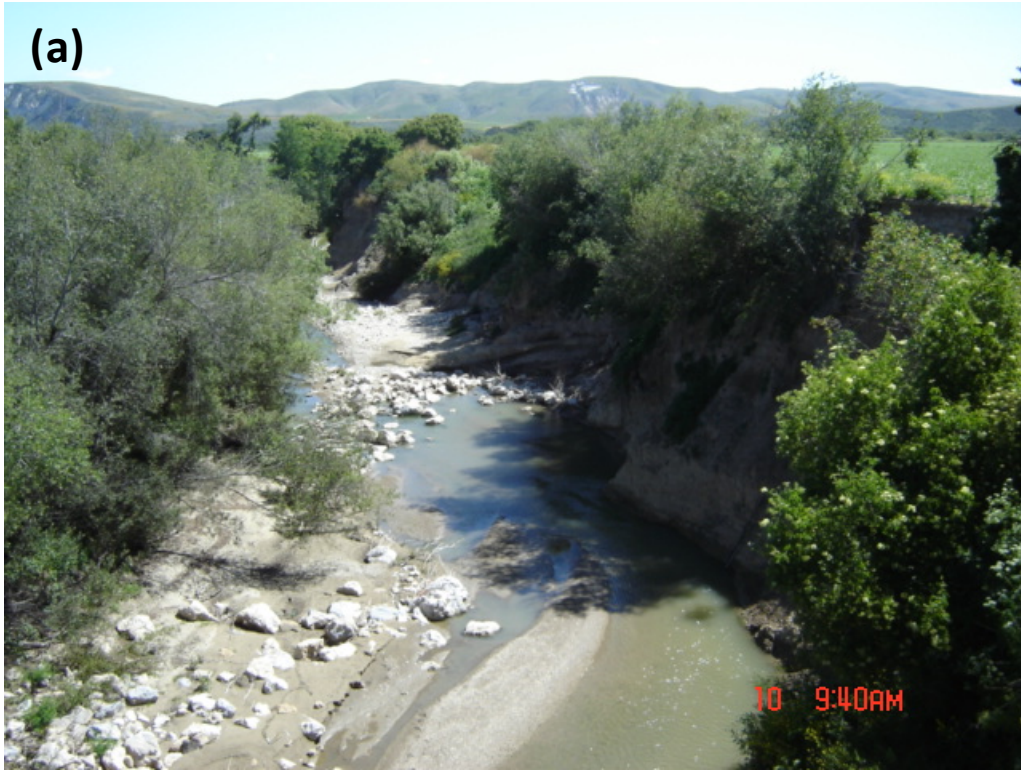
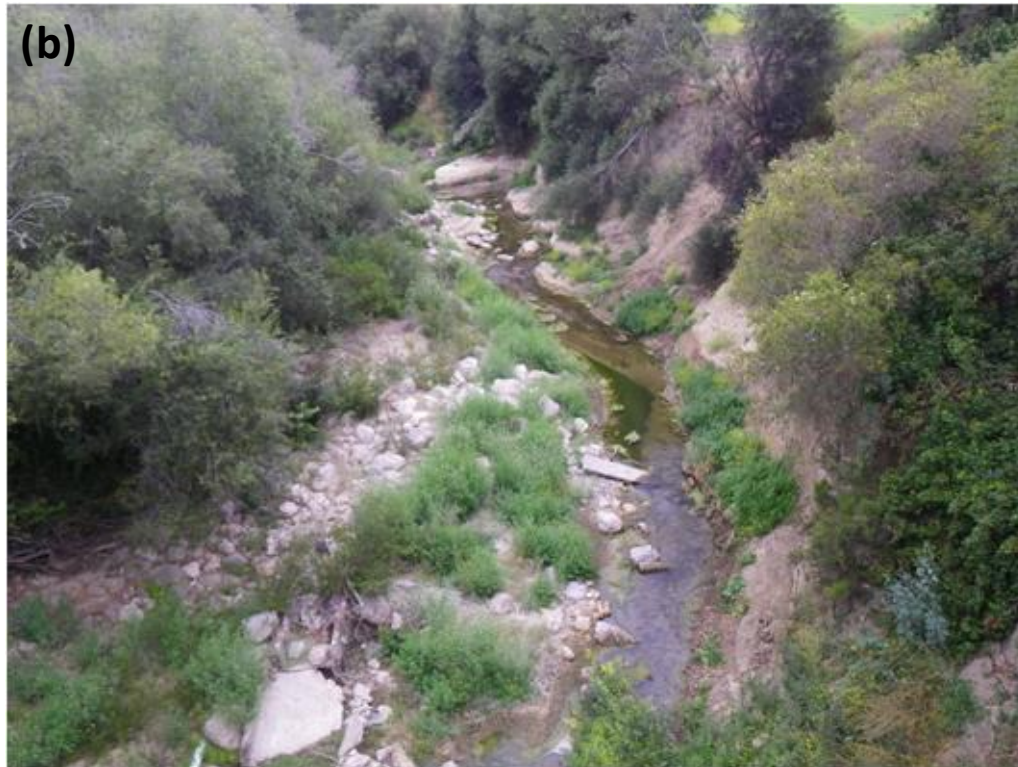
Figure 49: Photo point (T-6) collected at the Hilton Creek ridge trail looking upstream in (a) March 1999, (b) May 2005, and (c) October 2011.

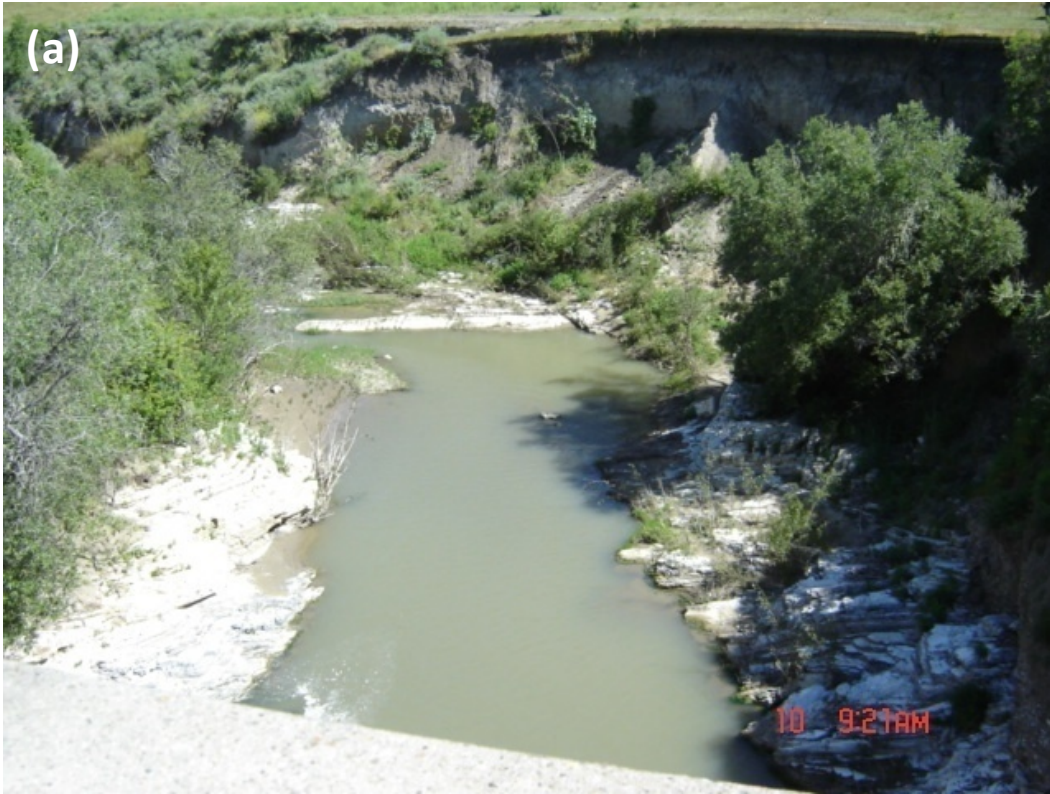
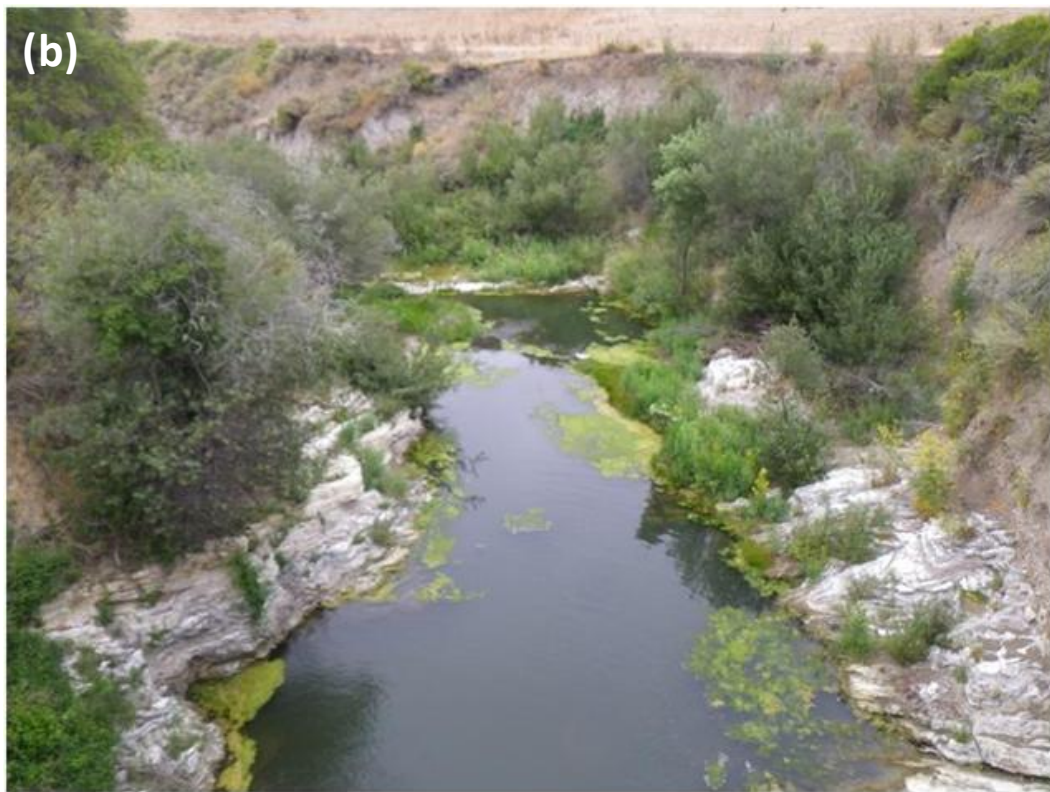
Figure 50: Photo point (T-28) collected at Salsipuedes Creek at Santa Rosa Bridge in (a) May 2005 and (b) August 2011.

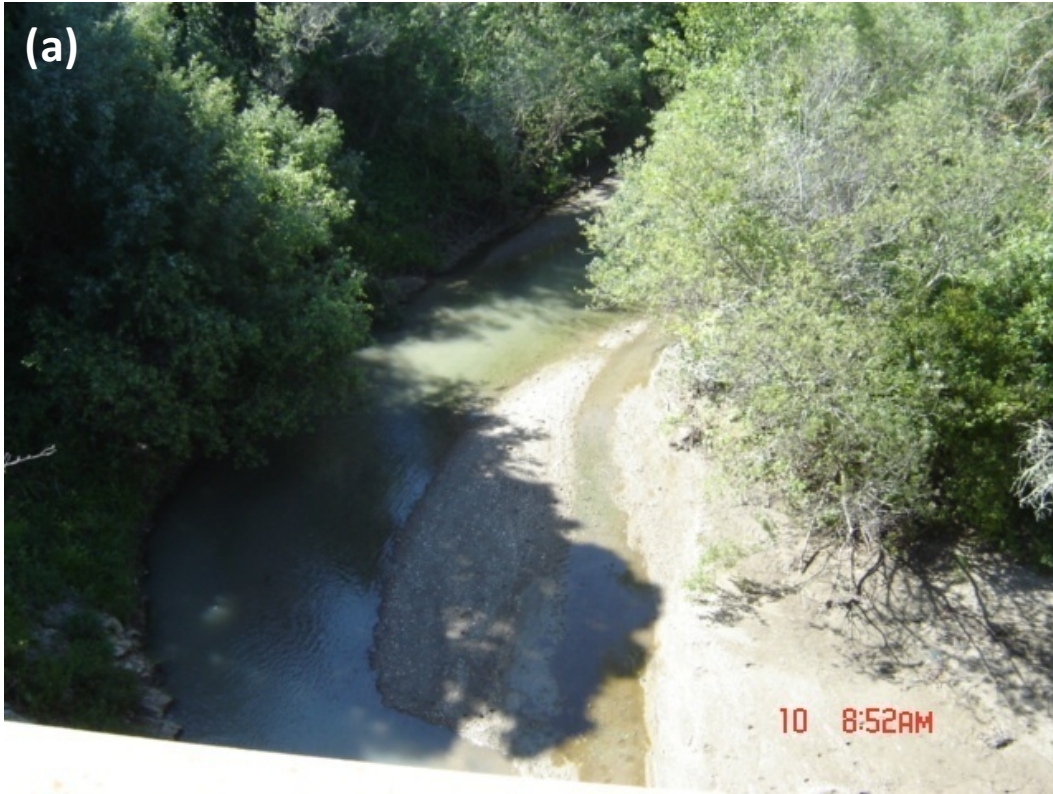
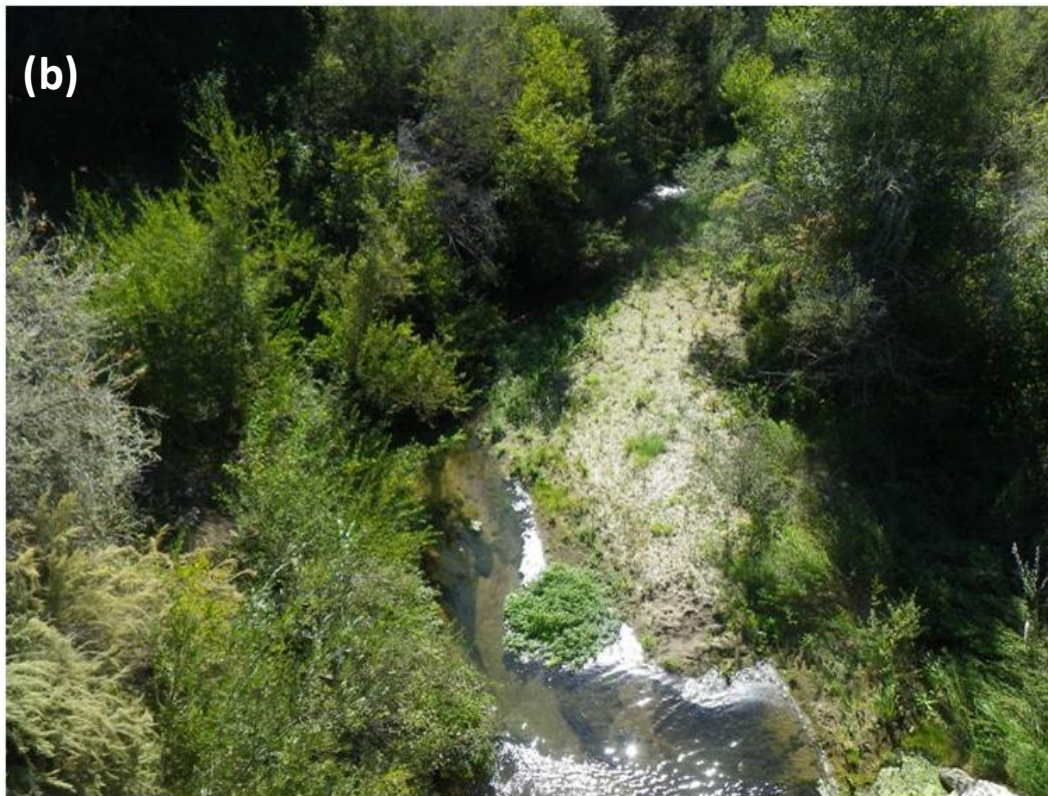
Figure 51: Photo point (T-39) collected at Salsipuedes Creek at Hwy 1 Bridge in May 2005 and (b) November 2008; no photo point was taken in August 2011.

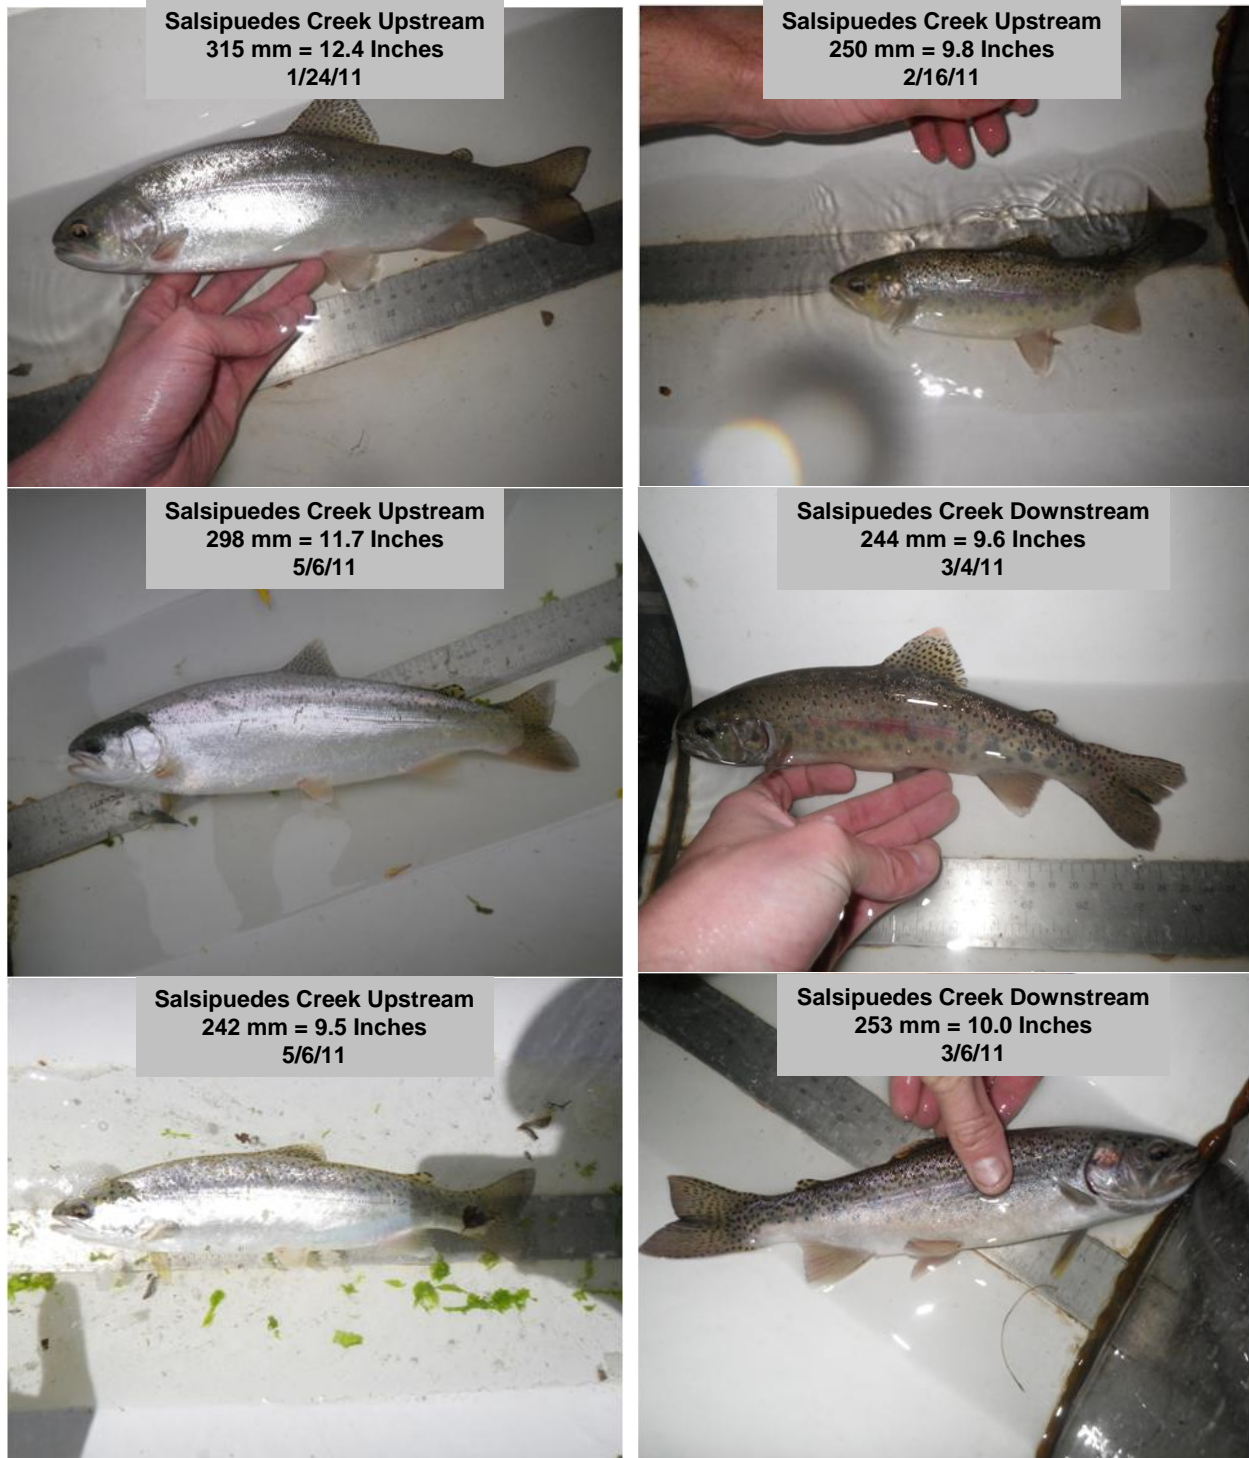
Figure 59: WY2011 Salsipuedes Creek potential LSYR lagoon fish caught on 1/24/11 and 5/6/11 in the left column and similar sized resident *O. mykiss* in the right column that depict the difference in origin between the two.

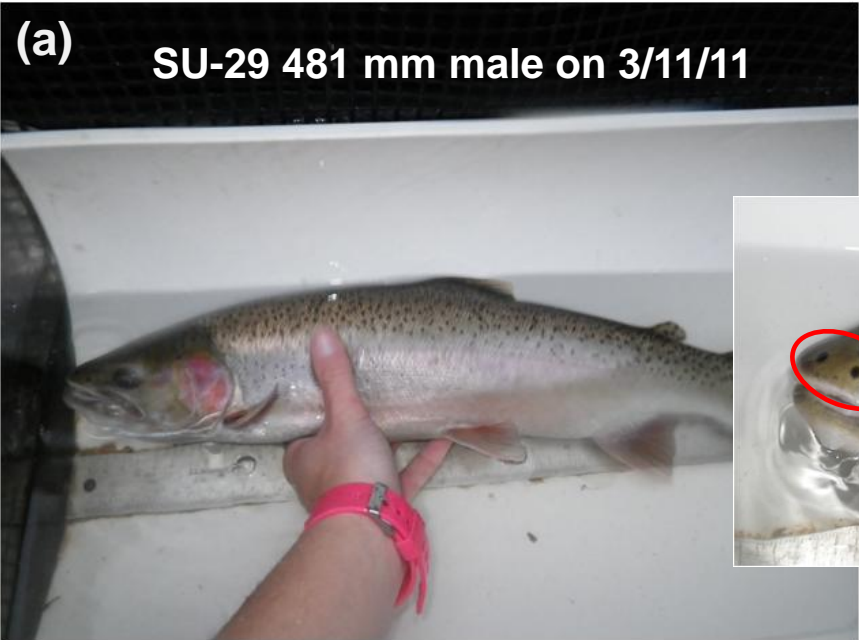
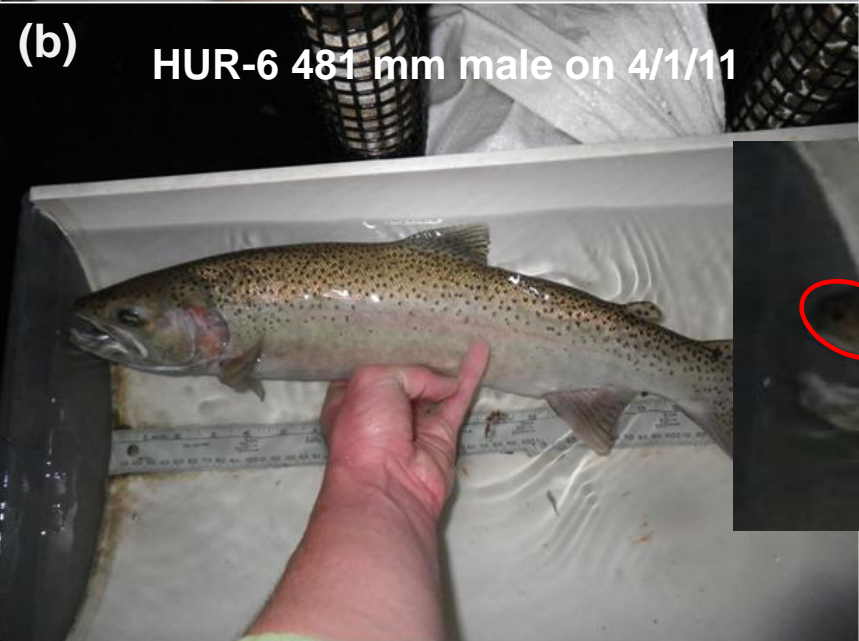
Figure 61: WY2011 adult steelhead captured at (a) Salsipuedes Creek on 3/11/11 and again at (b) Hilton Creek on 4/1/11 showing identical spot patterns.

WY2011 was a wet year with the fifth highest total number of *O. mykiss* migrant captures (481), second highest smolt (249), and second highest anadromous adult steelhead (9) at the three trapping sites within the LSYR since 2001. Eight of the 9 anadromous steelhead were captured at the Salsipuedes trap, 5 were ocean run that ranged in size from 481-528 mm (18.9-20.8 in) and 3 were thought to be LSYR Lagoon fish due to their smaller length, relatively large girth, and silver coloration that ranged in size from 242-315 mm (9.5-12.4 in). There is a debate whether lagoon fish should be included as anadromous adult steelhead but will be included as such for this report. The ninth anadromous adult steelhead was captured in the Hilton Creek trap and was a recaptured Salsipuedes Creek steelhead (Figure 61).

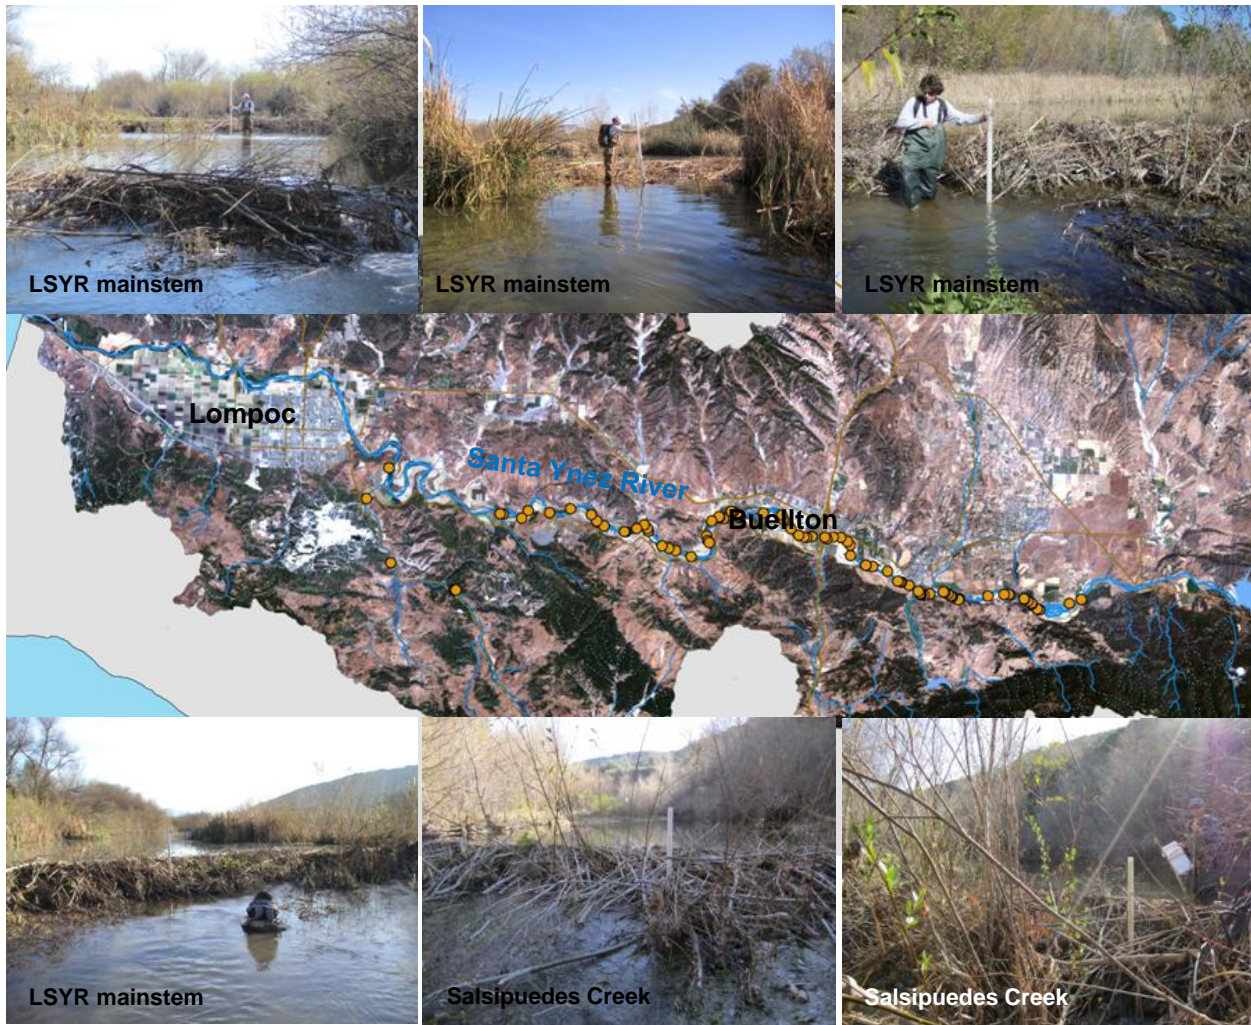
Figure 80: Spatial extent of beaver dams from the WY2011 survey within the LSZR drainage where 87 dams were observed in the LSZR basin.

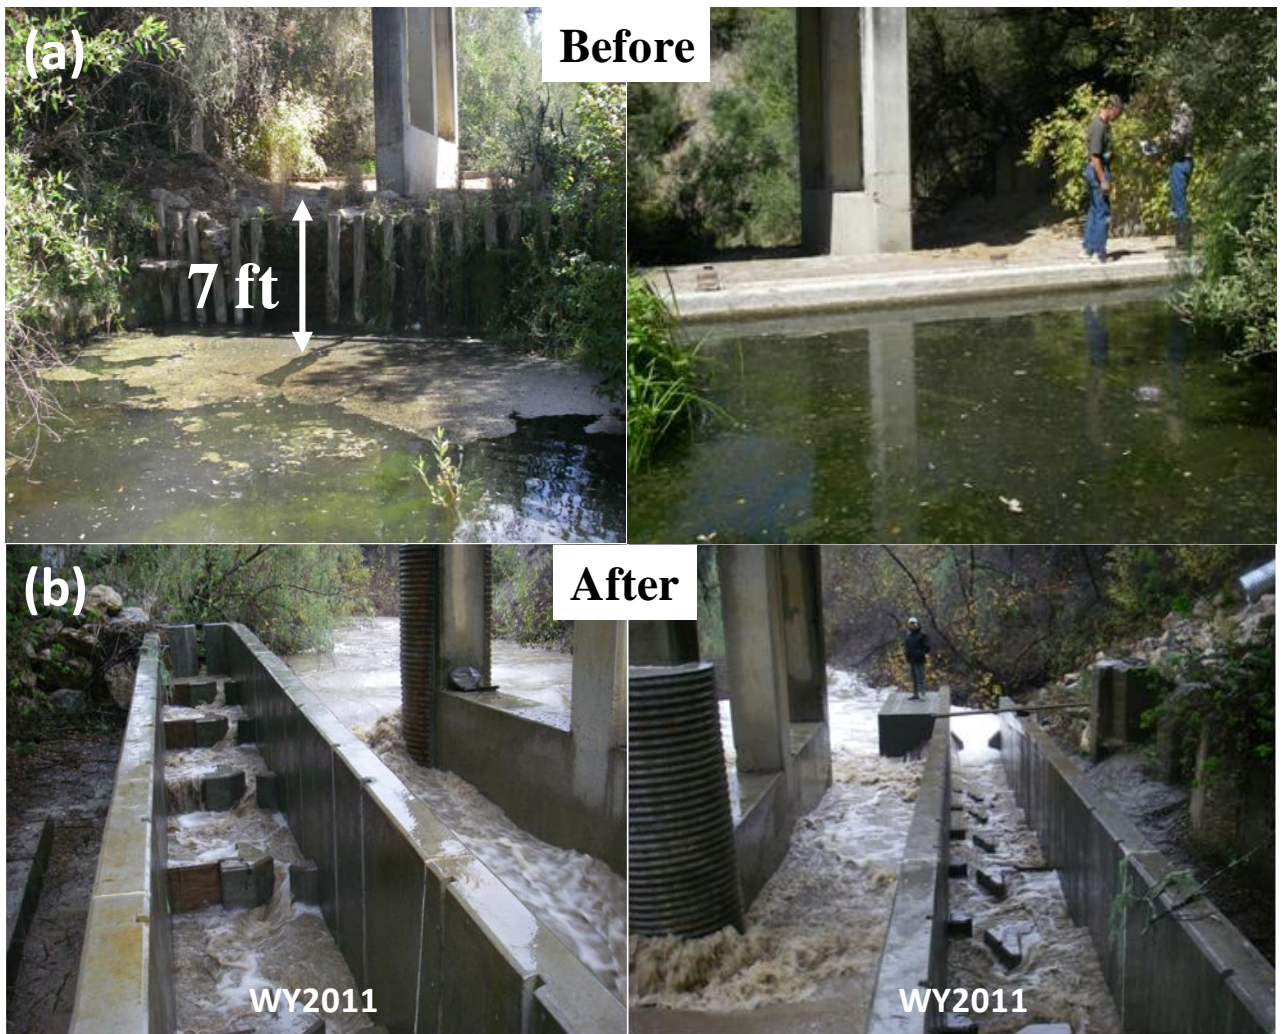
Figure 83: Fish passage and habitat restoration in the fall of 2008 at Rancho San Julian on El Jaro Creek.

By December 2011, eight tributary passage enhancement projects were completed within the LSYR basin: Salsipuedes Creek Highway 1 Bridge Fish Ladder, Salsipuedes Creek Jalama Road Bridge Fish Ladder, Hilton Creek Cascade Chute, El Jaro Creek Rancho San Julian Fish Ladder, Quiota Creek Crossing 6 Bridge, Cross Creek Ranch Fish Passage Project on El Jaro Creek, and Quiota Creek Crossing 2 Bridge as well as the HCWS which supplies water year round to Hilton Creek from Lake Cachuma (Tables 22 and 23, Figures 82-86). The HCWS also benefits the fish by promoting riparian vegetation growth that shades the creek and provides improved habitat and water quality with little to no thermal heating from the URP to the confluence (Figures 48, 49, and 86). In addition, three bank stabilization and erosion control projects were completed on El Jaro Creek. Each of these projects listed above removed a passage barrier for adult and juvenile *O. mykiss*, reduced sediment supply to the stream, or provided stream flows that enhanced passage and increased the potential for rearing and spawning of *O. mykiss* upstream of the project and in some cases within the project area.

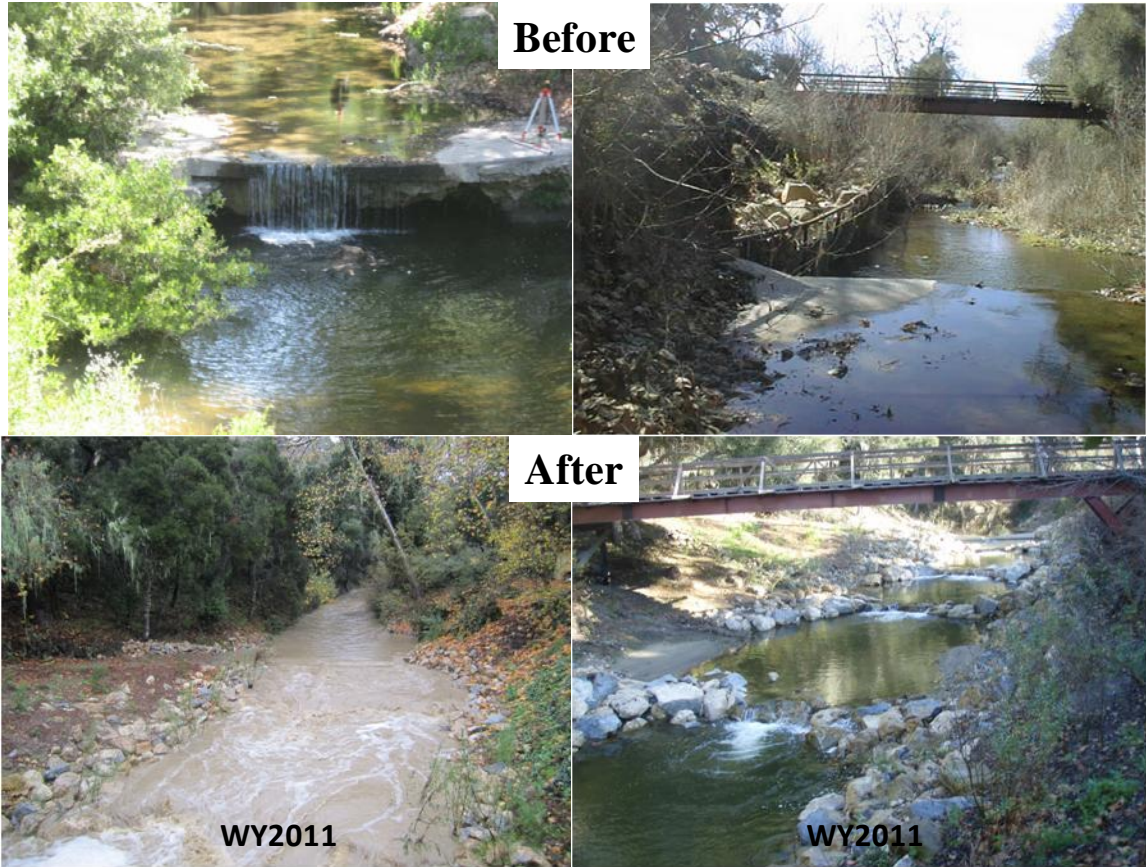
Figure 85: Fish passage and habitat restoration in the fall of 2009 at Cross Creek Ranch on El Jaro Cree, a tributary of Salsipuedes Creek and the Santa Ynez River.

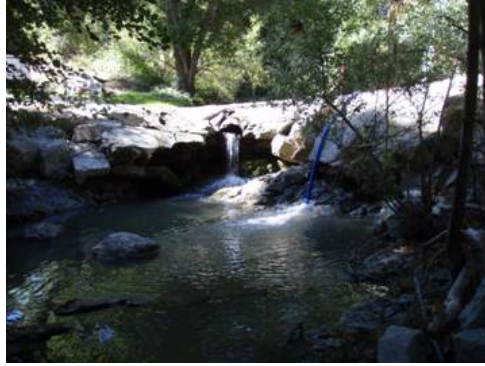
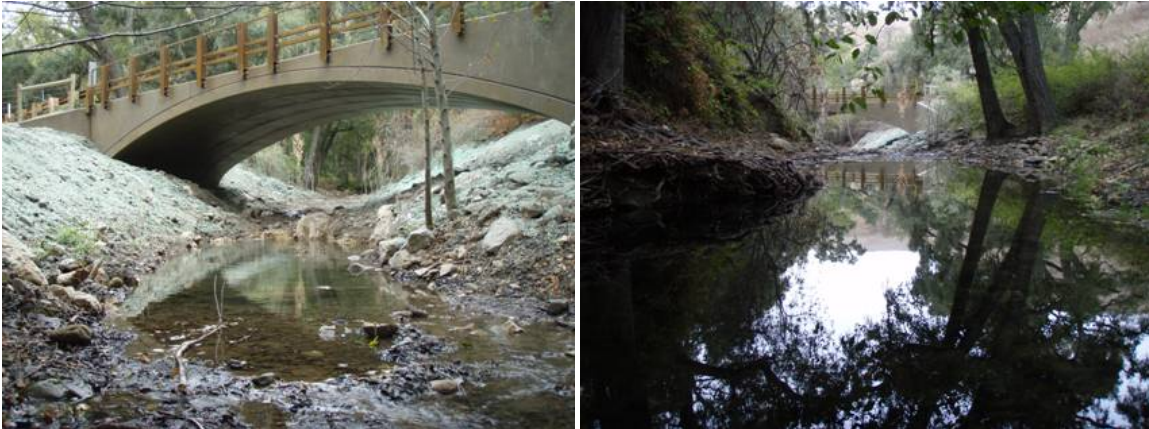
Figure 86: Fish passage and habitat restoration in the fall of 2011 at Refugio Road on Quiota Creek Crossing 2 from before (top) and after (bottom).

There are seven (Crossing 7 was funded and fixed in WY2012) remaining migration barriers on Quiota Creek, all of which are under design and will be systematically removed as funding becomes available (Tables 22 and 23). The passage enhancement project at Crossing 2 removed a partial barrier and opened up 3.4 miles of spawning and rearing habitat (Figure 86). Further monitoring in subsequent years will provide greater insight into the biological performance of this project and future projects along Quiota Creek, specifically at Crossing 2 (2011), Crossing 7 (2012), Crossing 1 (2013), and Crossing 0 (2014).
