WY2019 ANNUAL MONITORING SUMMARY

THE BIOLOGICAL OPINION FOR THE OPERATION AND MAINTENANCE OF THE CACHUMA PROJECT ON THE SANTA YNEZ RIVER IN SANTA BARBARA COUNTY, CALIFORNIA

**CACHUMA OPERATION AND MAINTENANCE BOARD
FISHERIES DIVISION**

JANUARY 30, 2020

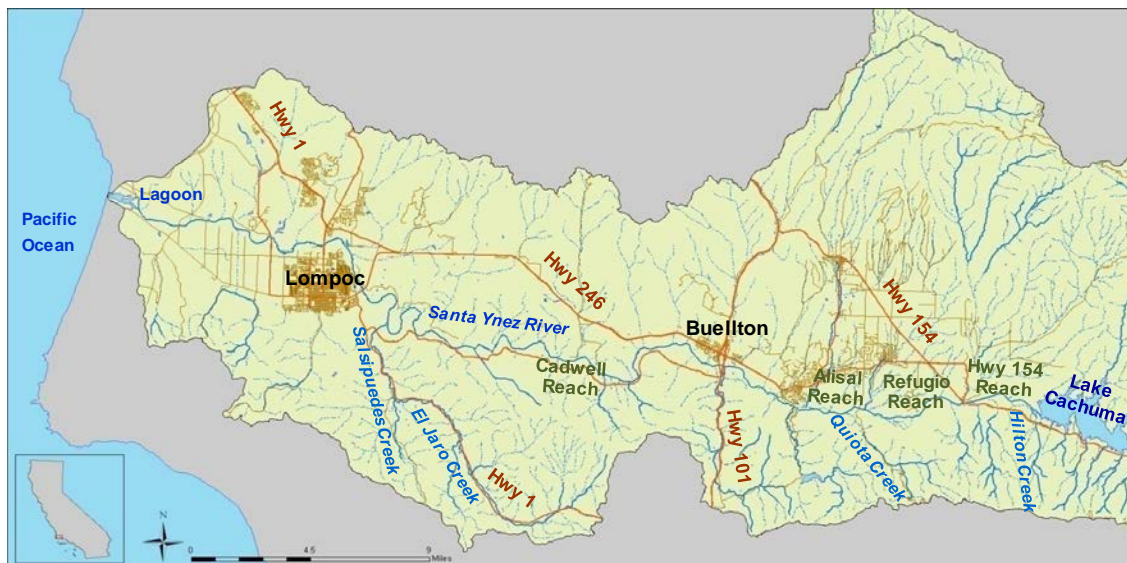
Figure ES-1: LSYR from Bradbury Dam and Lake Cachuma to the Pacific Ocean west of Lompoc, showing tributary creeks and management reaches of interest for the LSYR Fish Monitoring Program.

The monitoring tasks completed in WY2019 were performed below Bradbury Dam in the LSYR watershed and in Lake Cachuma, which is approximately half the drainage area (450 square miles) and stream distance (48 miles) to the ocean compared to the entire watershed. The area is within the Southern California Steelhead Distinct Population Segment (DPS) and the Monte Arido Highland Biogeographic Population Group (BPG) in the Southern Steelhead Recovery Planning Area (NMFS, 2012). Monitoring focused on three management reaches (Highway 154, Refugio, and Alisal reaches) and the Cadwell Reach on the LSYR mainstem, and tributaries (Hilton, Quiota, El Jaro, and Salsipuedes creeks) known to support suitable habitat for *O. mykiss* (Figure ES-1).

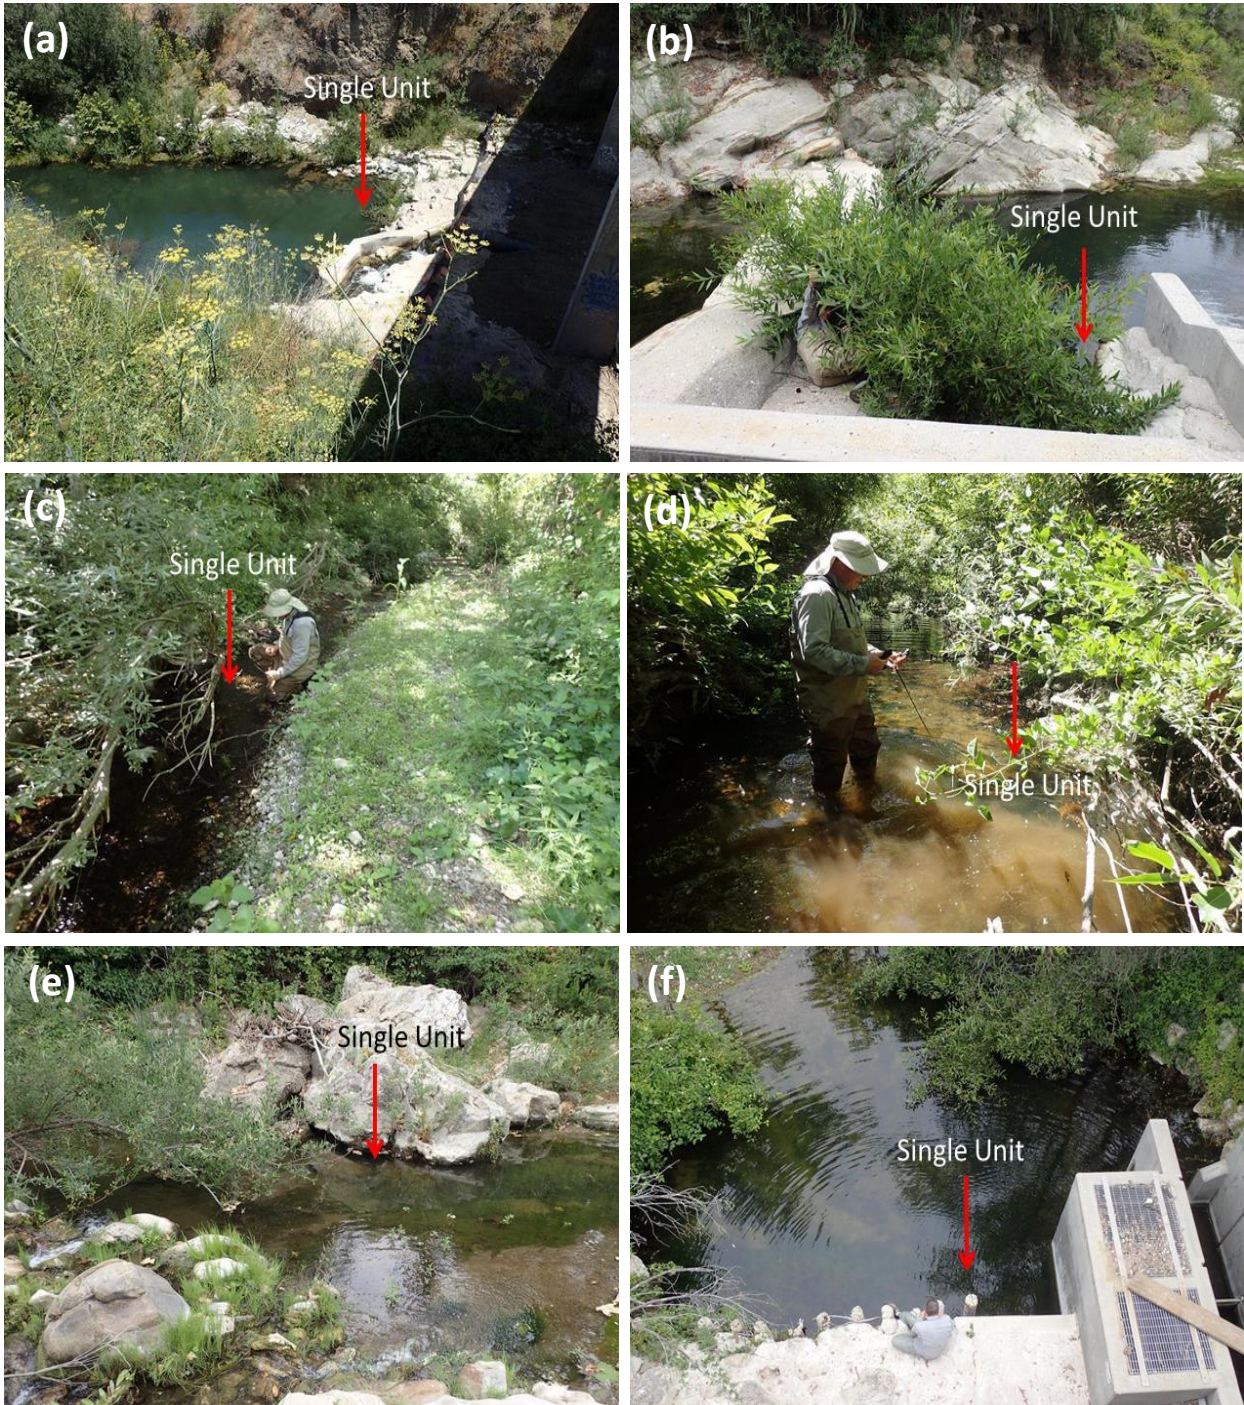
Figure 9: 2019 Tributary thermograph deployment locations at: a) SC-3.0, b) SC-3.5, c) SC-3.8, d) EJC-3.81, e) EJC-5.4, and f) EJC-10.82.

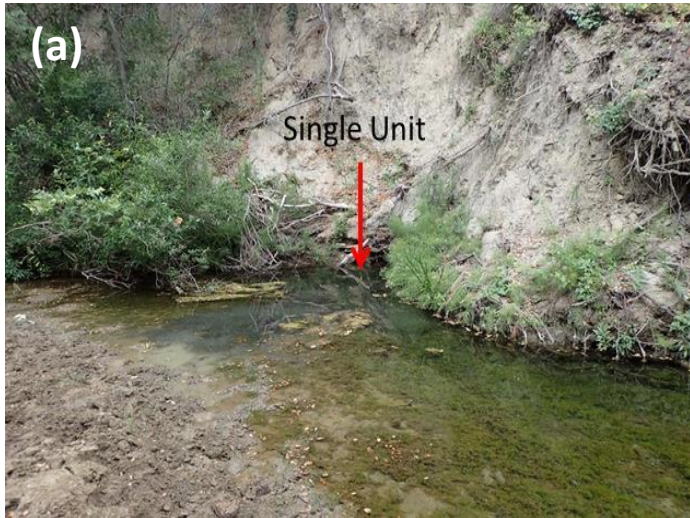
Figure 10: 2019 Tributary temperature unit deployment location at: a) LAC-7.0.

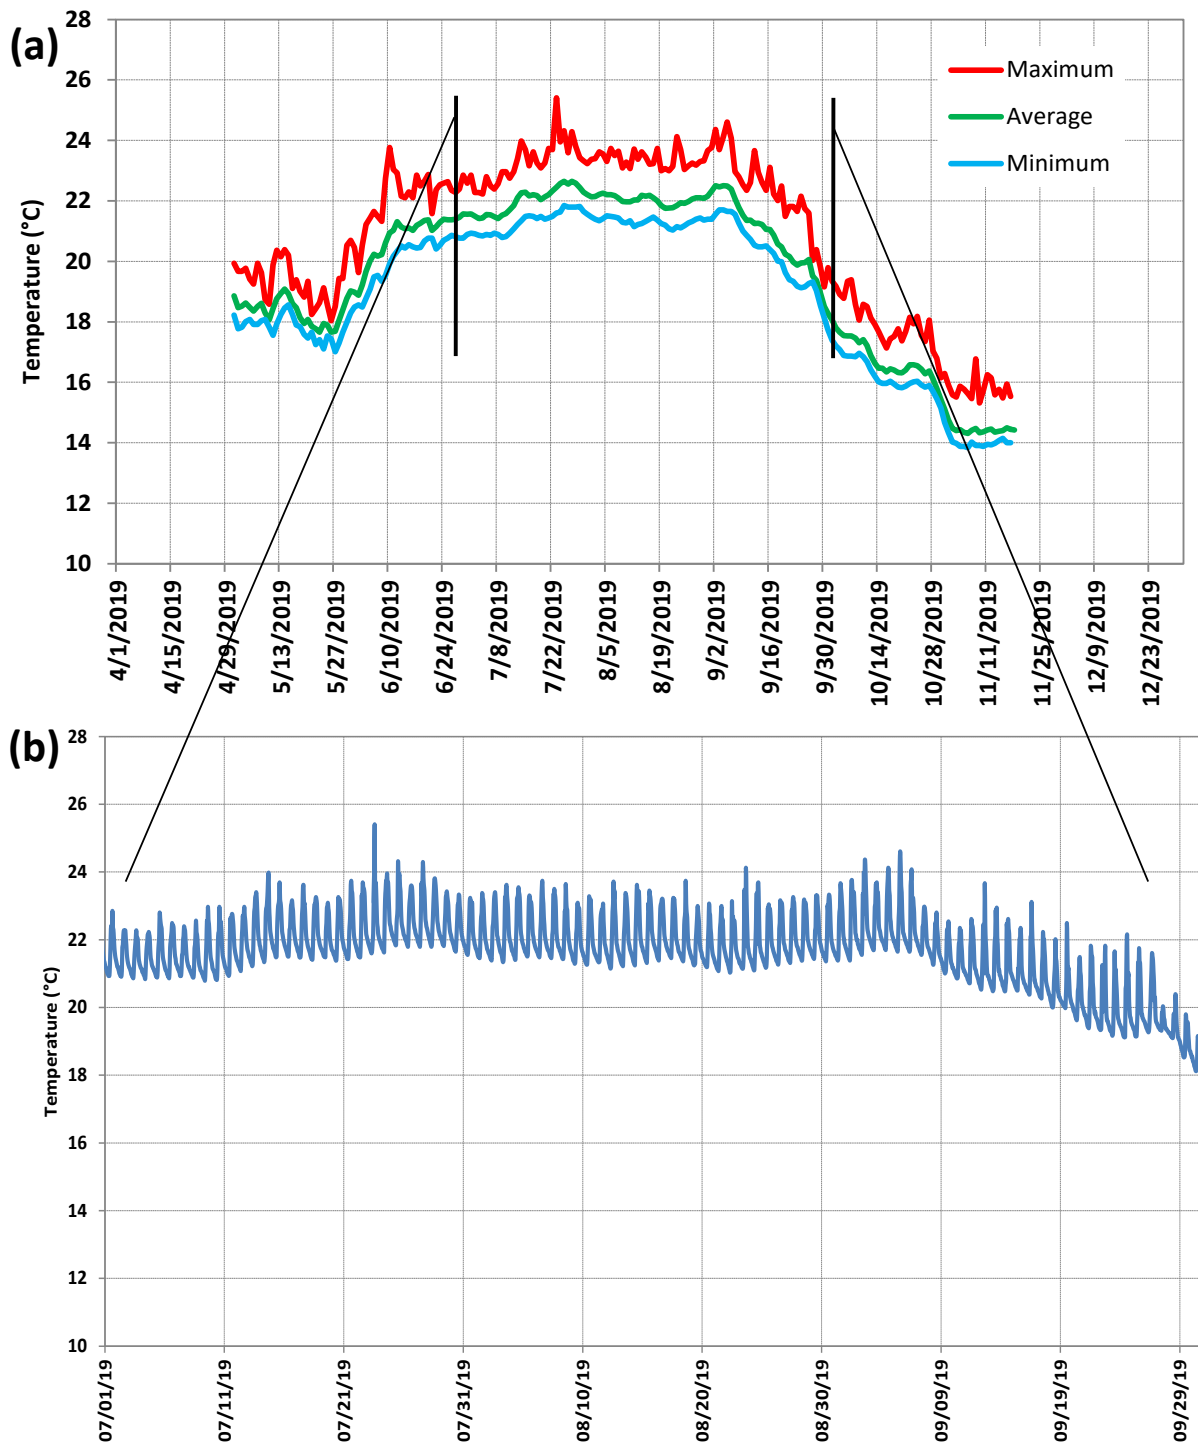
Figure 11: 2019 LSYR-0.01 (Stilling Basin parapet wall) surface (1.0 foot) water temperature for (a) daily maximum, average, and minimum for the entire period of deployment and (b) hourly measurements for the period of 7/1/19 - 10/1/19.

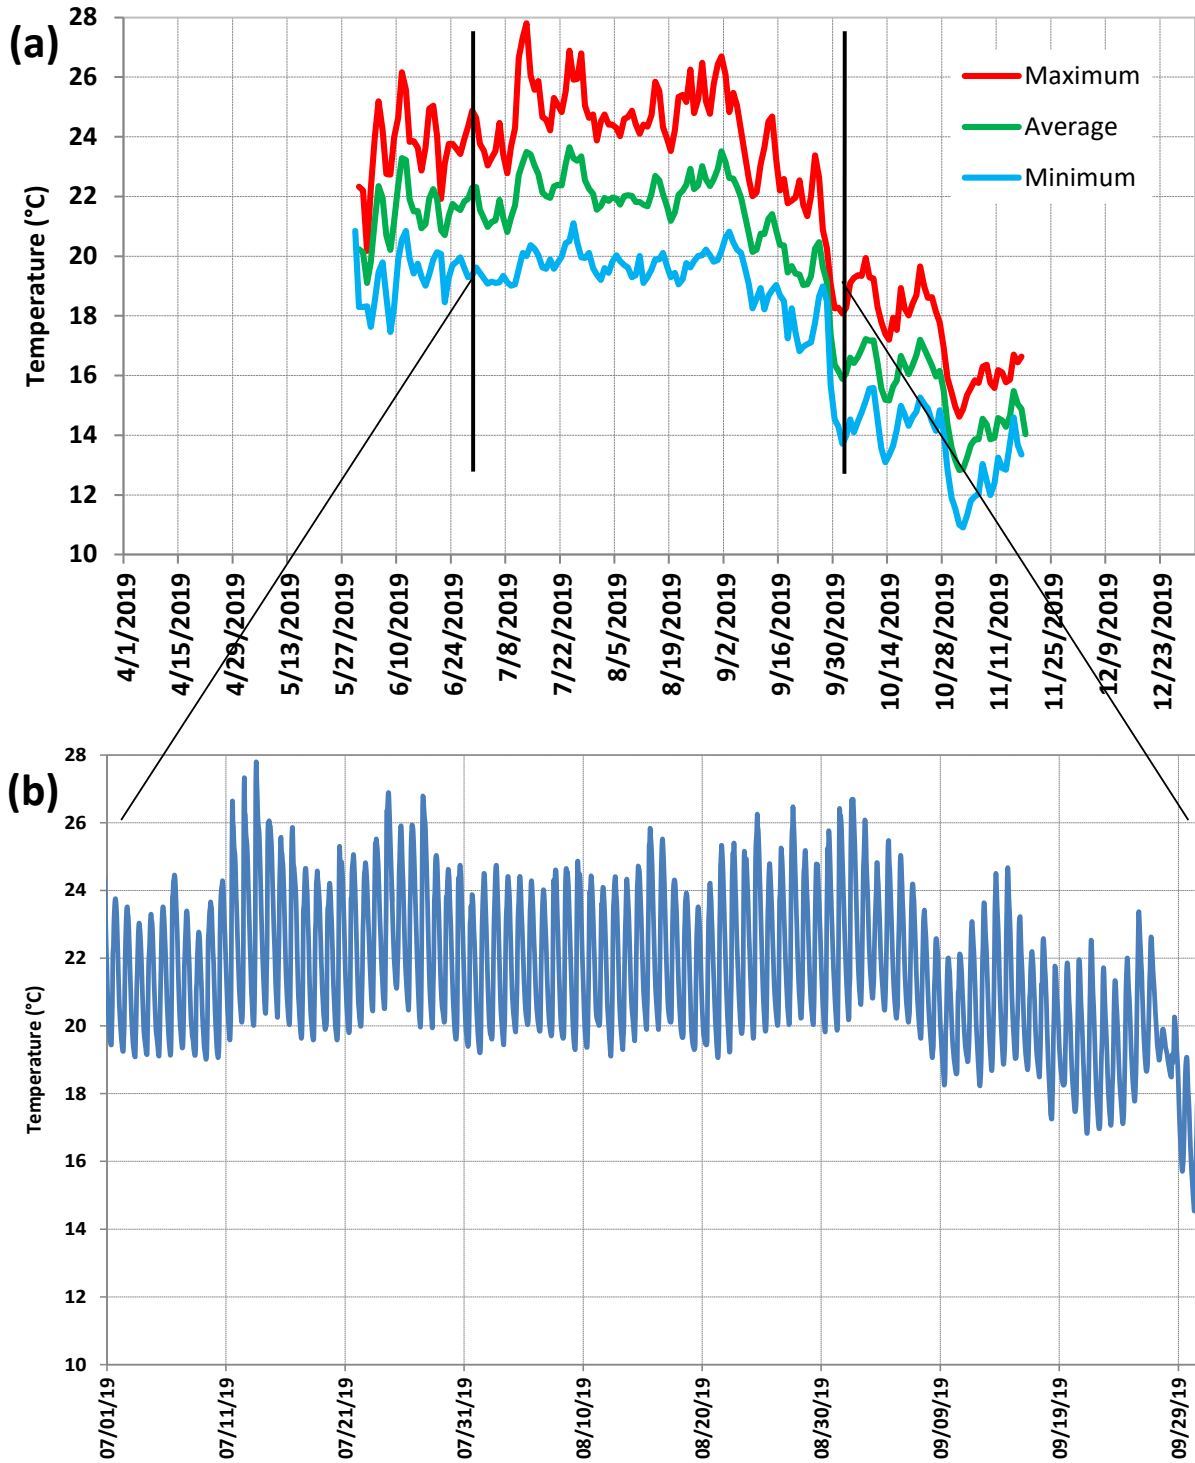
Figure 21: 2019 LSYR-1.71 (Grimm Property pool) –surface (1.0 foot) water temperature for (a) daily maximum, average, and minimum for the entire period of record and (b) hourly measurements from 7/1/19 - 10/1/19.

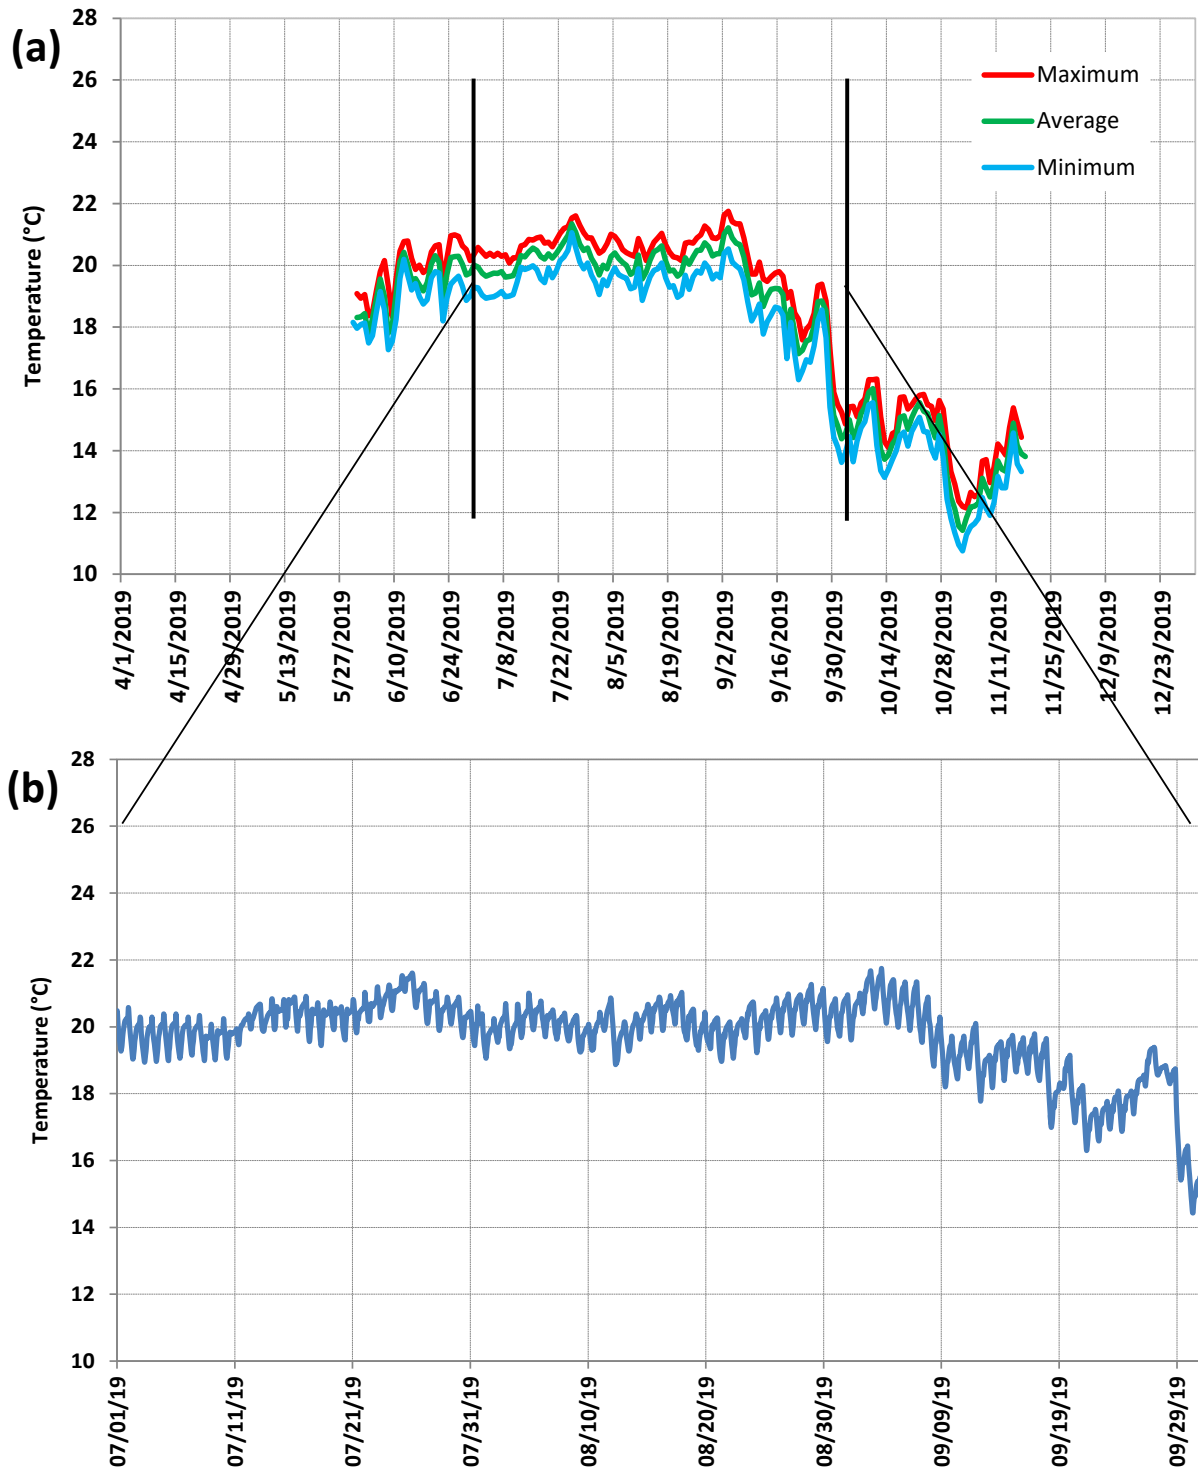
Figure 23: 2019 LSYS-1.71 (Grimm Property pool) bottom (6.5 feet) water temperature for (a) daily maximum, average, and minimum for the entire period of record and (b) hourly measurements from 7/1/19 - 10/1/19.

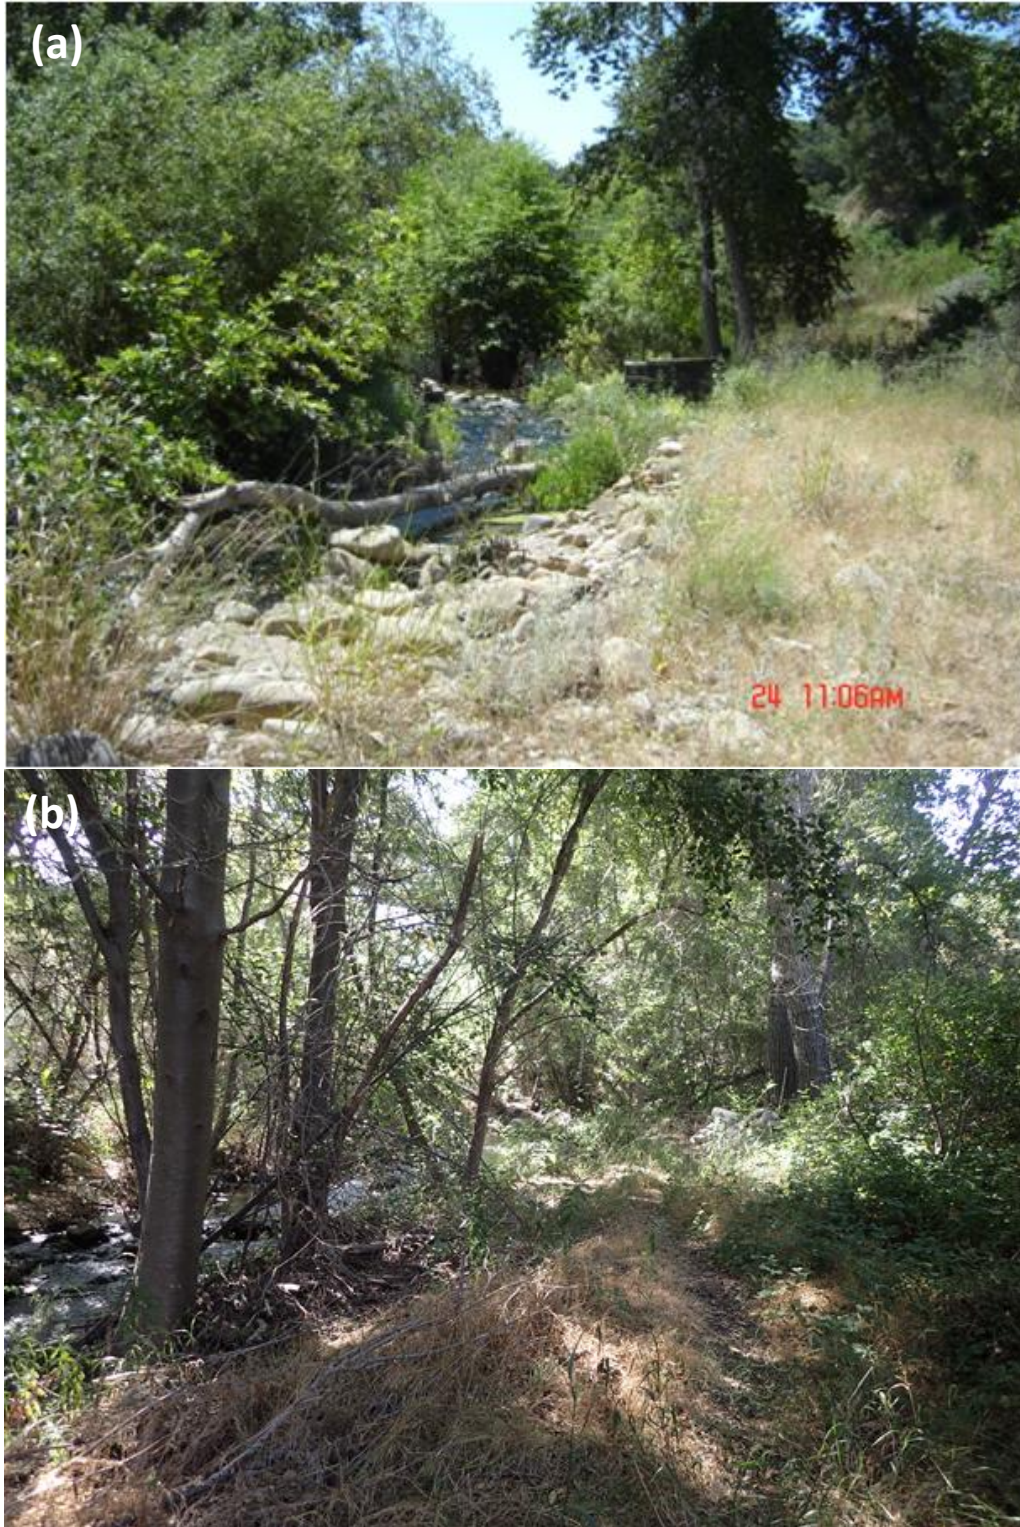
Figure 61: Photo point (T-1) collected at Hilton Creek looking upstream towards the trap site on (a) May 2005, and (b) August 2019.

The HCWS has transformed Hilton Creek into a dense riparian zone where there is little thermal heating from the URP to the confluence with the LSYR mainstem (Figures 61-62). In 2005, completion of the Hilton Creek Cascade Chute Project doubled the available habitat for *O. mykiss* in the watered section of Hilton Creek (Figure 86) and releases from the URP provided for extensive riparian vegetation growth that has shaded and cooled the stream water. Channel changes and the redistribution of optimal sized spawning gravels throughout Hilton Creek, coupled with activation of the URP during WY2019 has greatly enhanced instream rearing conditions throughout the creek. In fact, maximum water temperatures collected in Lower Hilton Creek this year represent some of the lowest water temperatures observed since 1998 (Figure 87).

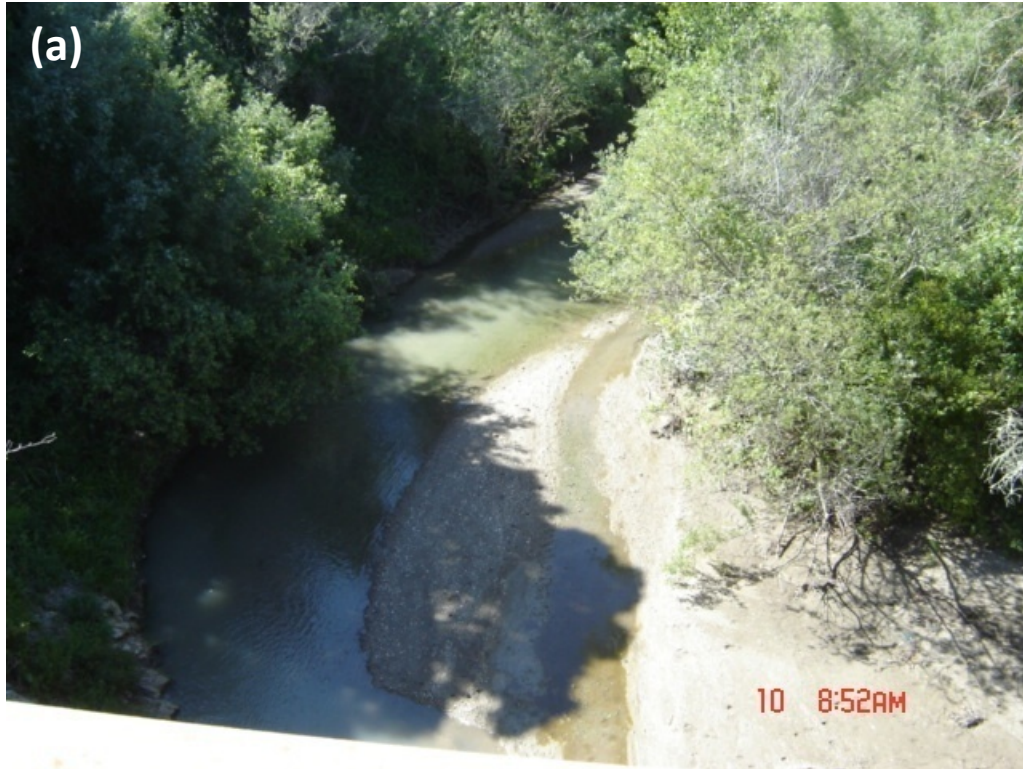
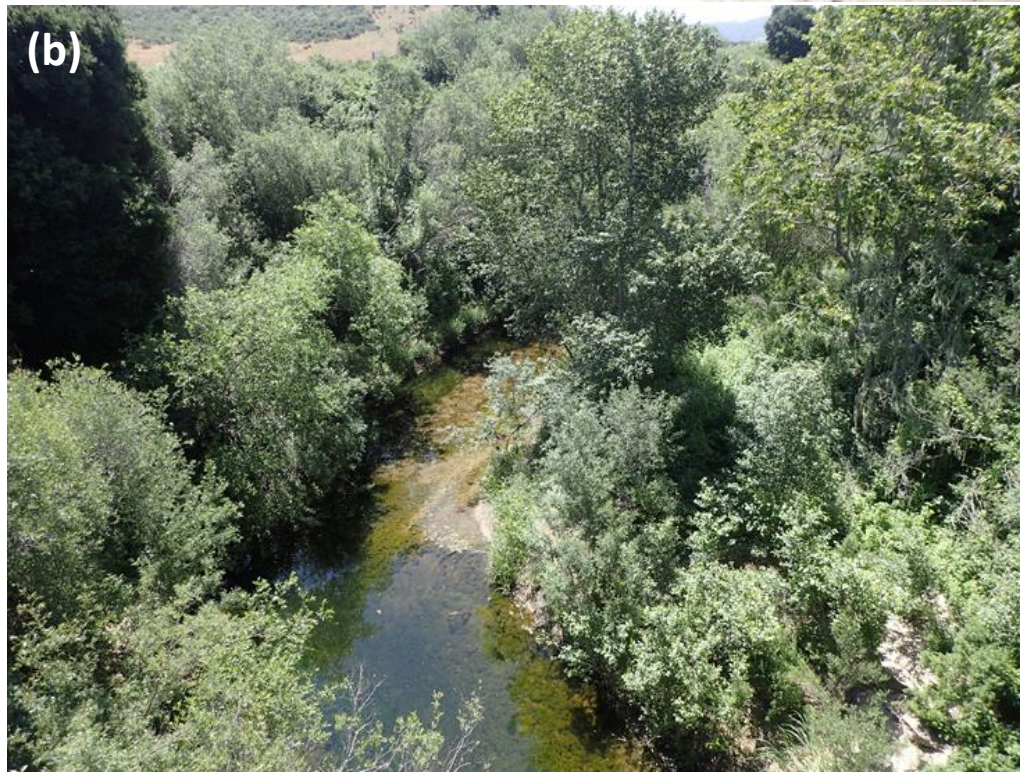
Figure 65: Photo point (T-42) collected at Salsipuedes Creek at Jalama Road Bridge in May 2005 and (b) May 2019.

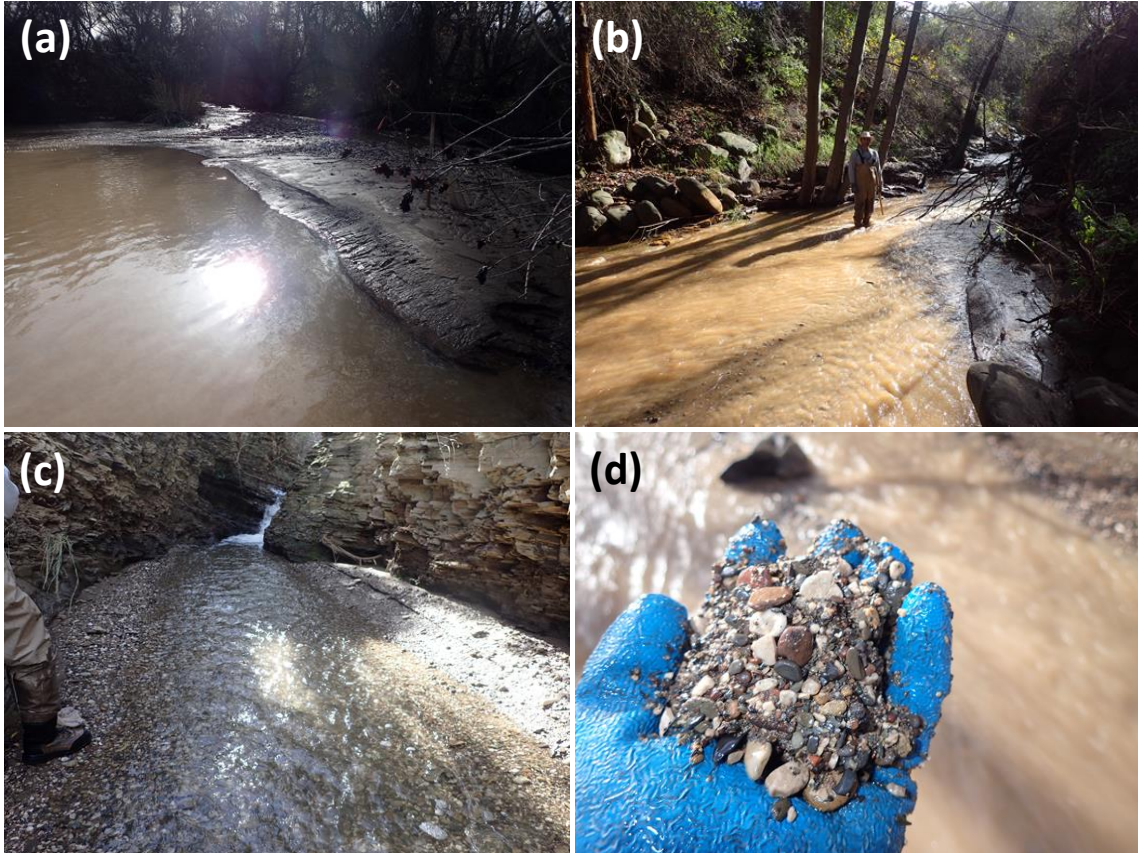
Figure 88: Hilton Creek post-storm habitat conditions showing (a) silt bar formation at head of Long Pool, (b) staff standing in the middle of the Spawning Pool in 6 inches of water (previously 6 feet deep), (c) sediment deposits within the Honeymoon Pool (previously 4 feet deep), and (d) general composition of the sand/gravel deposited from the high flow event.

Figure 88: Hilton Creek post-storm habitat conditions showing (a) silt bar formation at head of Long Pool, (b) staff standing in the middle of the Spawning Pool in 6 inches of water (previously 6 feet deep), (c) sediment deposits within the Honeymoon Pool (previously 4 feet deep), and (d) general composition of the sand/gravel deposited from the high flow event.

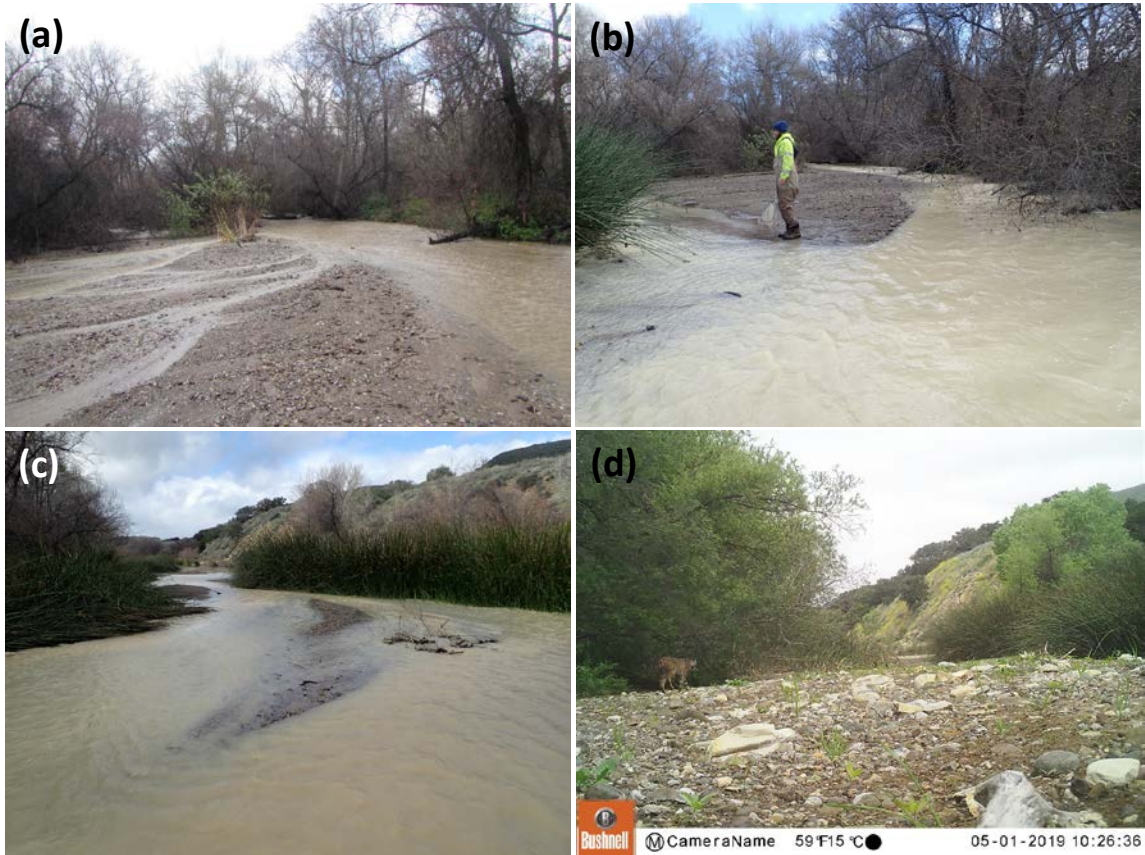
Figure 89: Confluence of Hilton Creek with the LSYR mainstem showing (a-b) the formation of an extensive delta looking up towards the creek confluence from within the Long Pool (previously at least 3 feet deep), (c) looking downstream towards the center of the Long Pool within the previous pool habitat, and (d) again looking downstream towards the center of the Long Pool well after winter storms showing extensive deposition with a bobcat captured with a game camera.

Figure 89: Confluence of Hilton Creek with the LSYR mainstem showing (a-b) the formation of an extensive delta looking up towards the creek confluence from within the Long Pool (previously at least 3 feet deep), (c) looking downstream towards the center of the Long Pool within the previous pool habitat, and (d) again looking downstream towards the center of the Long Pool well after winter storms showing extensive deposition with a bobcat captured with a game camera.

The large amount of sediment that transited Hilton Creek from the Whittier Fire burn scar ended up in the Long Pool of the LSYR mainstem (Figure 89). The COMB-FD was on
