WY2020 ANNUAL MONITORING SUMMARY

THE BIOLOGICAL OPINION FOR THE OPERATION AND MAINTENANCE OF THE CACHUMA PROJECT ON THE SANTA YNEZ RIVER IN SANTA BARBARA COUNTY, CALIFORNIA

**CACHUMA OPERATION AND MAINTENANCE BOARD
FISHERIES DIVISION**

FEBRUARY 24, 2021

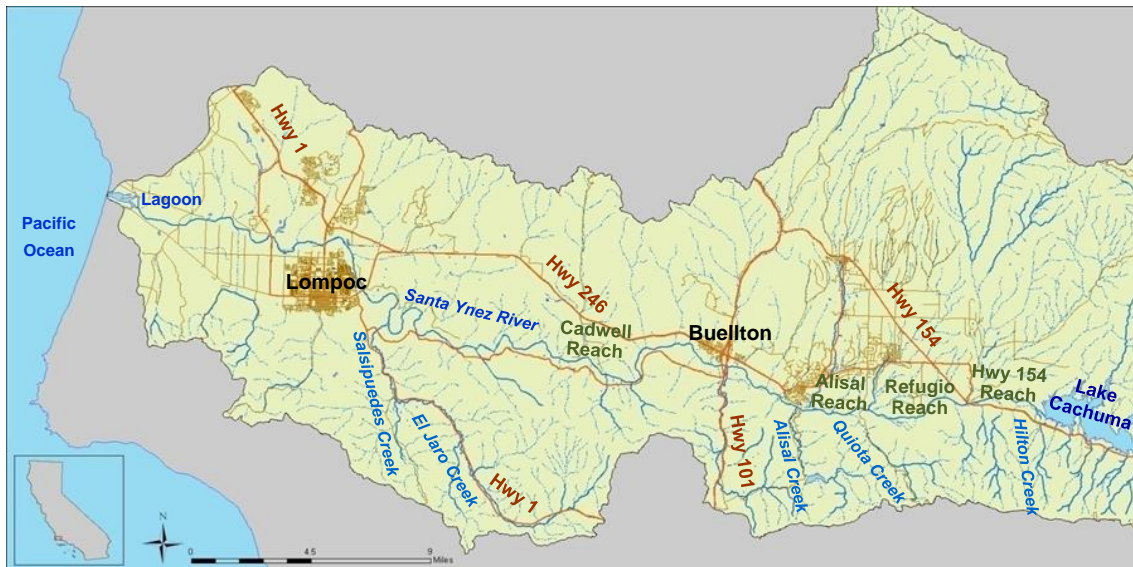
Figure ES-1: LSYR from Bradbury Dam and Lake Cachuma to the Pacific Ocean west of Lompoc, showing tributary creeks and management reaches of interest for the LSYR Fish Monitoring Program.

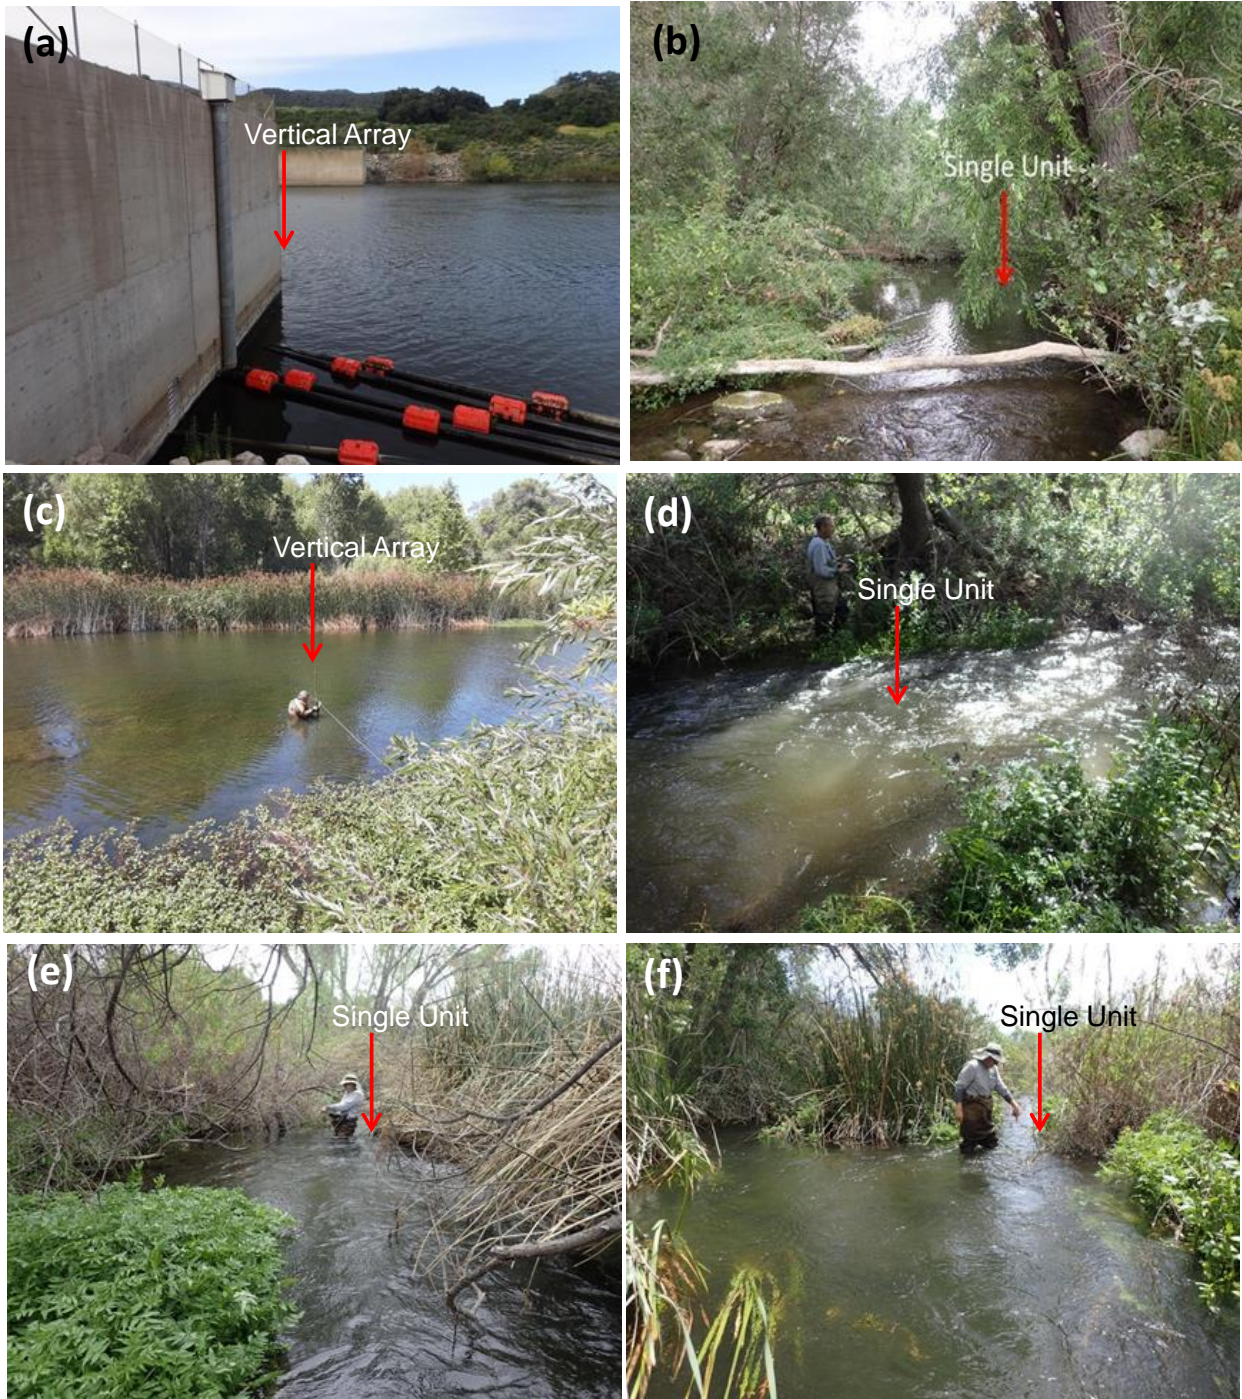
Figure 6: 2020 LSYS mainstem temperature unit deployment locations at: a) LSYS-0.01, b) LSYS-0.25, c) LSYS-0.51, d) LSYS-0.68, e) LSYS-1.09, f) LSYS-1.54.

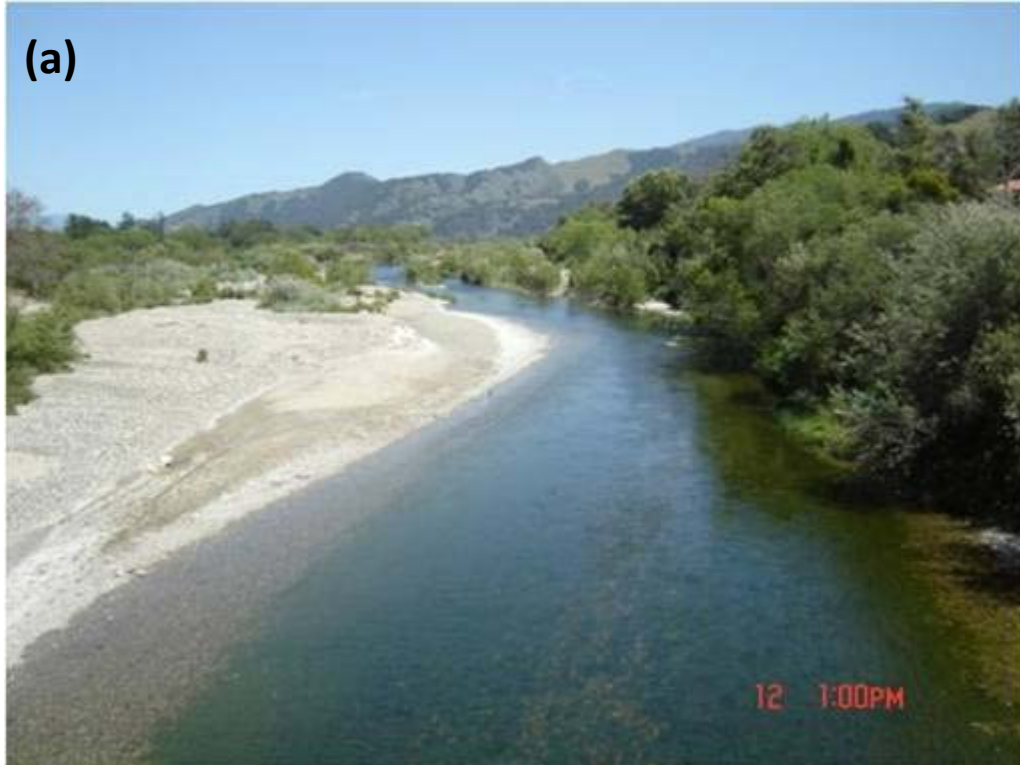
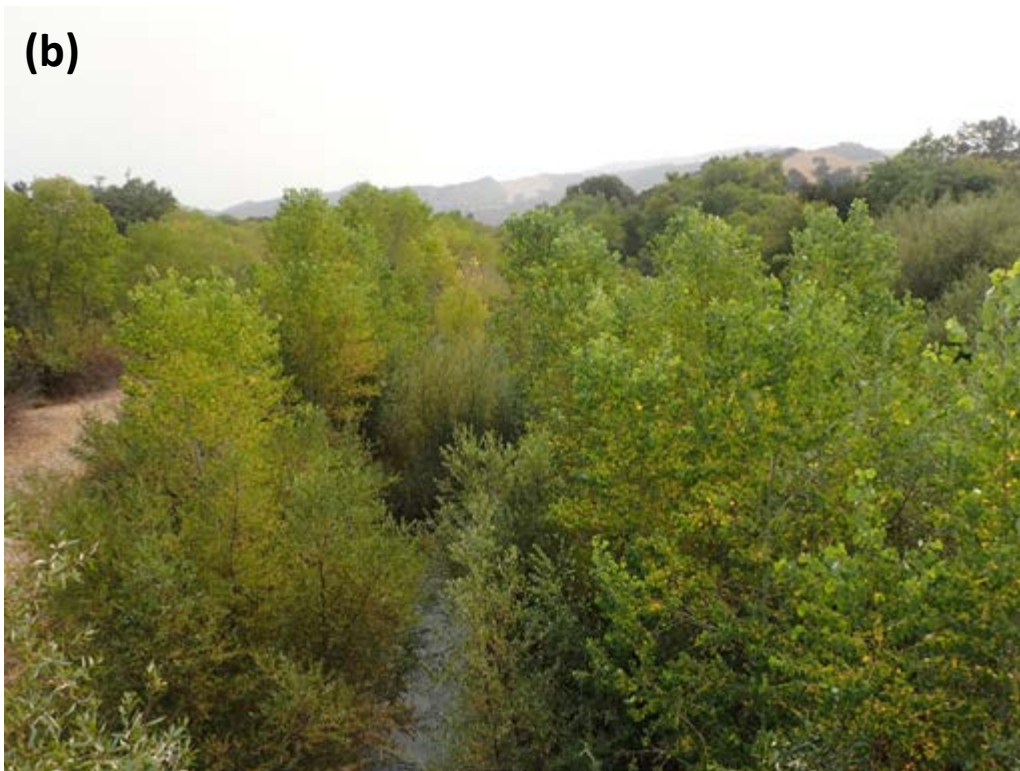
Figure 58: Photo point (M-12) collected at Refugio Bridge looking upstream in (a) May 2005, and (b) September 2020.

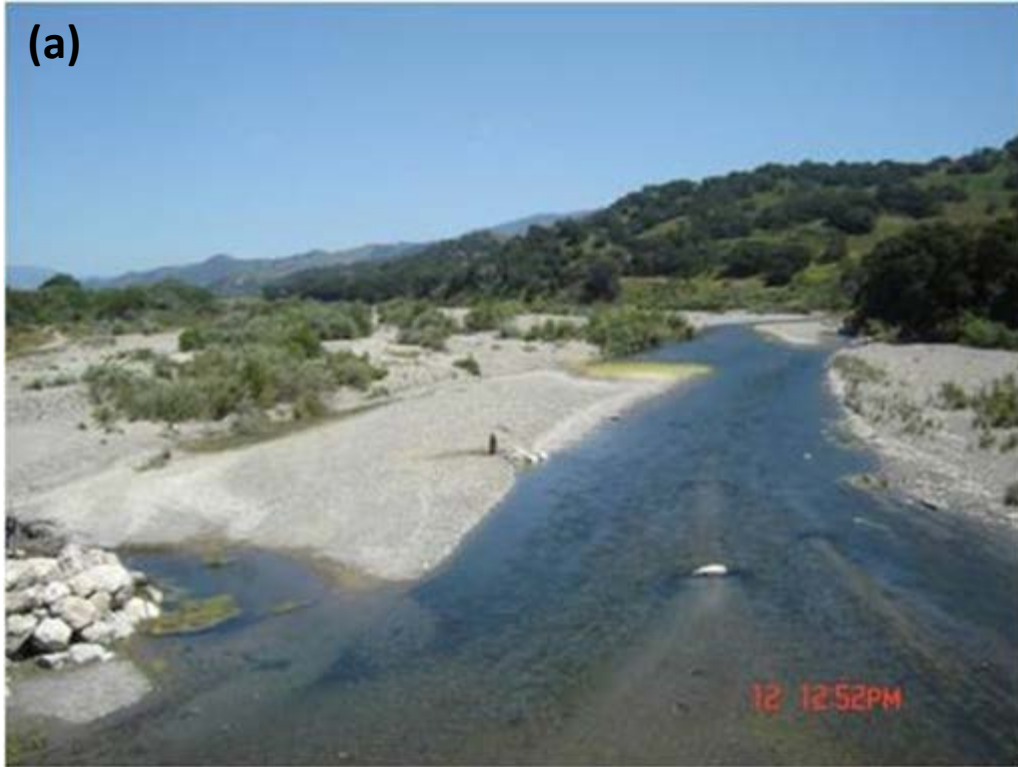
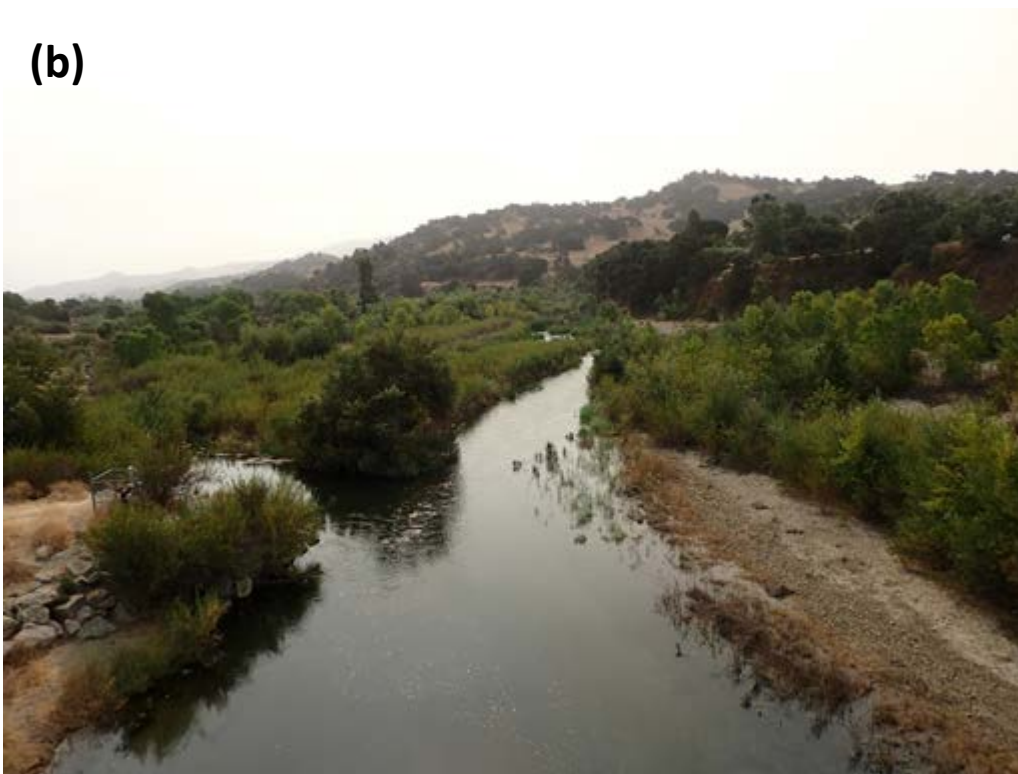
Figure 59: Photo point (M-14) collected at Alisal Bridge looking upstream in a) May 2005, and b) September 2020.

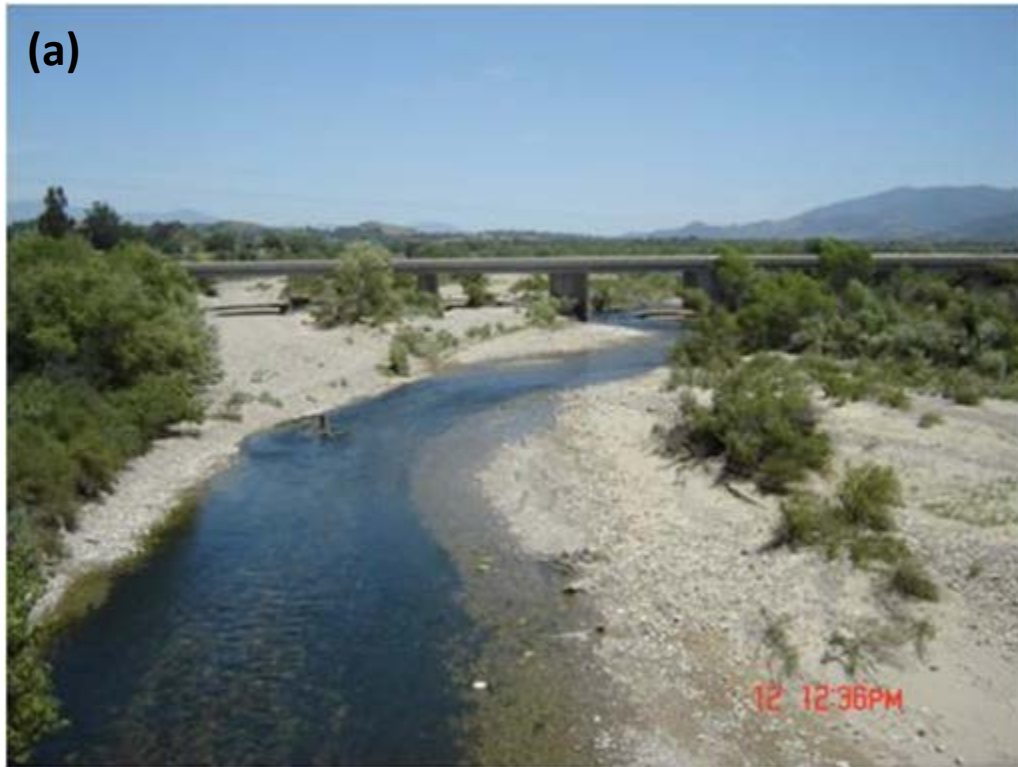
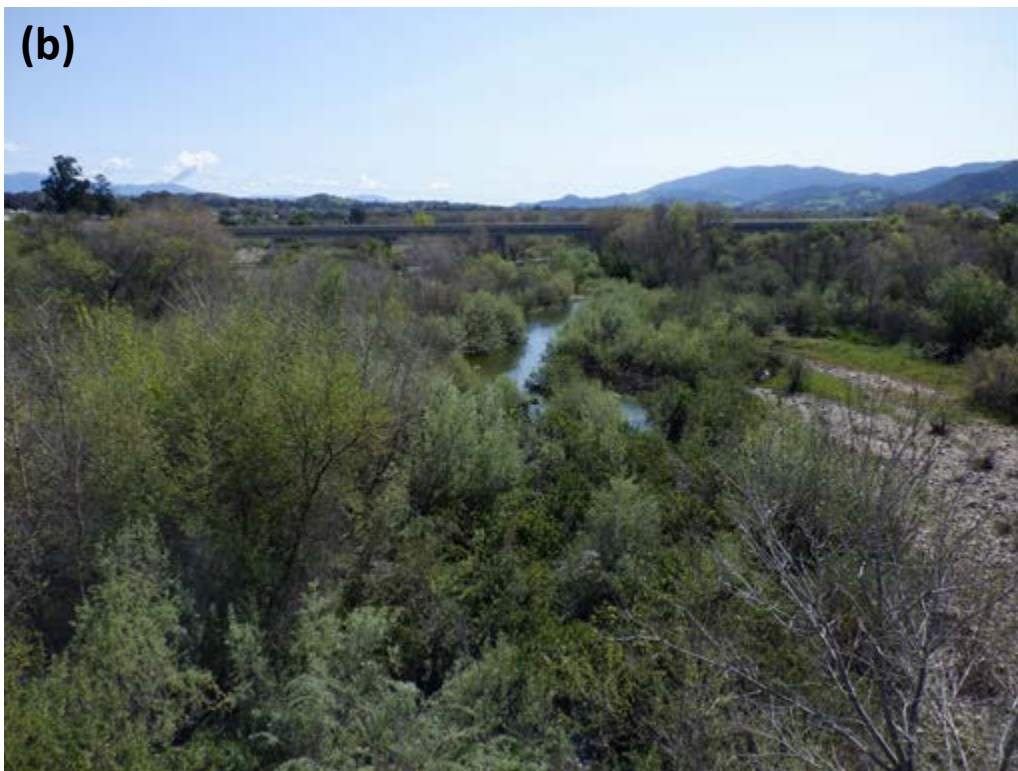
Figure 60: Photo point (M-19) collected at Avenue of the Flags Bridge looking upstream in (a) May 2005, and (b) March 2020.

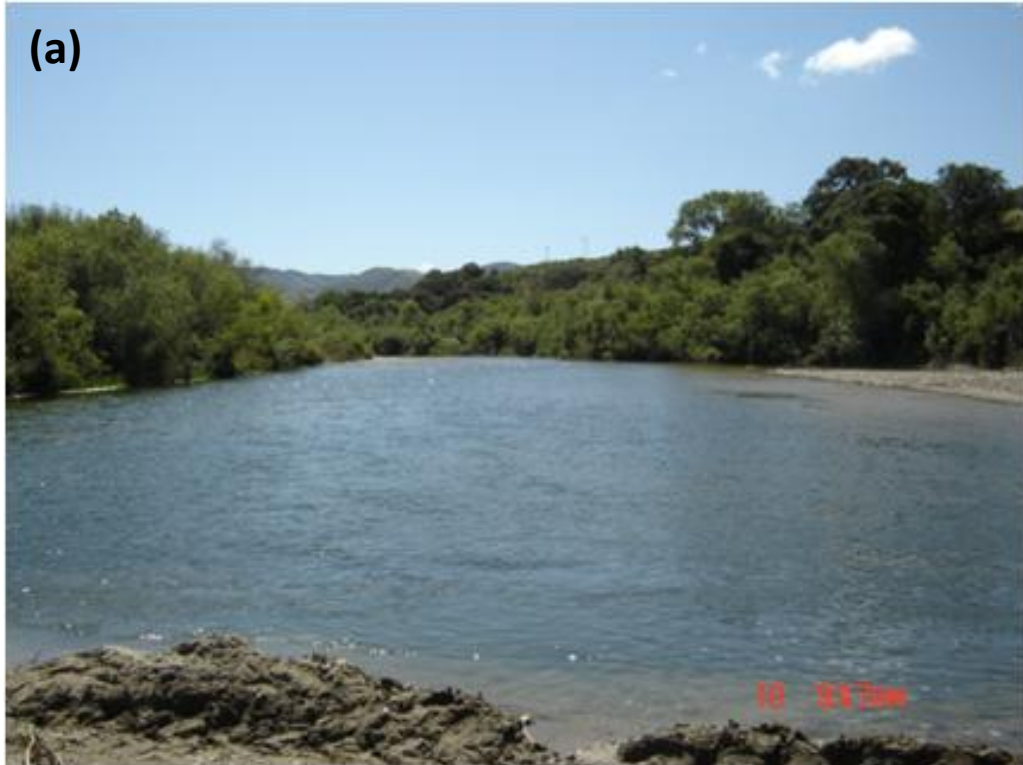
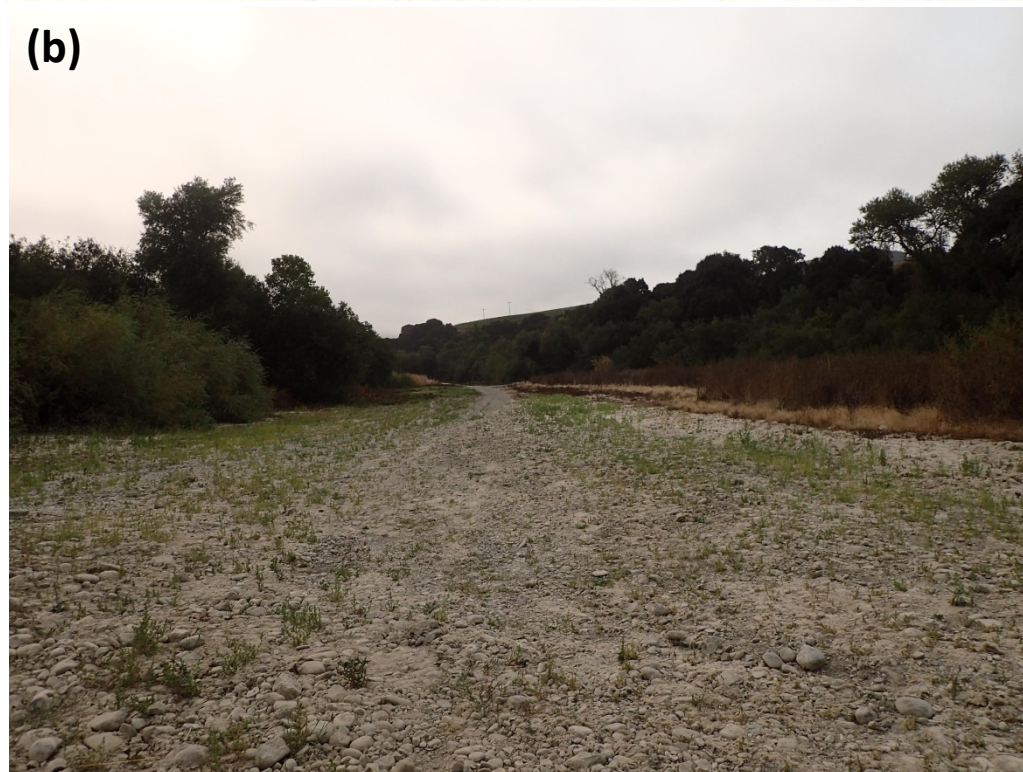
Figure 61: Photo point (M-21) collected at Sweeney Road Crossing looking upstream in (a) May 2005, and (b) September 2020.

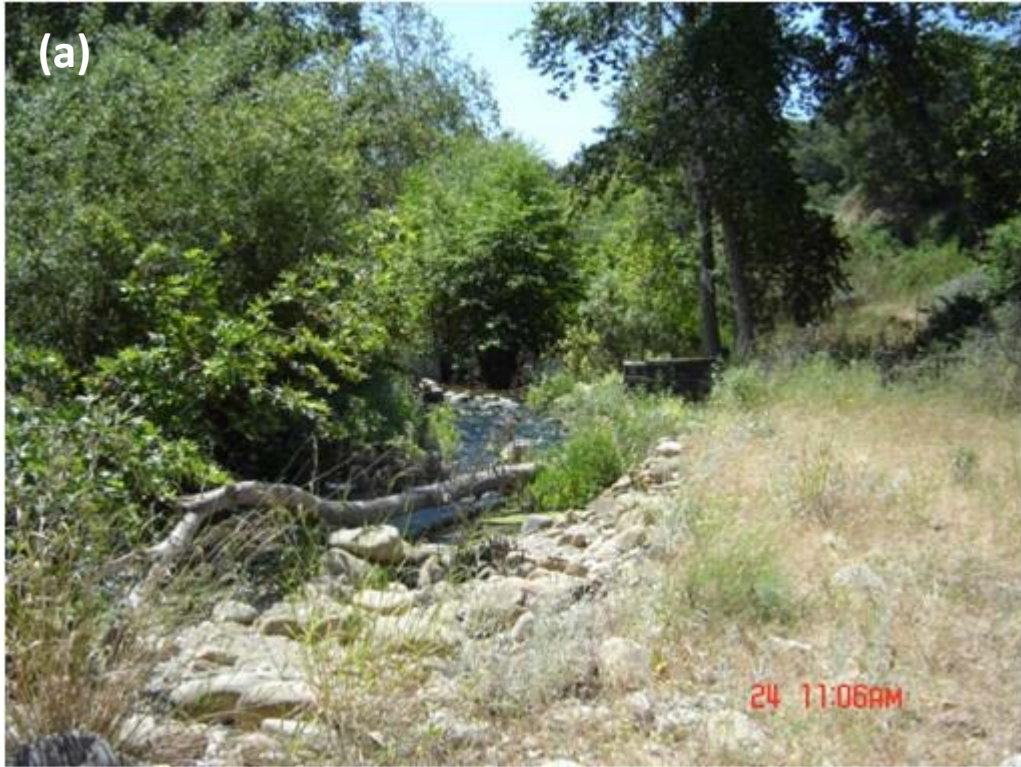
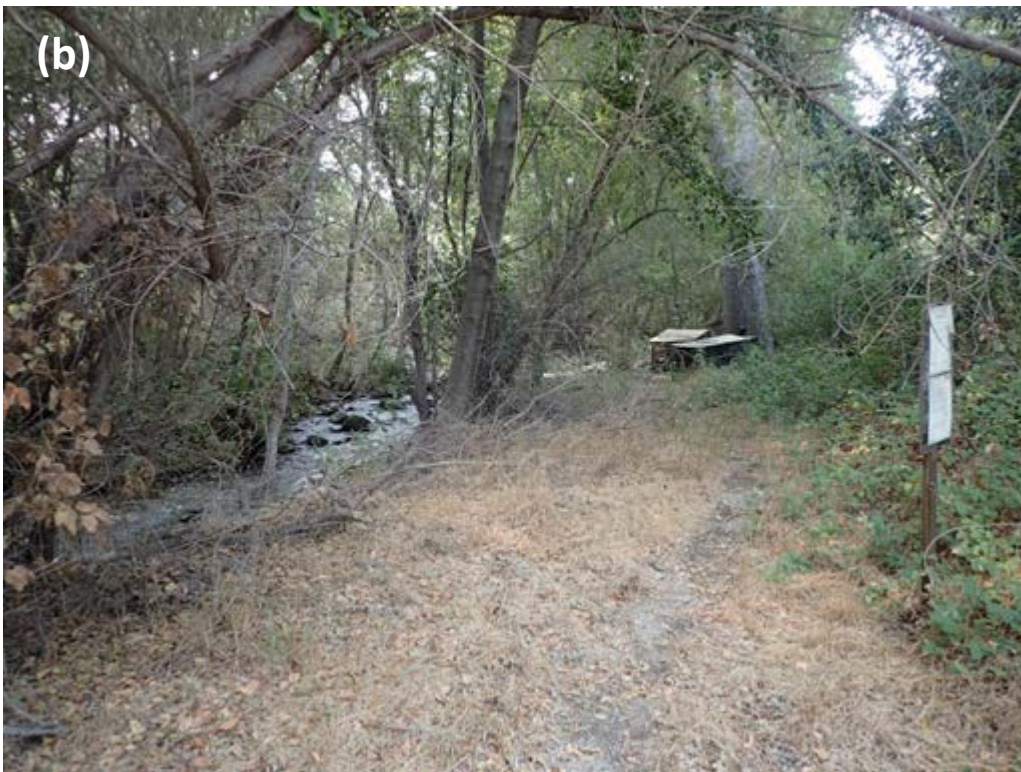
Figure 62: Photo point (T-1) collected at Hilton Creek looking upstream towards the trap site on (a) May 2005, and (b) September 2020.

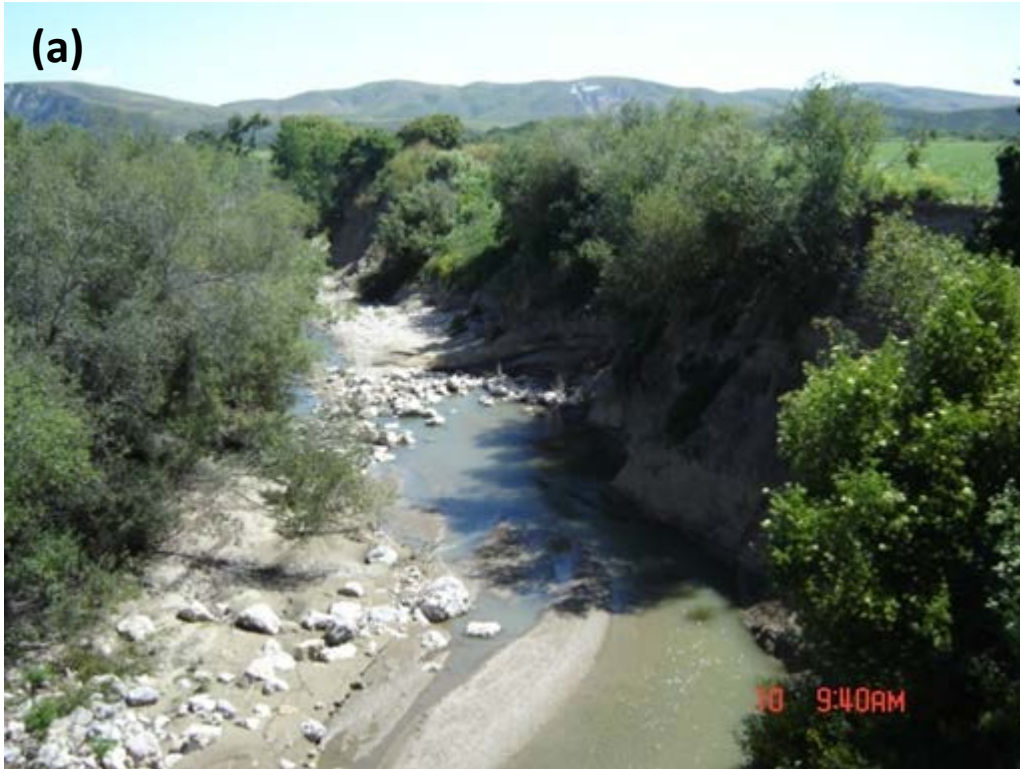
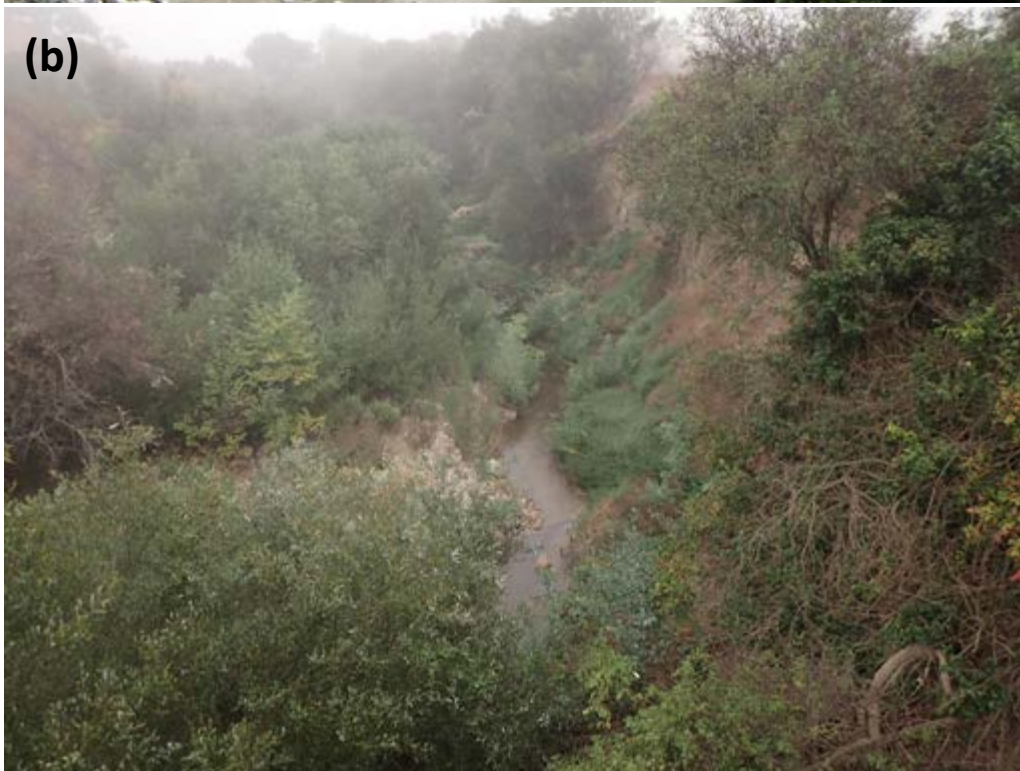
Figure 64: Photo point (T-28) collected at Salsipuedes Creek at Santa Rosa Bridge in (a) May 2005 and (b) September 2020.

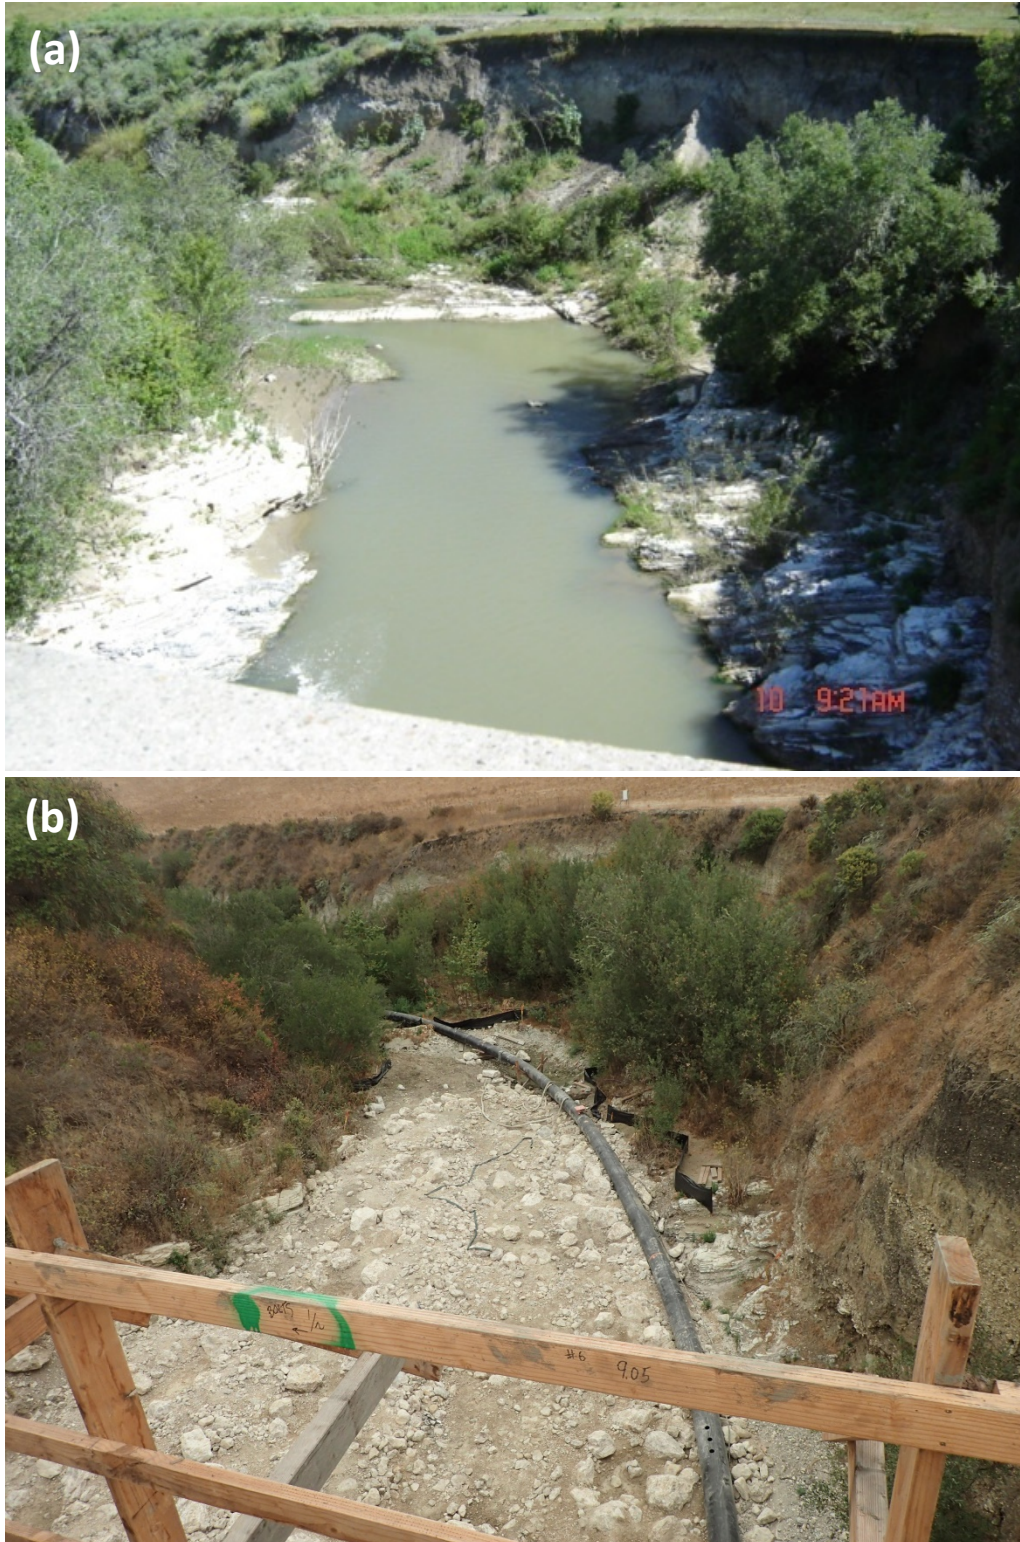
Figure 65: Photo point (T-39) collected at Salsipuedes Creek at Hwy 1 Bridge in May 2005 and (b) September 2020 (during Caltrans bridge replacement project).

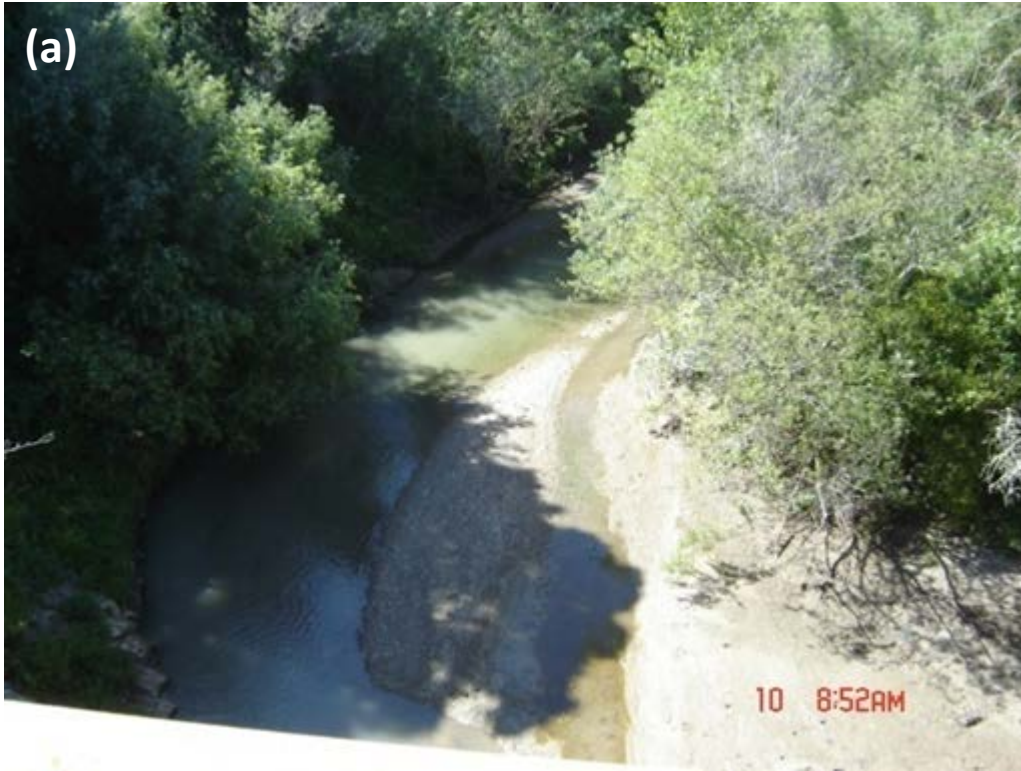
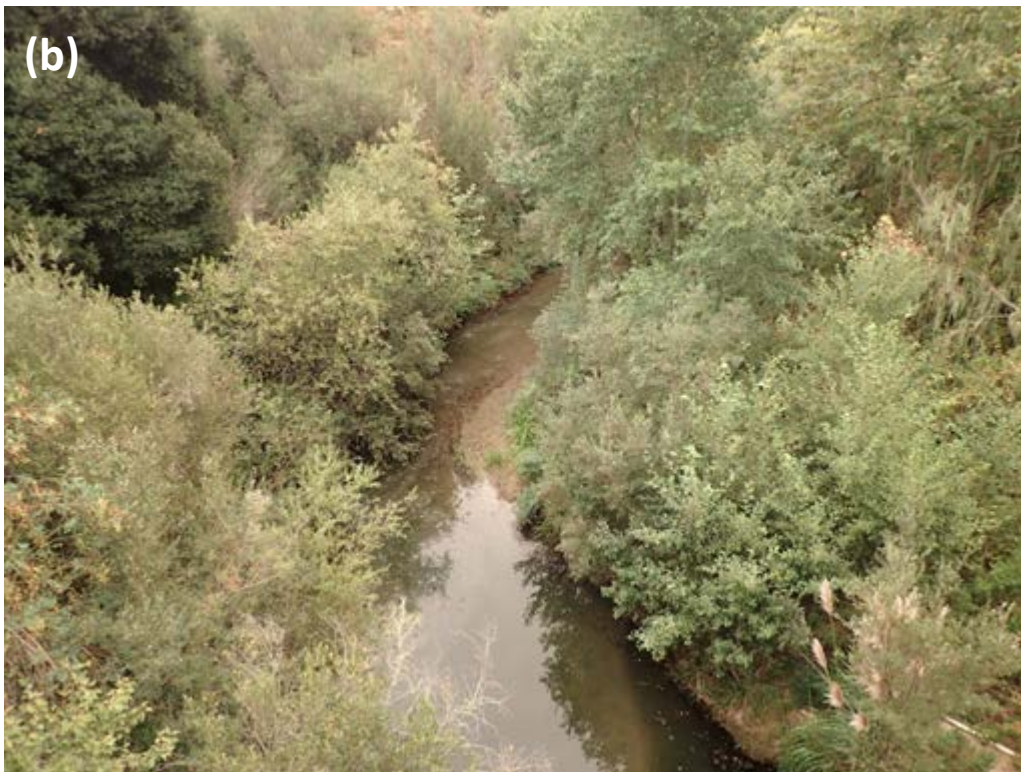
Figure 66: Photo point (T-42) collected at Salsipuedes Creek at Jalama Road Bridge in May 2005 and (b) September 2020.

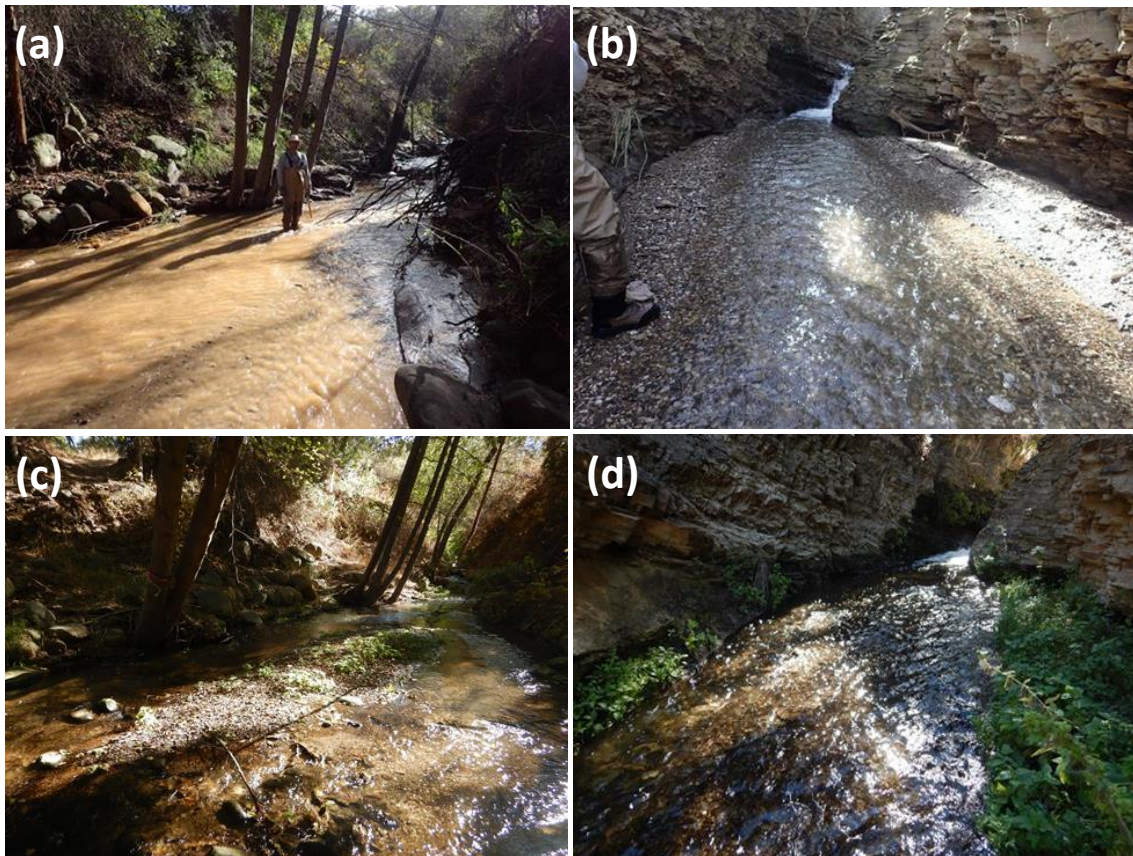
Figure 92: Hilton Creek post-storm habitat conditions showing (a) sediment deposition in the (a) Spawning Pool (1/18/19) and (b) Honeymoon Pool just upstream (1/22/19), and

In Hilton Creek, there were 2 high streamflow events from the upper watershed on 12/25/19 and 4/6/20, the latter brought down a large quantity of streambed material from the Whittier Fire burn scar (see the WY2018 AMS for details). The first event produced a steep storm hydrograph with a rapid increase followed by an equally rapid decrease in

streamflow resulting in 1 mortality found in a high flow channel. During the subsequent April storm, stream sediments refilled most of the small and large pool habitats throughout the reaches on Reclamation property as well as continued to fill in the Long Pool. The amount of sediments moving downstream and impact to the water quality and habitats made for difficult conditions for the Hilton Creek *O. mykiss* population. There were 9 *O. mykiss* mortalities found in association with that stormflow event and most likely many fish either washed downstream or perished. Reports for these 2 stormflow events were produced and submitted to Reclamation who then provided them to NMFS.

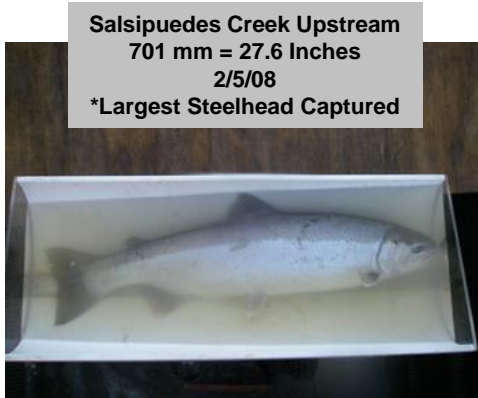
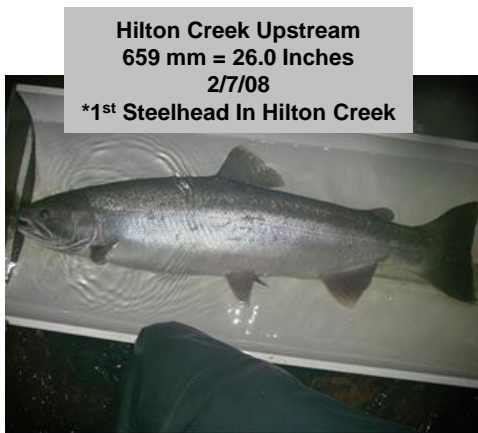
WY2008 Adult Steelhead Captures					
#	#	Location	Direction	Size (mm)	Date
1	1	Salsipuedes	US	640	2/4
2	2	Salsipuedes	US	701	2/5
3	3	Salsipuedes	DS	496	2/7
4	4	Salsipuedes	US	635	2/17
5	5	Salsipuedes	US	663	3/25
6	6	Salsipuedes	US	675	3/29
7	1	Mainstem	US	678	2/10
8	2	Mainstem	US	600	3/18
9	1	Hilton	US	659	2/7
10	2	Hilton	DS	578	2/11
11	3	Hilton	US	691	2/16
12	4	Hilton	US	510	2/26
13	5	Hilton	DS	617	3/4
14	6	Hilton	US	563	3/5
15	7	Hilton	US	660	3/7
16	8	Hilton	US	688	3/23

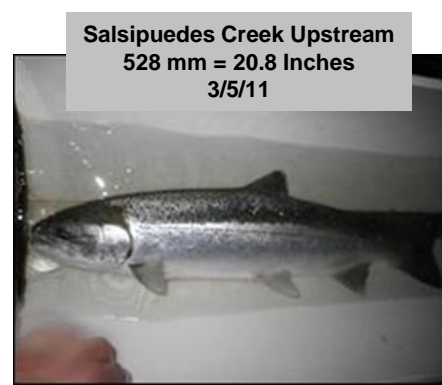
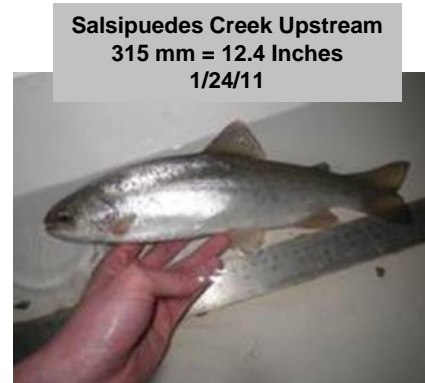
WY2011 Adult Steelhead Captures					
#	#	Location	Direction	Size (mm)	Date
1	1	Salsipuedes	US	315*	1/24
2	2	Salsipuedes	US	528	3/5
3	3	Salsipuedes	US	481	3/11
4	4	Salsipuedes	US	490	4/2
5	5	Salsipuedes	US	458	4/8
6	6	Salsipuedes	US	507	4/10
7	7	Salsipuedes	US	298*	5/6
8	8	Salsipuedes	US	242*	5/6
9	1	Hilton	US	481**	4/1

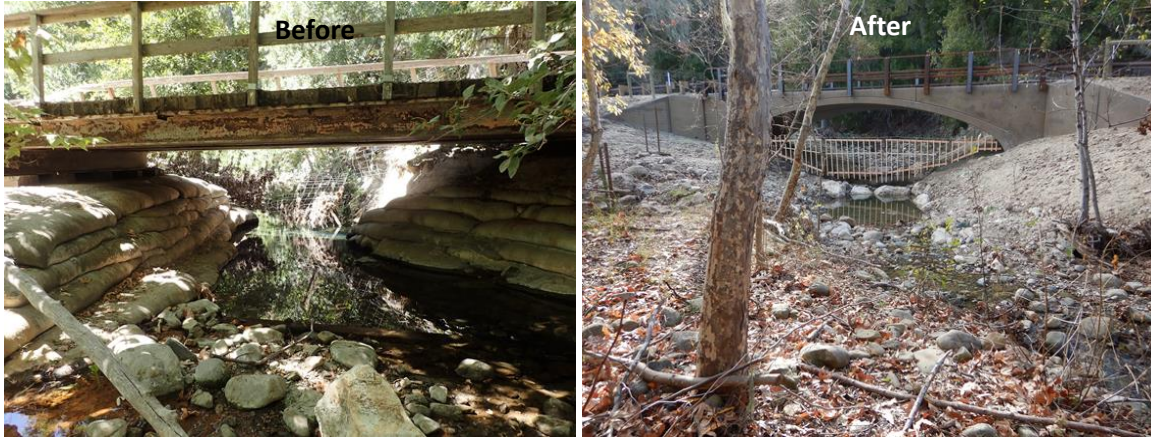
Figure 116: Fish passage and habitat restoration at Quiota Creek Crossing 8 completed in 2019.

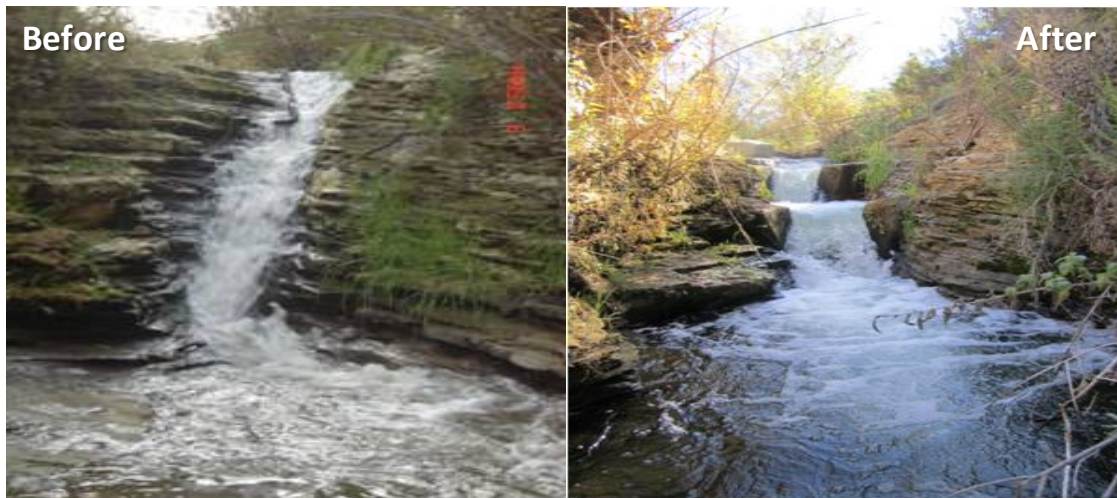
Figure 117: Fish passage and habitat restoration at Hilton Creek at the Cascade Chute Project that was completed in 2005.
