WY2015 ANNUAL MONITORING SUMMARY

**THE BIOLOGICAL OPINION FOR THE OPERATION
AND MAINTENANCE OF THE CACHUMA PROJECT
ON THE SANTA YNEZ RIVER
IN SANTA BARBARA COUNTY, CALIFORNIA**

**CACHUMA OPERATION AND MAINTENANCE BOARD
FISHERIES DIVISION**

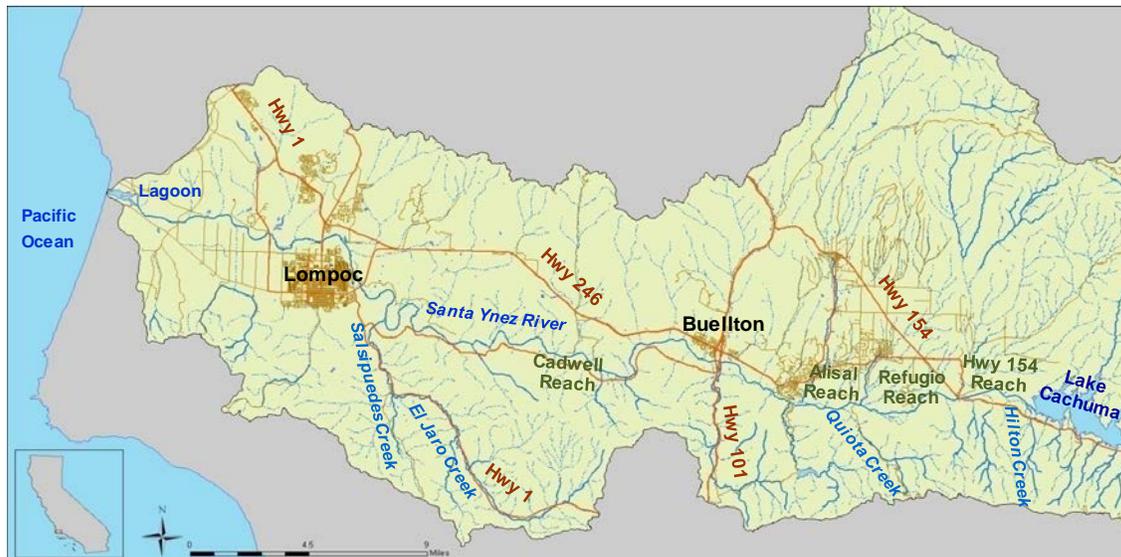
Figure ES-1: LSYR from Bradbury Dam and Lake Cachuma to the Pacific Ocean west of Lompoc, showing tributary creeks and management reaches of interest for the LSYR Fisheries Monitoring Program.

The monitoring tasks completed in WY2015 were performed below Bradbury Dam in the LSYR watershed and in Lake Cachuma, which is approximately half the drainage area (450 square miles) and stream distance (48 miles) to the ocean compared to the entire watershed. The area is within the Southern California Steelhead Distinct Population Segment (DPS) and the Monte Arido Highland Biogeographic Population Group (BPG) in the Southern Steelhead Recovery Planning Area (NMFS, 2012). Monitoring focused on three management reaches (Highway 154, Refugio, and Alisal reaches) and the Cadwell Reach on the LSYR mainstem, and tributaries (Hilton, Quiota, El Jaro, and Salsipuedes creeks) known to support suitable habitat for *O. mykiss* (Figure ES-1).

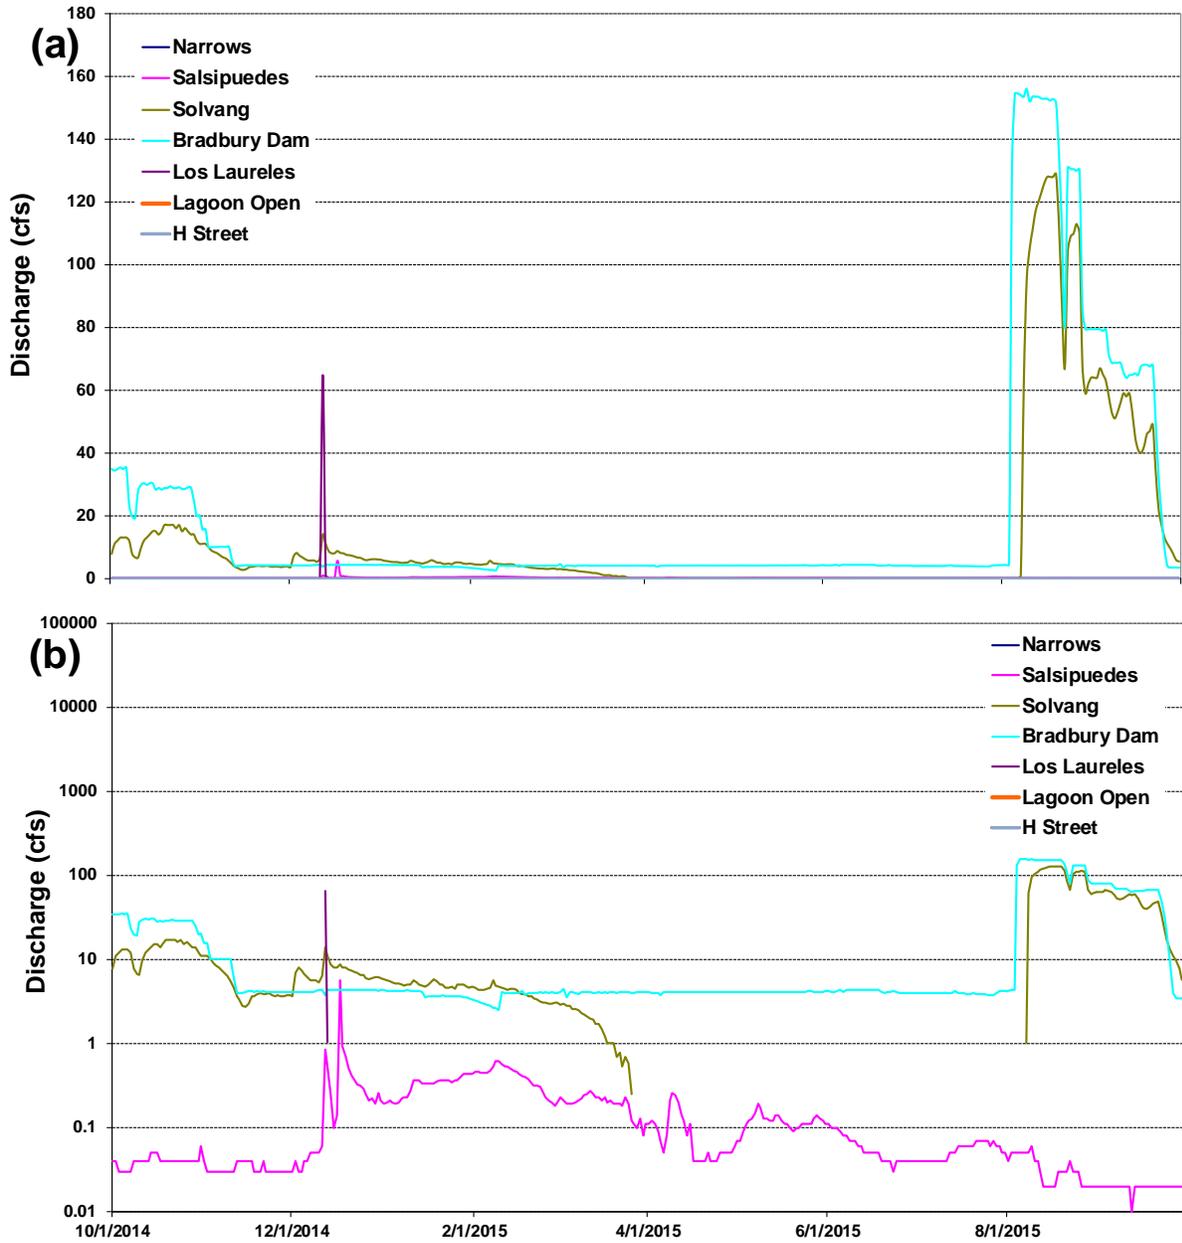
Figure 2: Santa Ynez River and tributary average daily discharge in WY2015 with a (a) normal and (b) logarithmic distribution; the Santa Ynez River lagoon was not open in WY2015 (source USGS and USBR).

Annual hydrographs along the Santa Ynez River at Los Laureles, Solvang, Narrows and Salsipuedes Creek gauges show lower than normal spring runoff conditions throughout the basin (Figure 2). Aside from the 5 outages associated with failure of the HCWS,

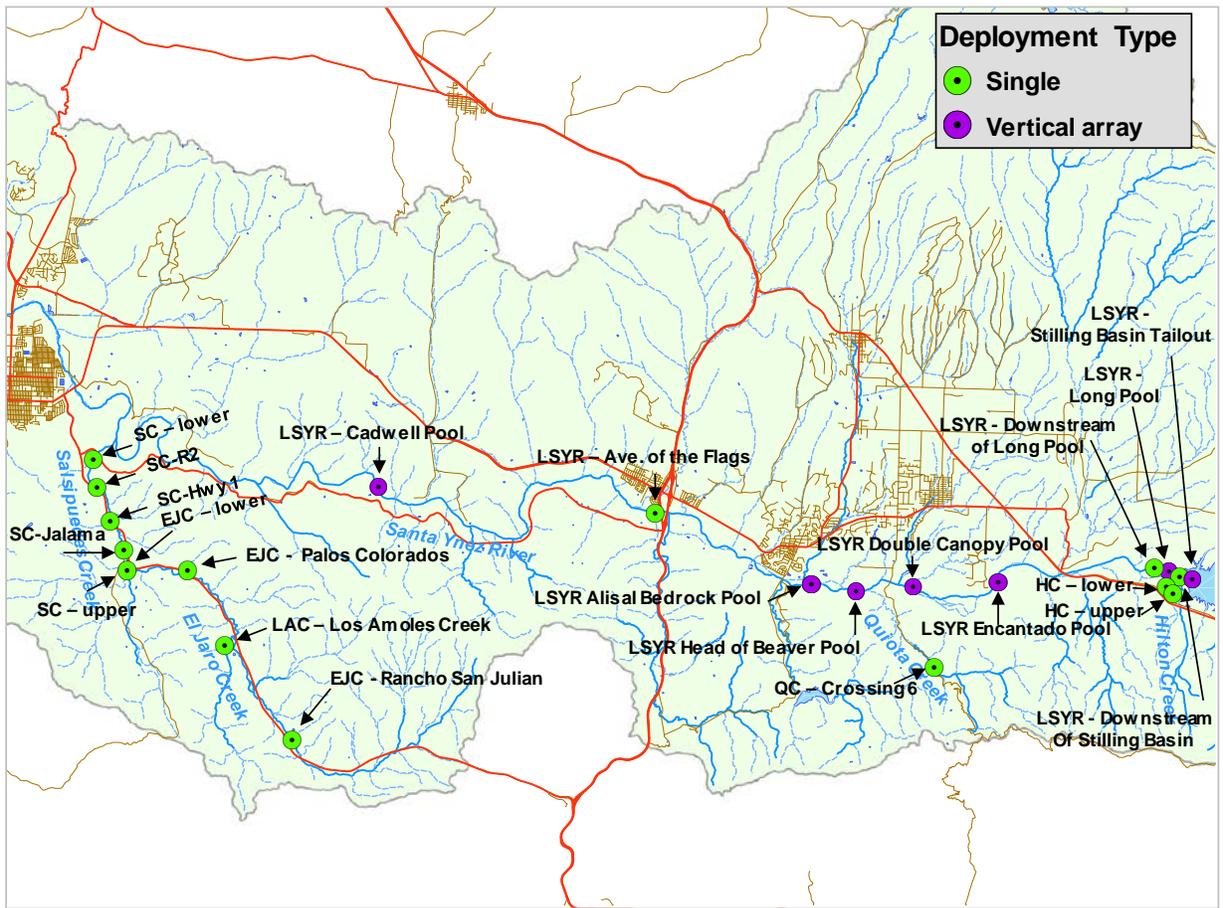
Figure 5: Thermograph single and vertical array deployment locations in WY2015 within the LSYS and its tributaries (HC – Hilton Creek, QC – Quiota Creek, SC – Salsipuedes Creek, and EJC – El Jaro Creek); the El Jaro Creek site and upper Salsipuedes Creek sites are very close together with overlapping symbols.

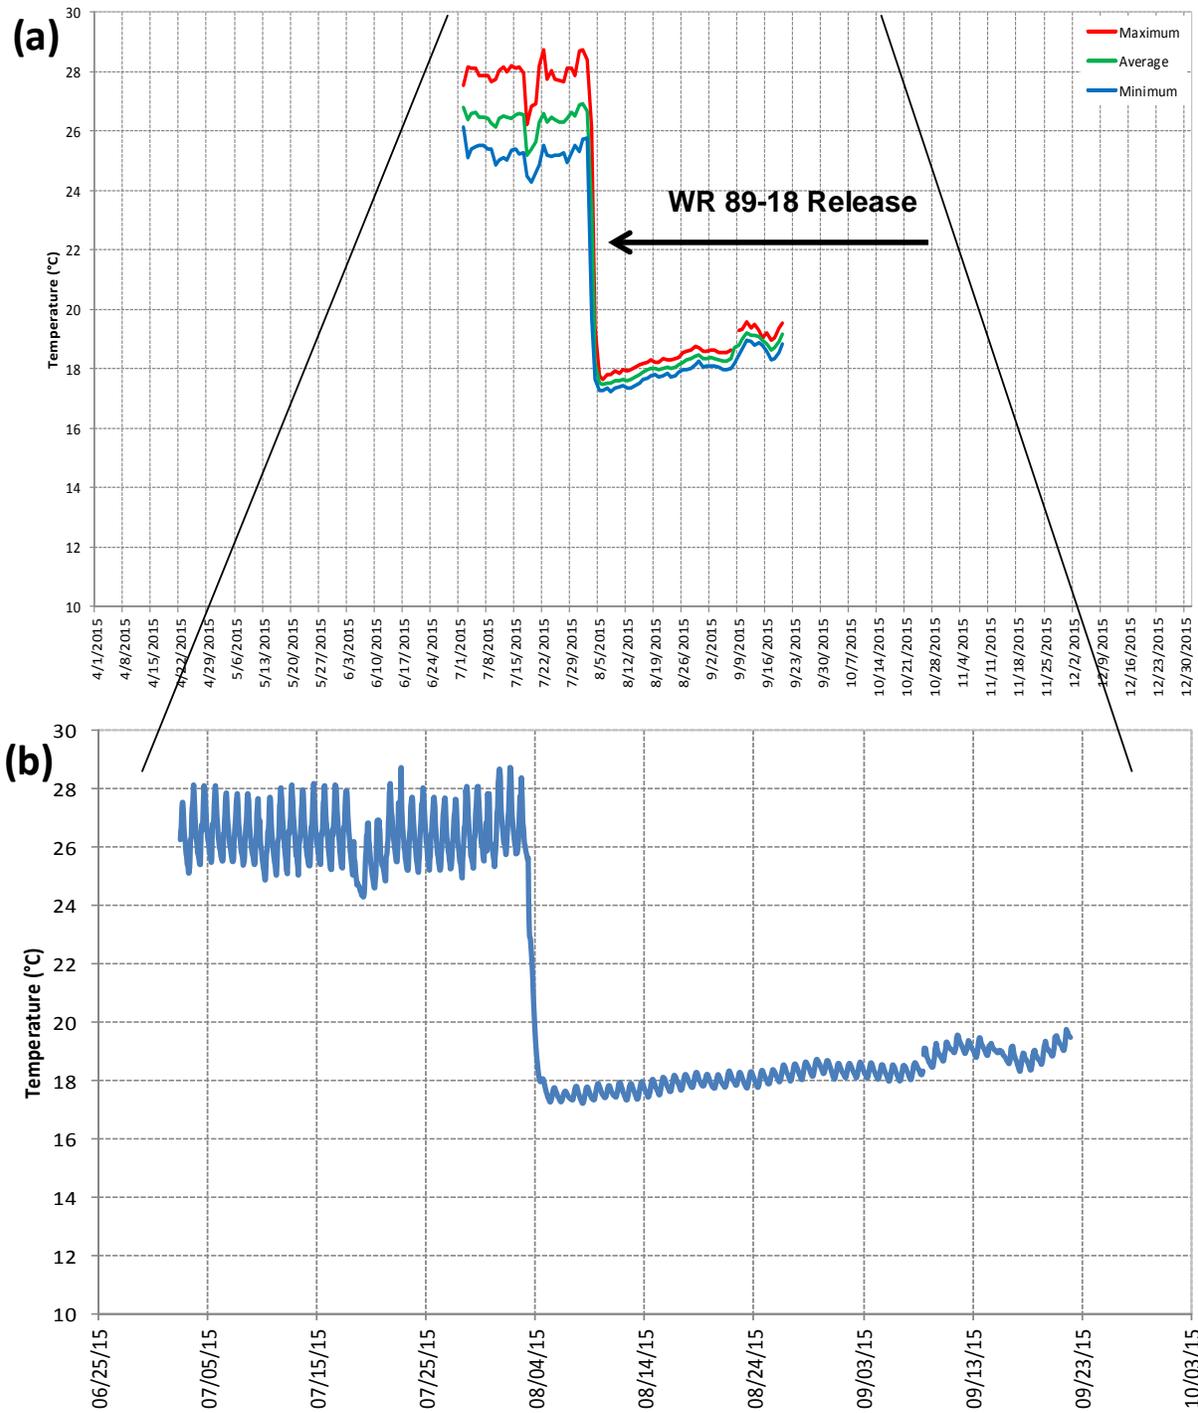
Figure 6: 2015 LSYR-0.2 (Stilling Basin tail out) surface (1.0 foot) water temperature for (a) daily maximum, average, and minimum for the entire period of deployment and (b) hourly measurements for the period of record.

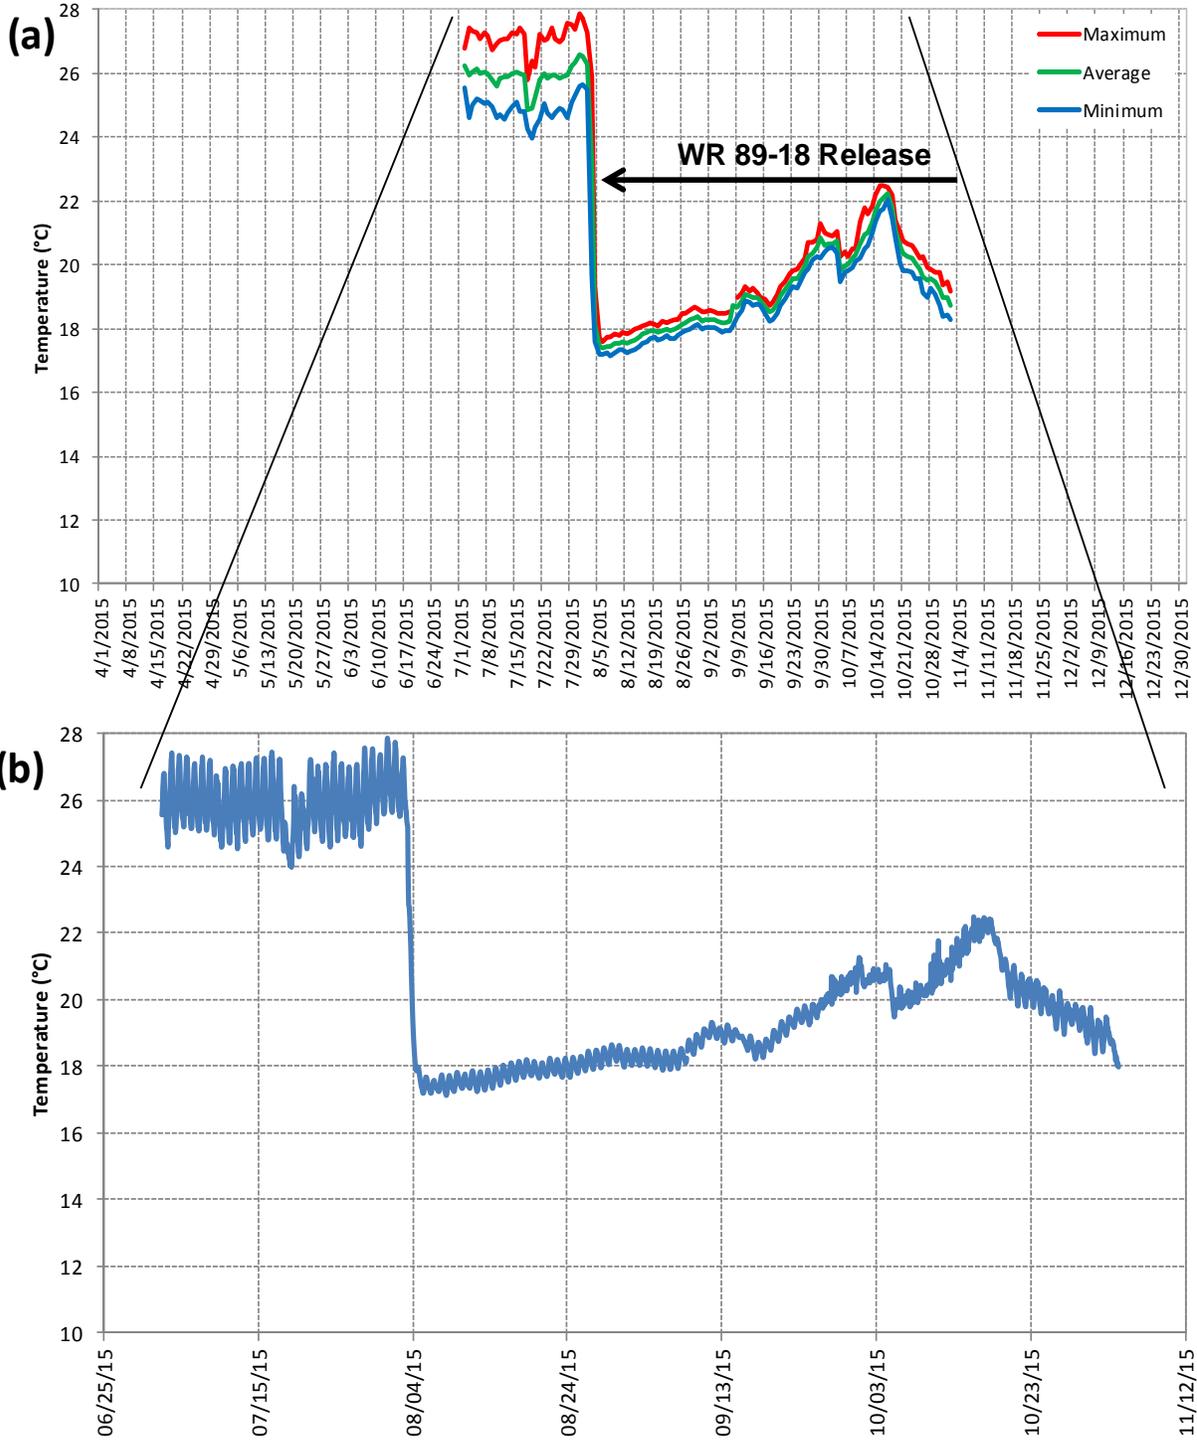
Figure 7: 2015 LSYR-0.2 (Stilling Basin tail out) bottom (7.0 feet) water temperature for (a) daily maximum, average, and minimum for the entire period of deployment and (b) hourly measurements for the period of record.

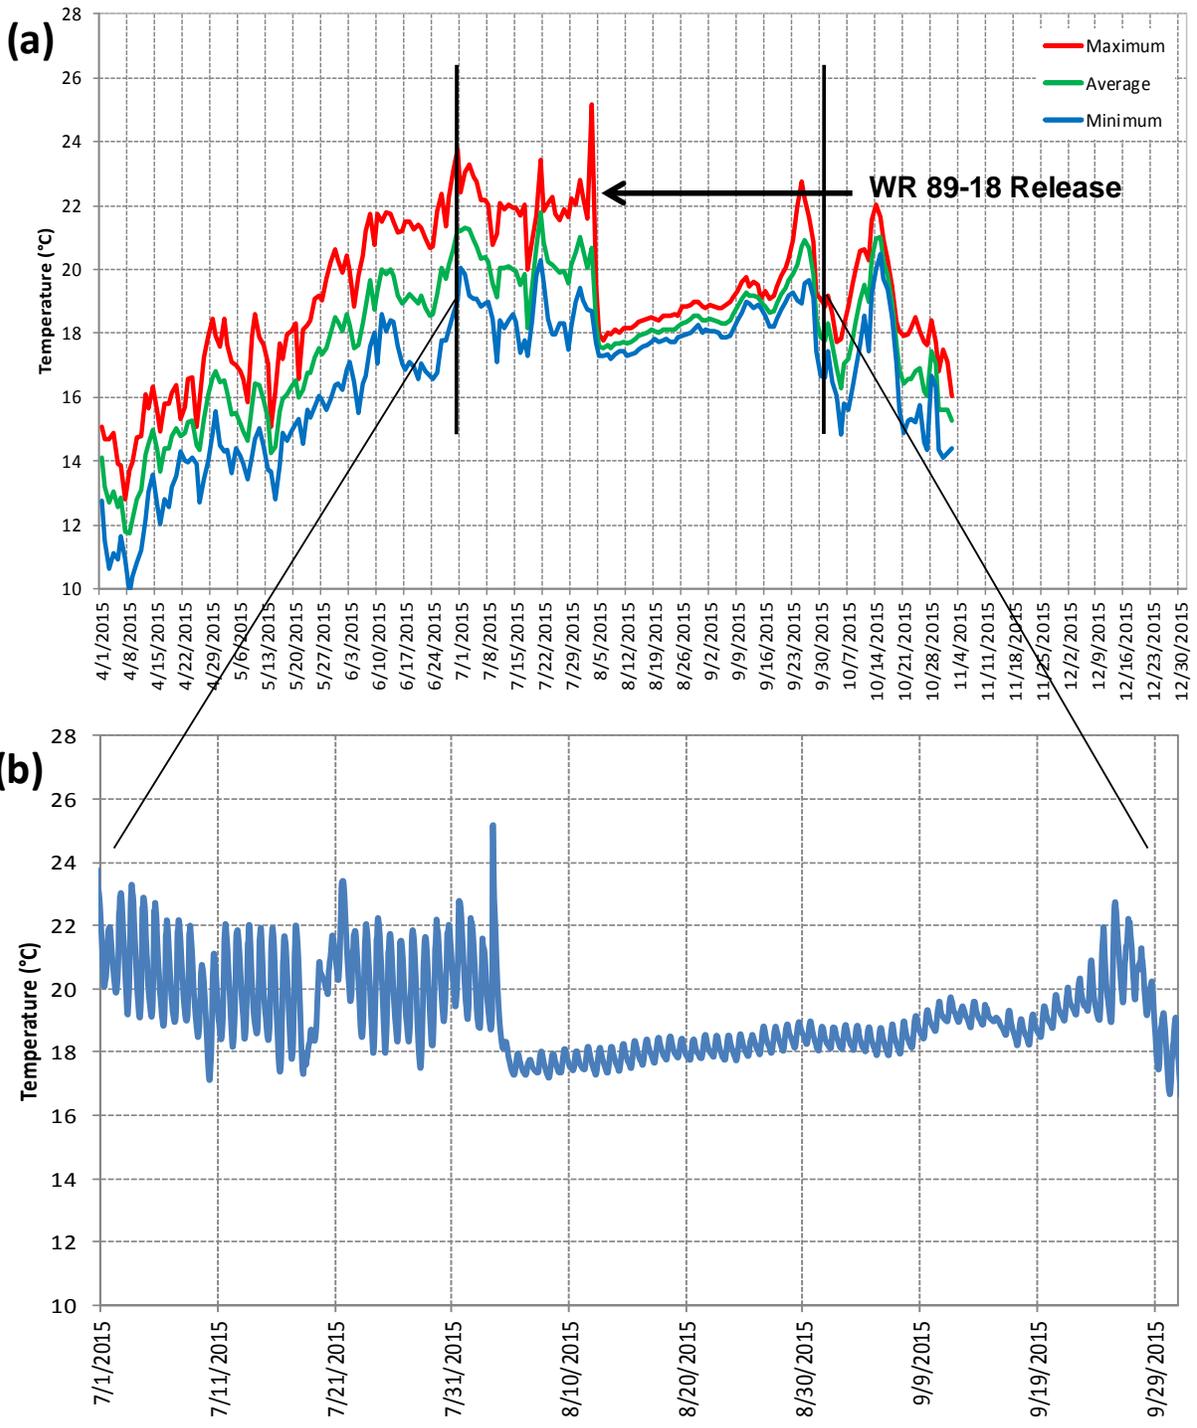
Figure 8: 2015 LSYR-0.25 (Downstream of the Stilling Basin) bottom (1.5 feet) water temperature for (a) daily maximum, average, and minimum for the entire period of deployment and (b) hourly measurements for the period 7/1/15 – 10/1/15.

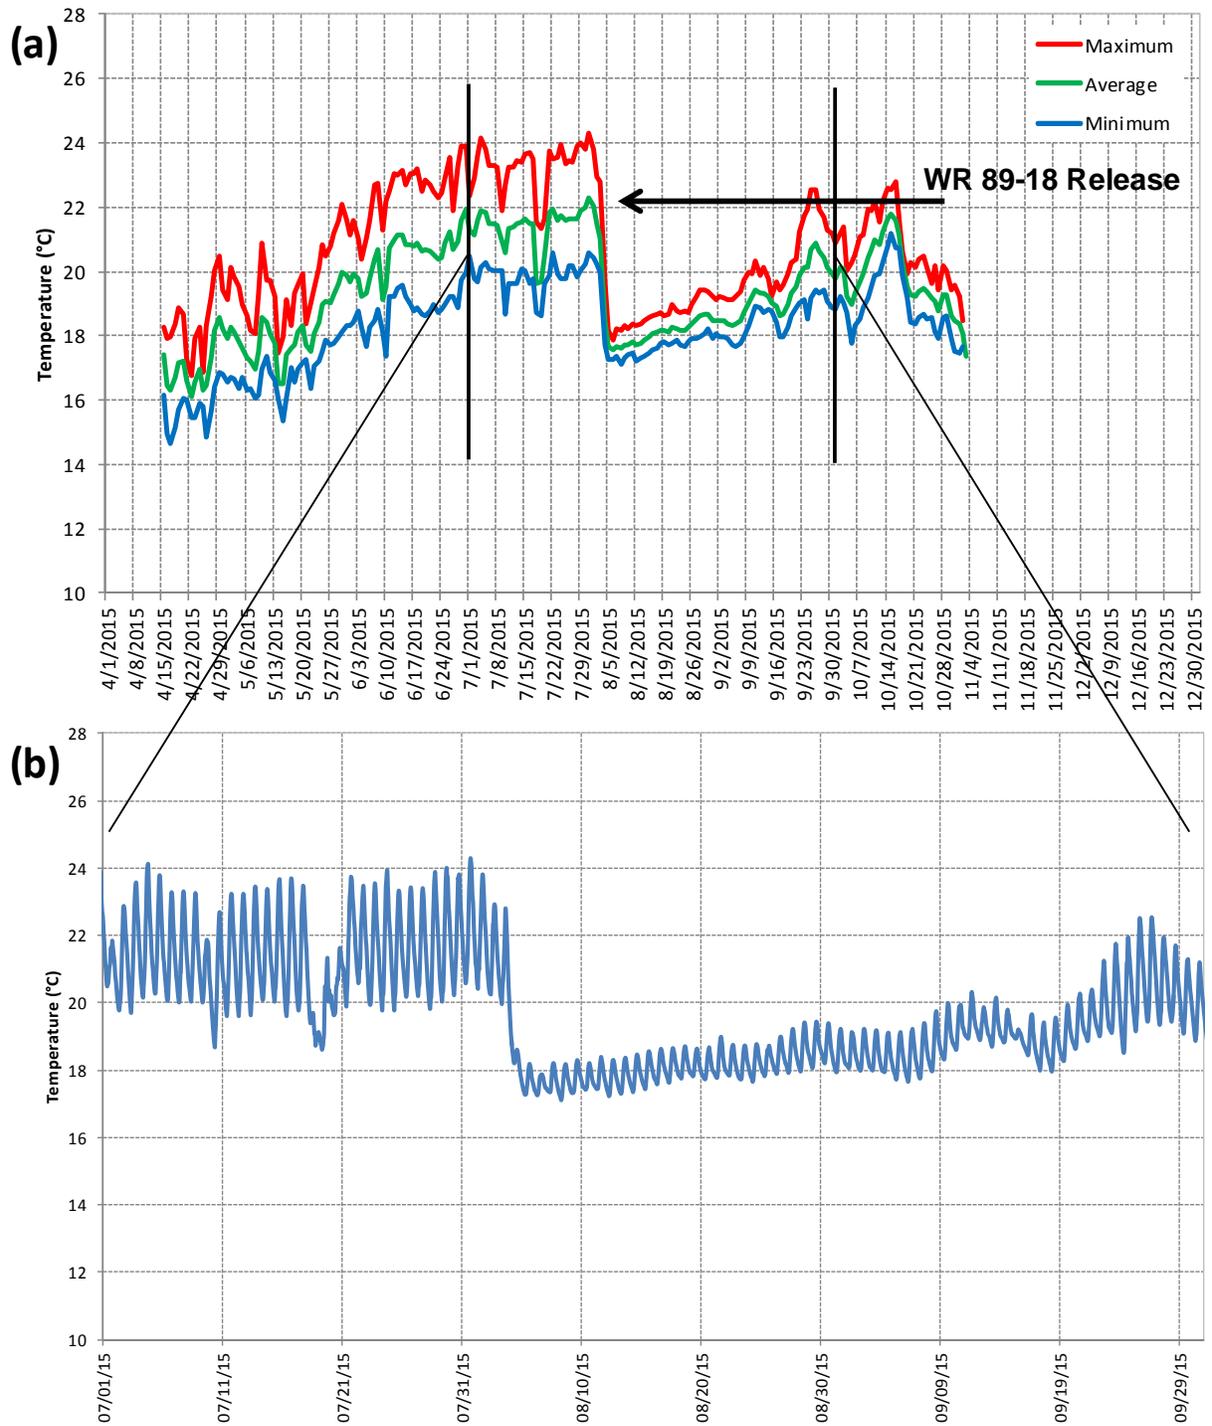
Figure 9: 2015 LSYR-0.51 (Long Pool) surface (1.0 foot) thermograph for (a) daily maximum, average, and minimum values and (b) hourly data for the period of 7/1/15 – 10/1/15.

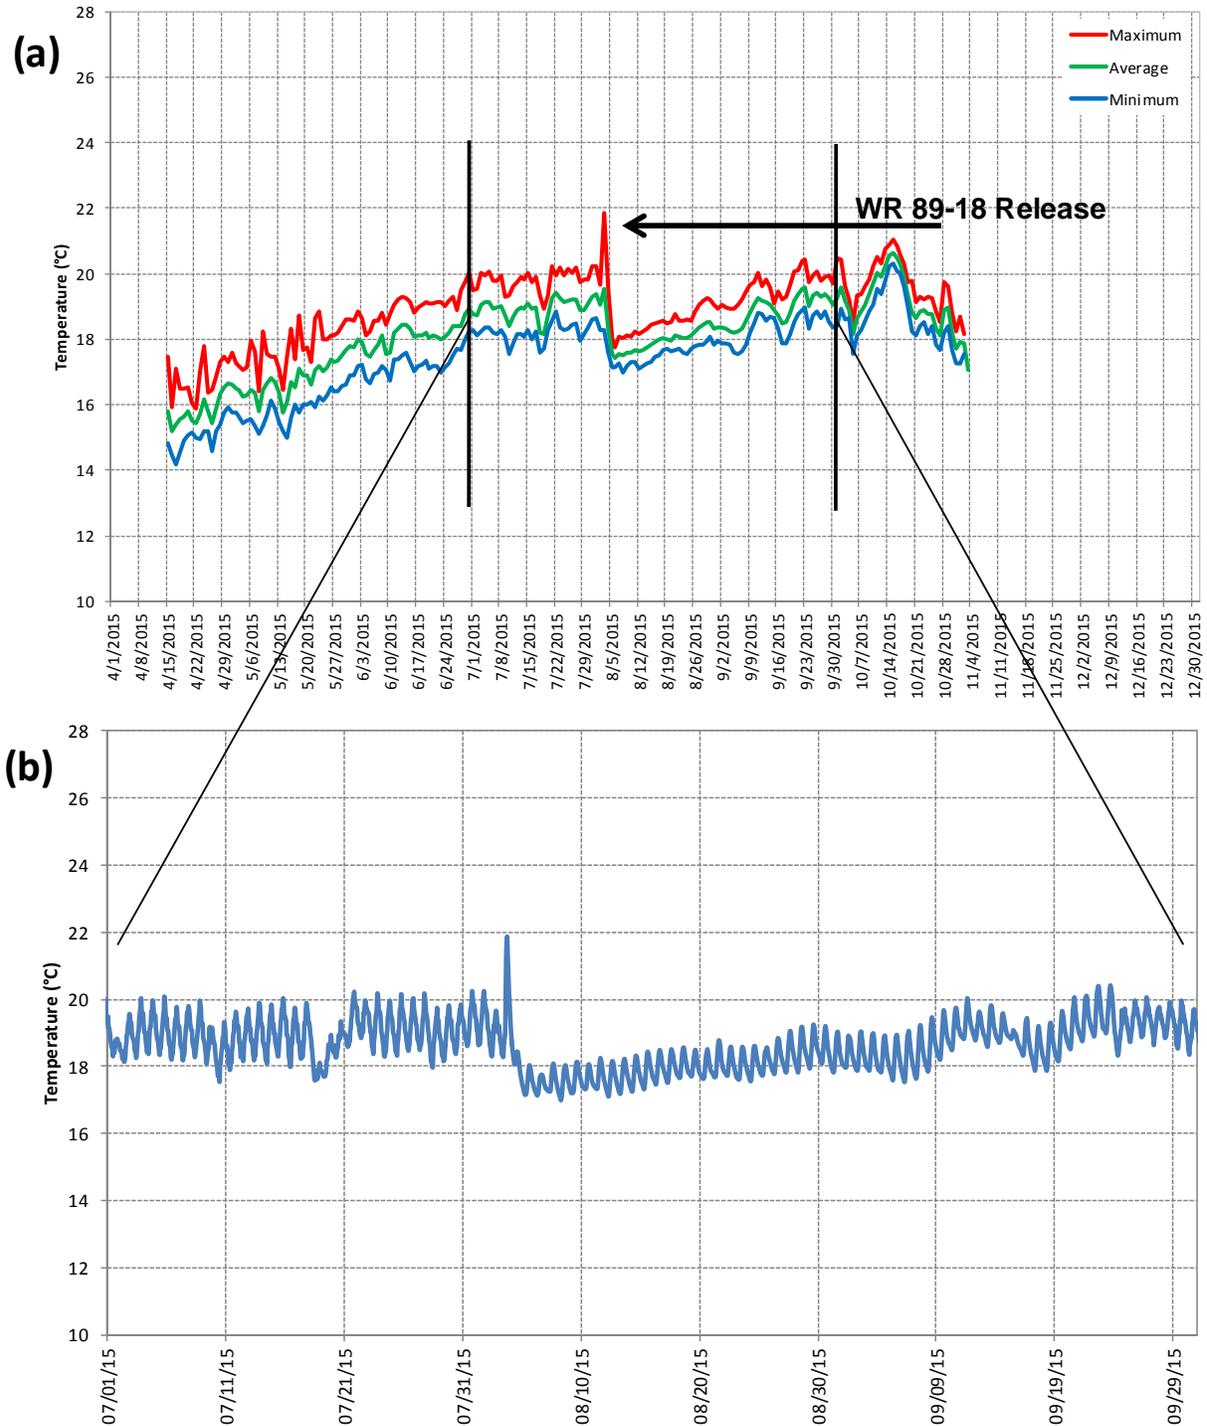
Figure 10: 2015 LSYR-0.51 (Long Pool) middle (4.5 feet) thermograph for (a) daily maximum, average, and minimum values and (b) hourly data for the period of 7/1/15 – 10/1/15.

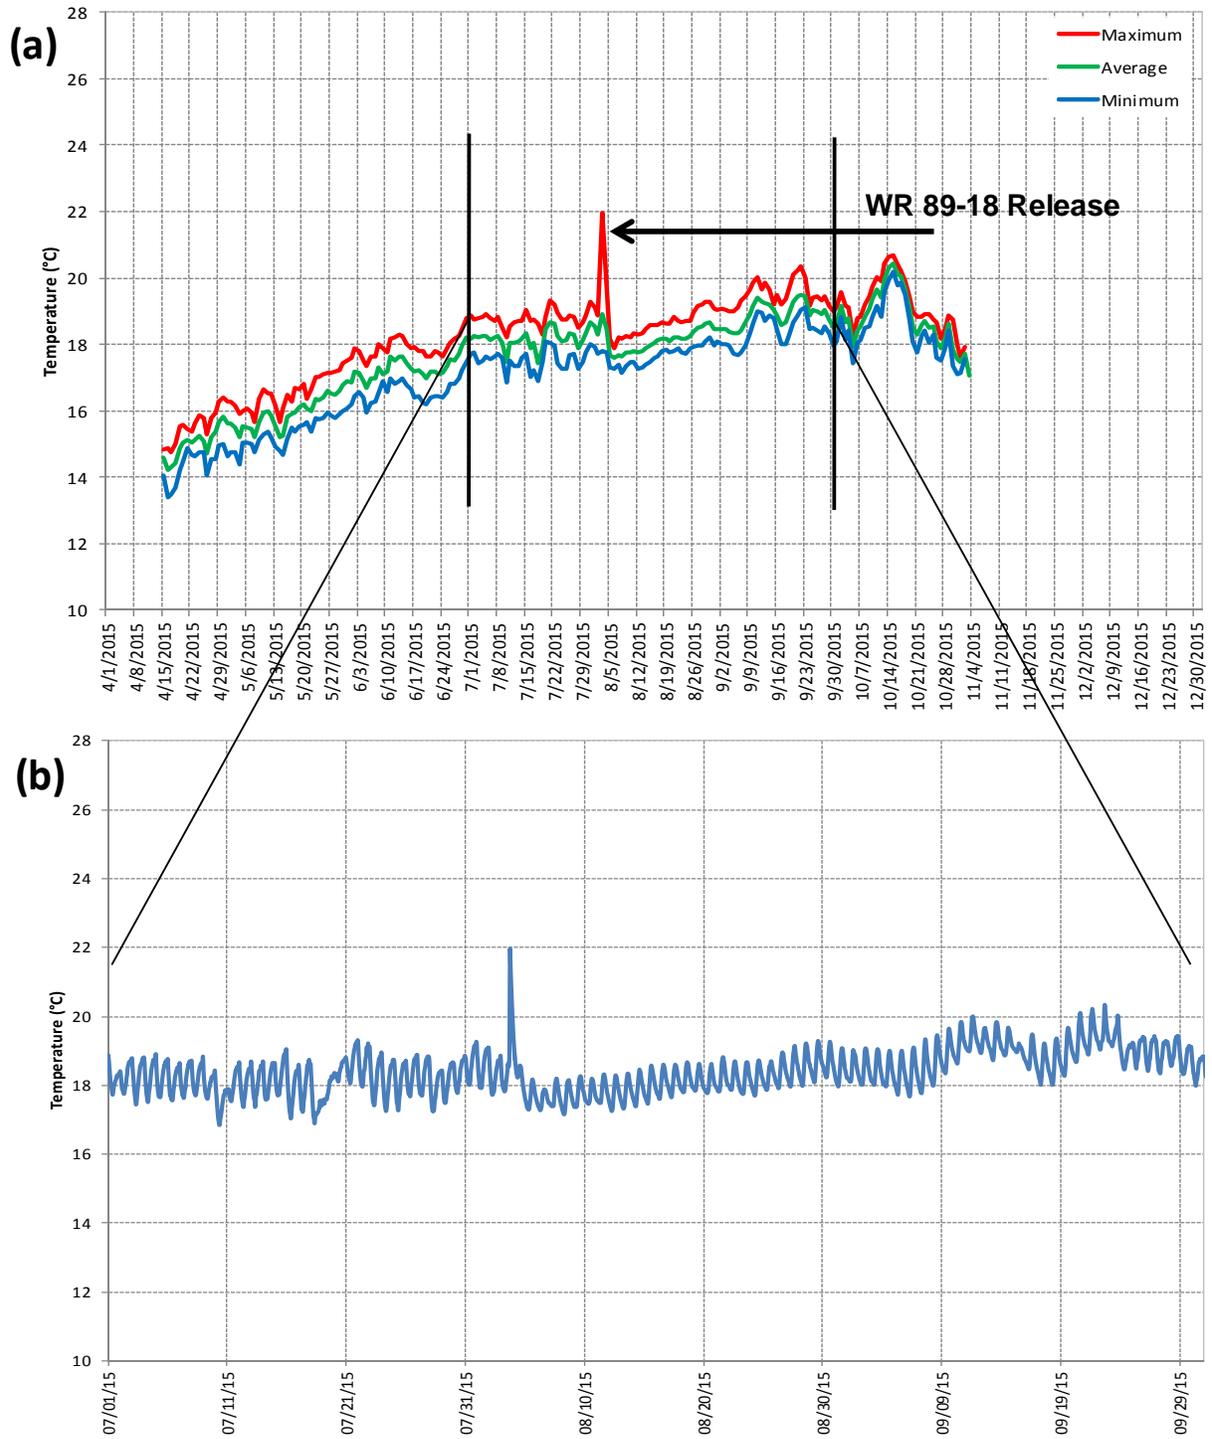
Figure 11: 2015 LSJR-0.51 (Long Pool) bottom (8.5 feet) thermograph for (a) daily maximum, average, and minimum values and (b) hourly data for the period of 7/1/15 – 10/1/15.

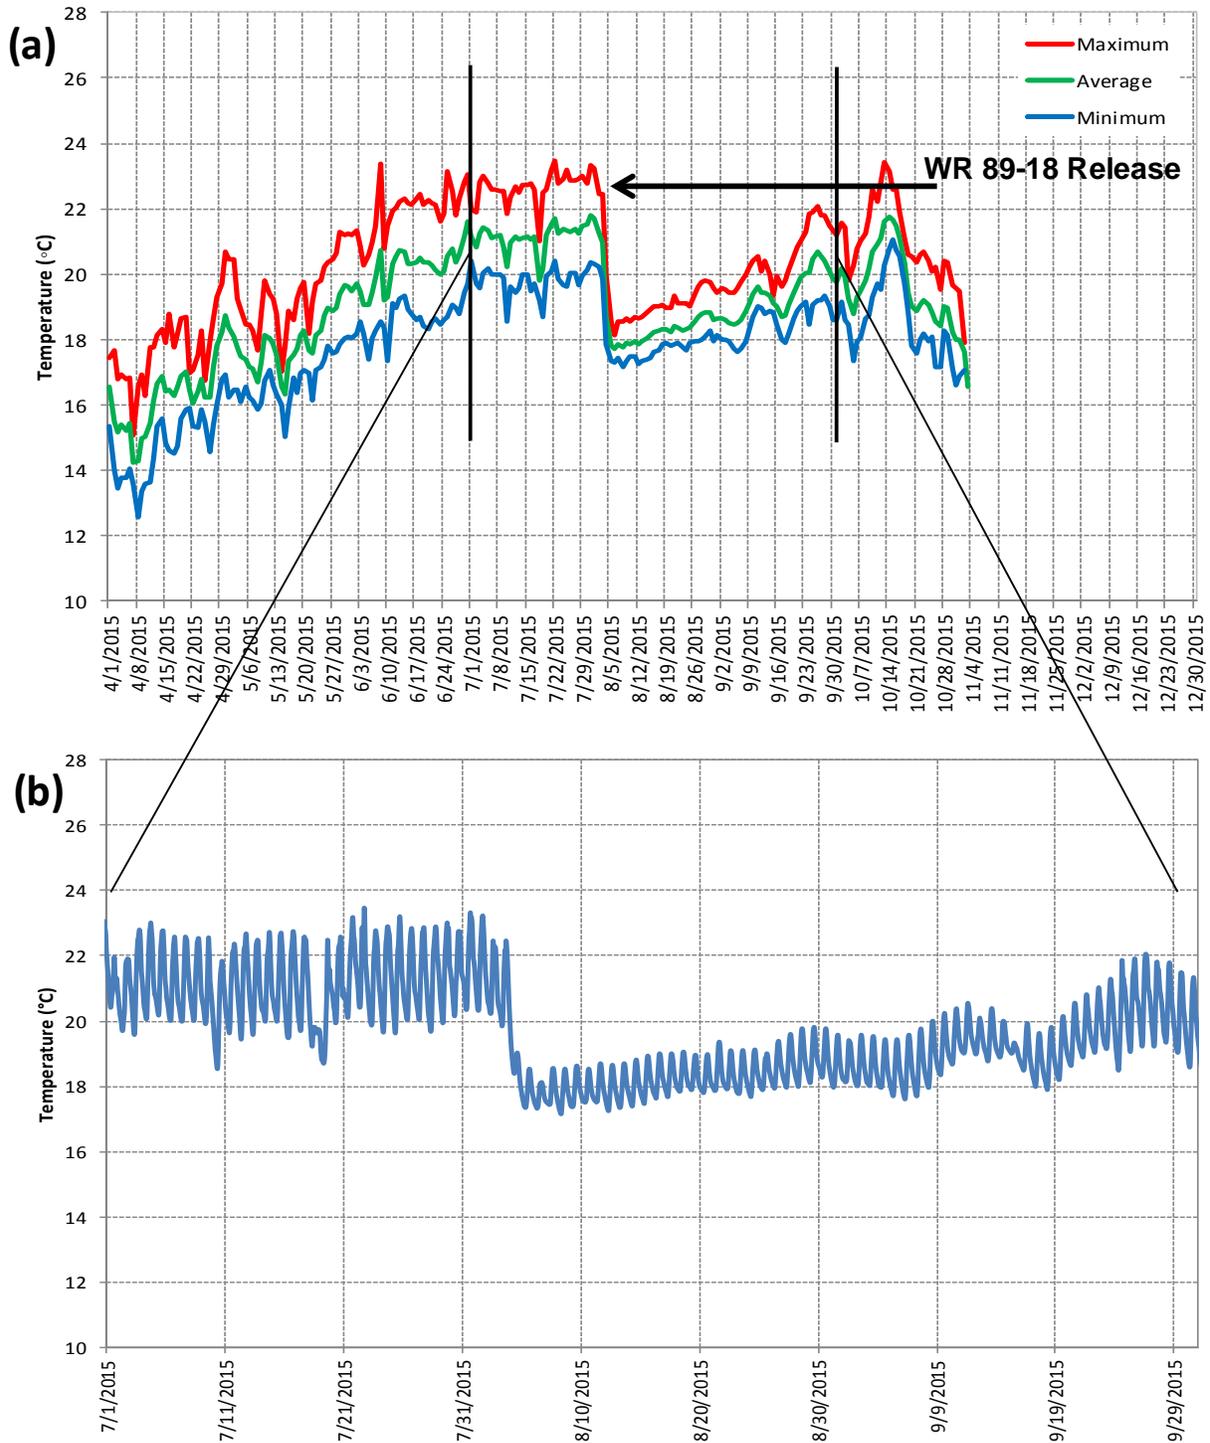
Figure 12: 2015 Reclamation property boundary LSZR 0.62 (downstream of the Long Pool) bottom (2.0 feet) thermograph for (a) daily maximum, average, and minimum values and (b) hourly data for the period of 7/1/15 – 10/1/15.

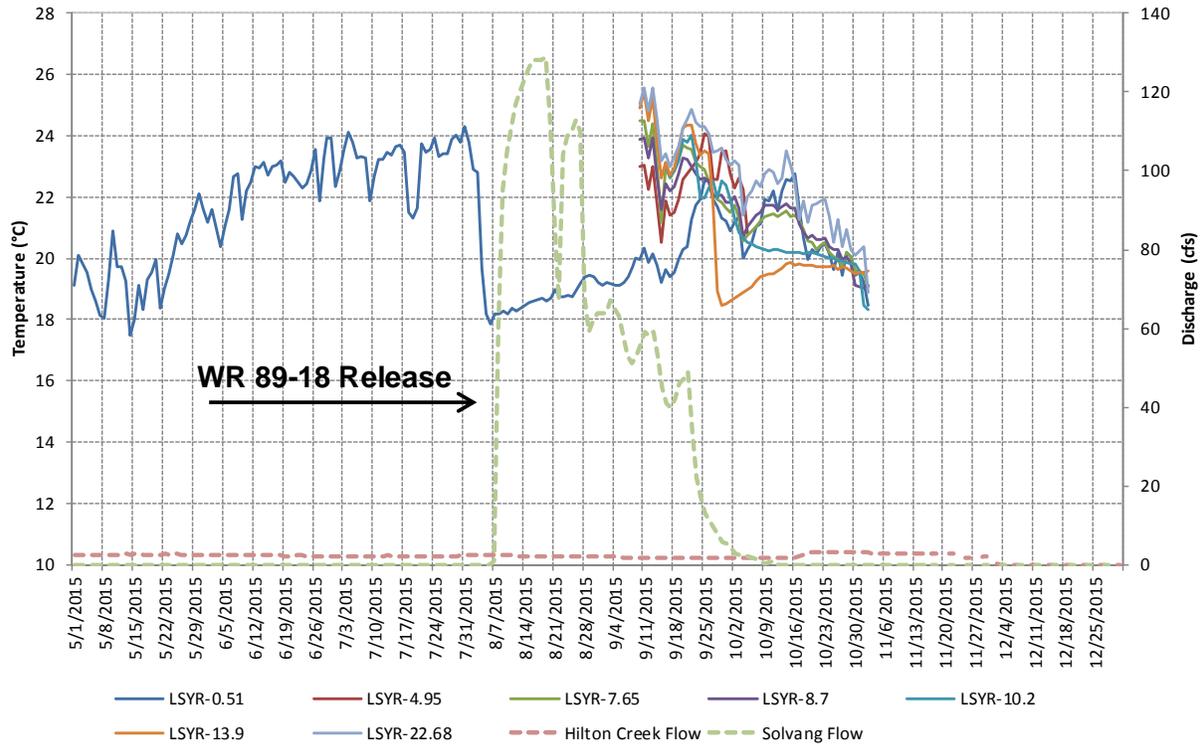
Figure 29: 2015 Longitudinal maximum surface water temperatures at: downstream of the Long Pool (LSYR-0.51), Encantado Pool (LSYR-4.95), Double Canopy Pool (LSYR-7.65), Head of Beaver Pool (LSYR-8.7), Alisal Bedrock Pool (LSYR-10.20), Avenue of the Flags Pool (LSYR-13.90, bottom of pool), and Cadwell Pool (LSYR-22.68) with daily flow (discharge) at the Hilton Creek and Solvang (at the Alisal Bridge) USGS gauges.

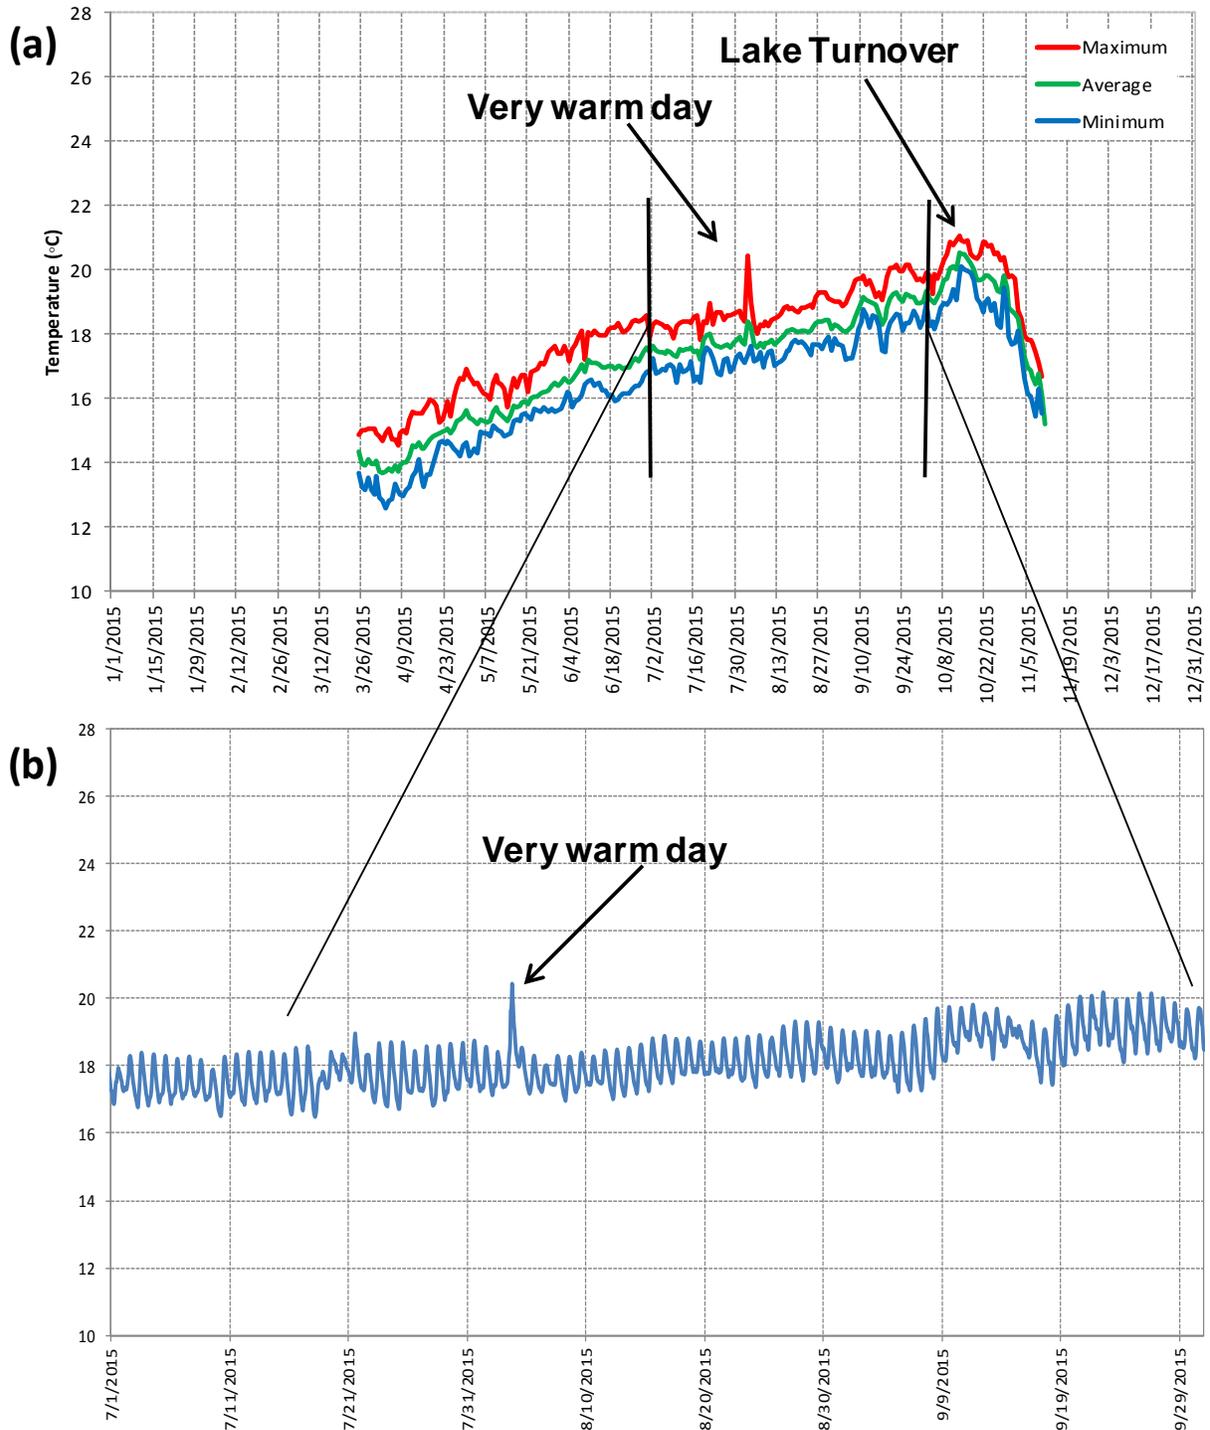
Figure 30: 2015 Lower Hilton Creek (HC-0.12) bottom (0.5 foot) thermograph for (a) daily maximum, average, and minimum daily values and (b) hourly data for the period 7/1/15 – 10/1/15; shown in the graph is a temperature increase during a very warm day and a lake turnover event near the end of the deployment period.

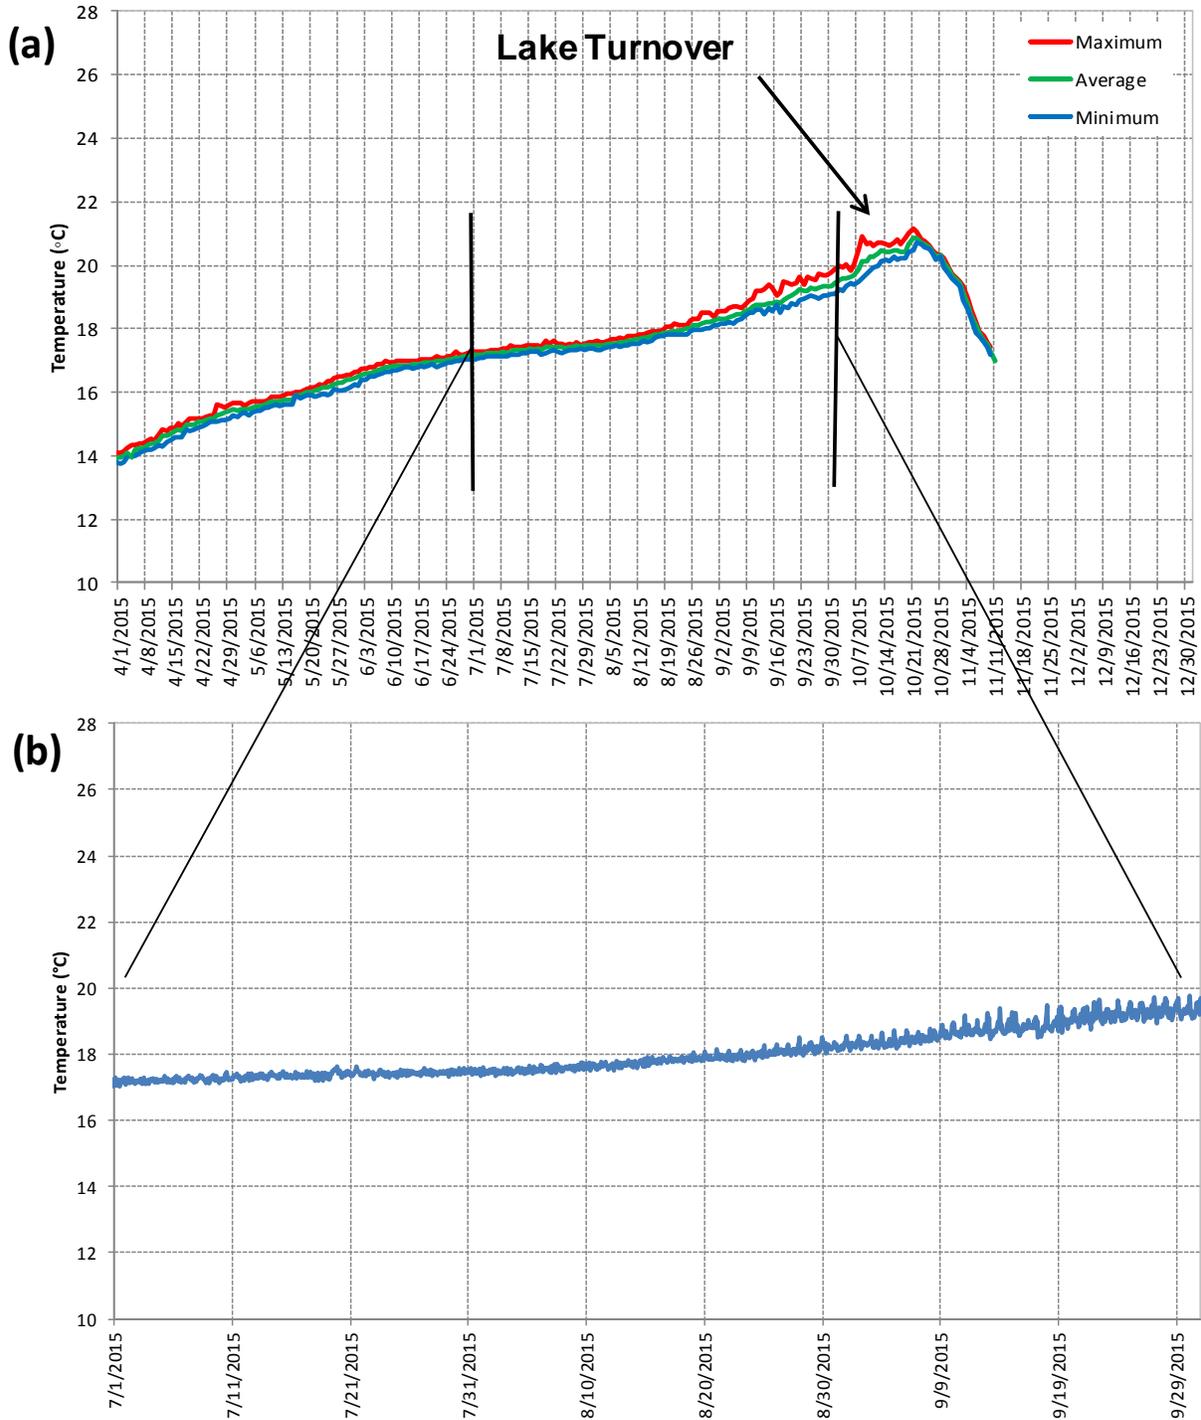
Figure 31: 2015 Upper Hilton Creek (HC-0.54) bottom (2.5 feet) thermograph for (a) daily maximum, average, and minimum daily values and (b) hourly data for the period 7/1/15 – 10/1/15; shown in the graph is a lake turnover event near the end of the deployment period.

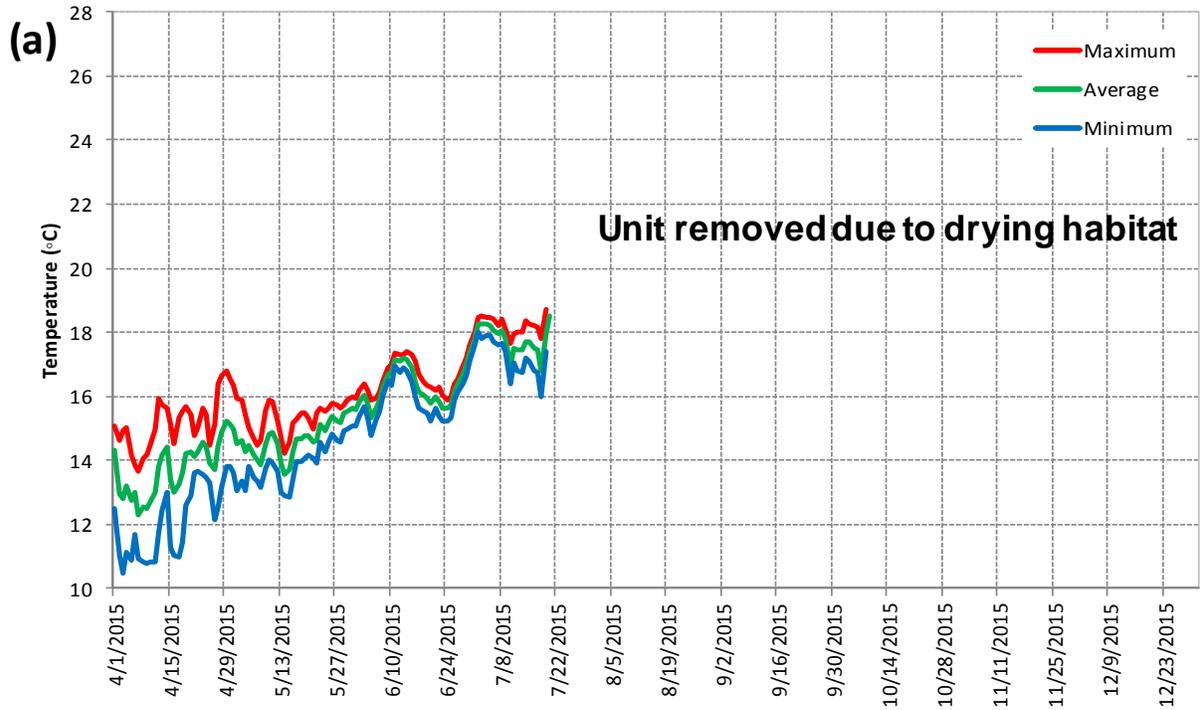
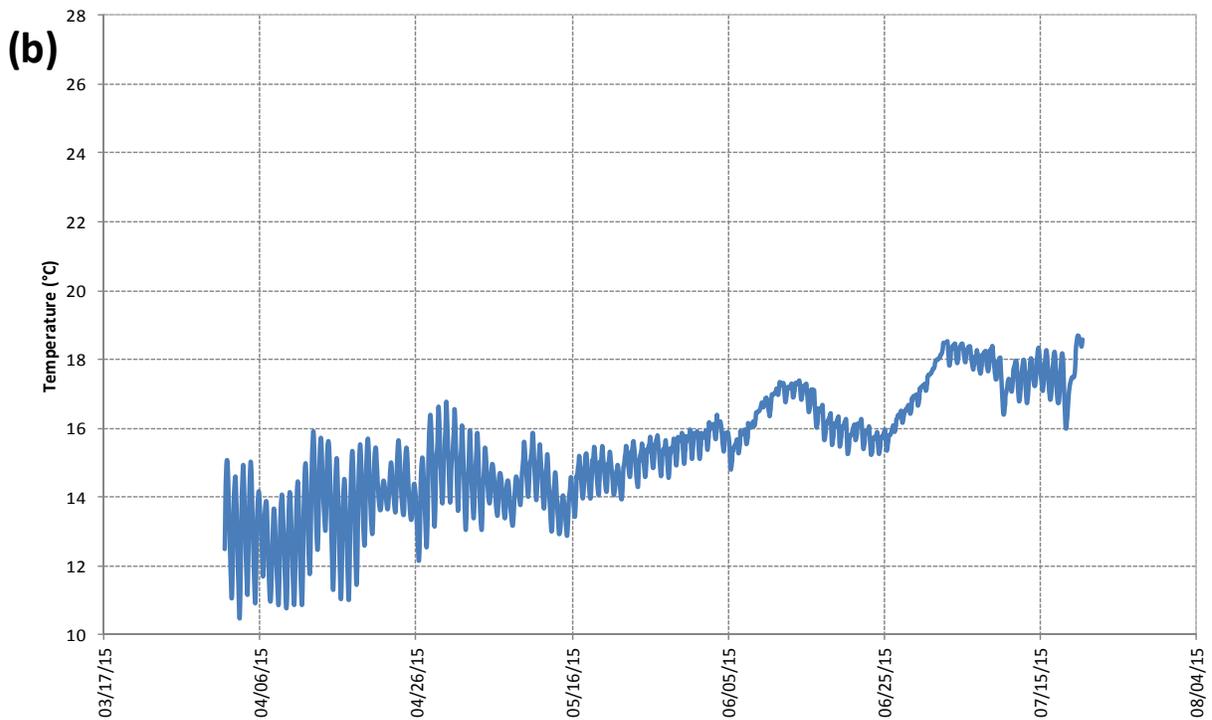
Figure 32: 2015 Quiota Creek (QC-2.66) bottom (0.5 foot) thermograph for (a) daily maximum, average, and minimum daily values and (b) hourly data for the period 4/1/15 – 7/22/15 (the entire period of deployment); the unit was removed from the site due to lack of water.
