WY2015 ANNUAL MONITORING SUMMARY

**THE BIOLOGICAL OPINION FOR THE OPERATION
AND MAINTENANCE OF THE CACHUMA PROJECT
ON THE SANTA YNEZ RIVER
IN SANTA BARBARA COUNTY, CALIFORNIA**

**CACHUMA OPERATION AND MAINTENANCE BOARD
FISHERIES DIVISION**

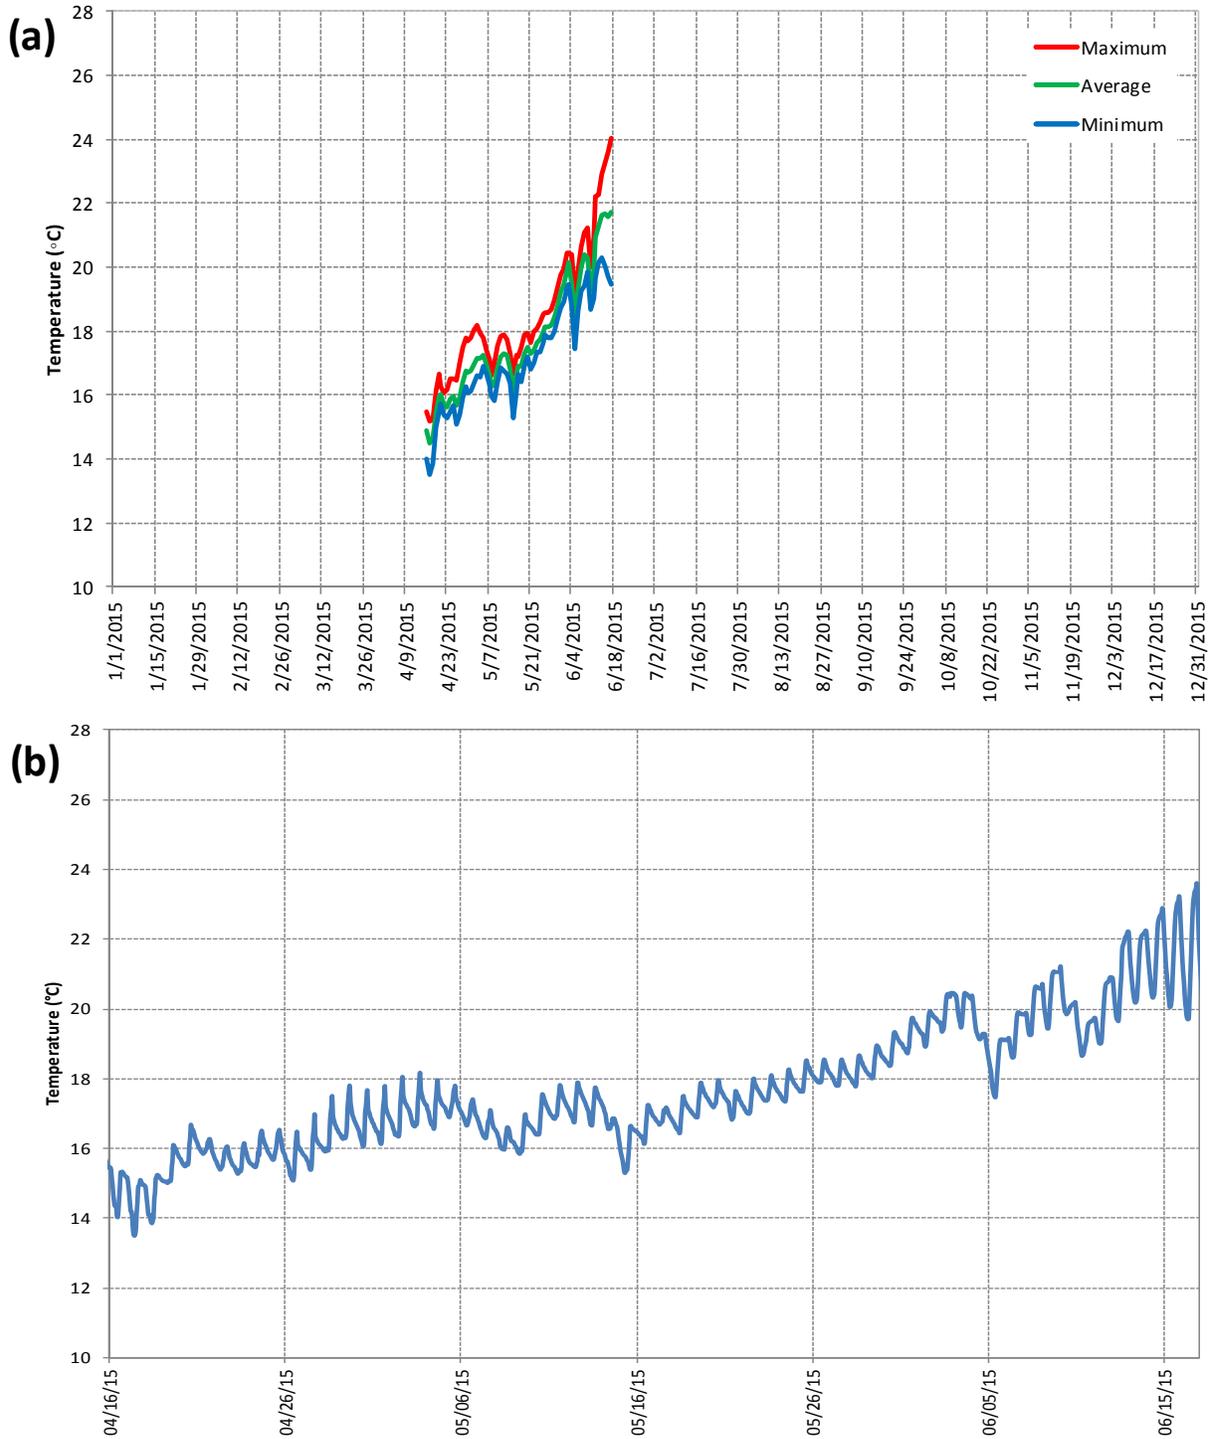
Figure 39: 2015 EJC-10.82 – water temperature at Rancho San Julian Fish Ladder bottom (2.5 feet) for (A) daily maximum, average, and minimum for the entire period of deployment and (b) hourly measurements for the period of deployment; the thermograph was removed from the habitat on 6/24/15 due to drying conditions.

Figure 39: 2015 EJC-10.82 – water temperature at Rancho San Julian Fish Ladder bottom (2.5 feet) for (A) daily maximum, average, and minimum for the entire period of deployment and (b) hourly measurements for the period of deployment; the thermograph was removed from the habitat on 6/24/15 due to drying conditions.

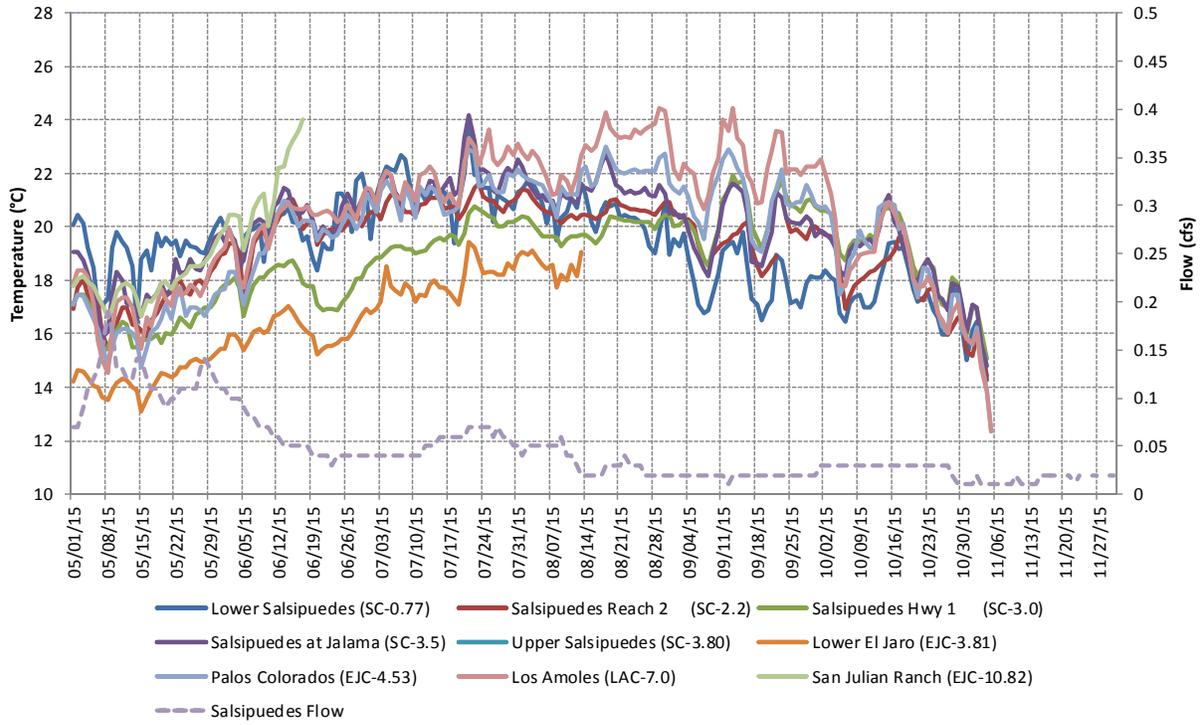
Figure 41: 2015 Longitudinal maximum daily water temperatures within the Salsipuedes Creek watershed which included El Jaro Creek at Rancho San Julian (EJC-10.82), Palos Colorados (EJC-5.4), lower El Jaro Creek (EJC-3.81), at Jalama Bridge (SC-3.5), at Highway 1 (SC-3.0), at Bedrock Section (SC-2.2), at lower Salsipuedes Creek (SC-0.77), and at Los Amoles Creek (LAC-7.0) as tributary to El Jaro Creek, versus flow (cfs) measured at the Salsipuedes Creek USGS gauging station.

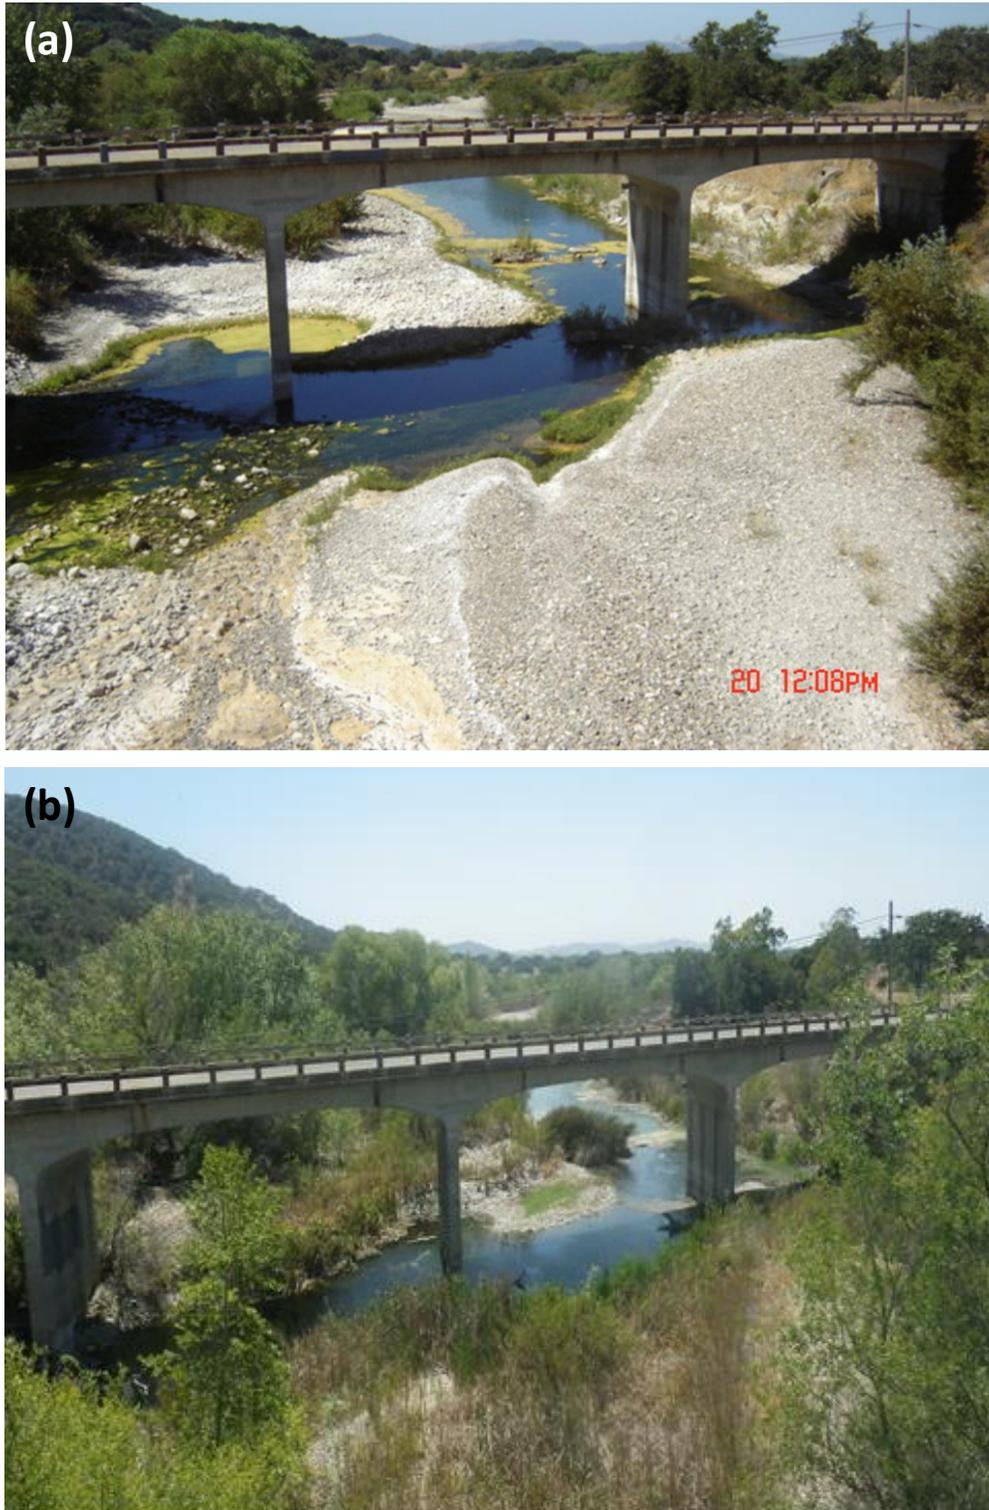
Figure 43: Photo points (M-6) collected at Highway 154 Bridge looking downstream in (a) September 2005 and (b) June 2015.

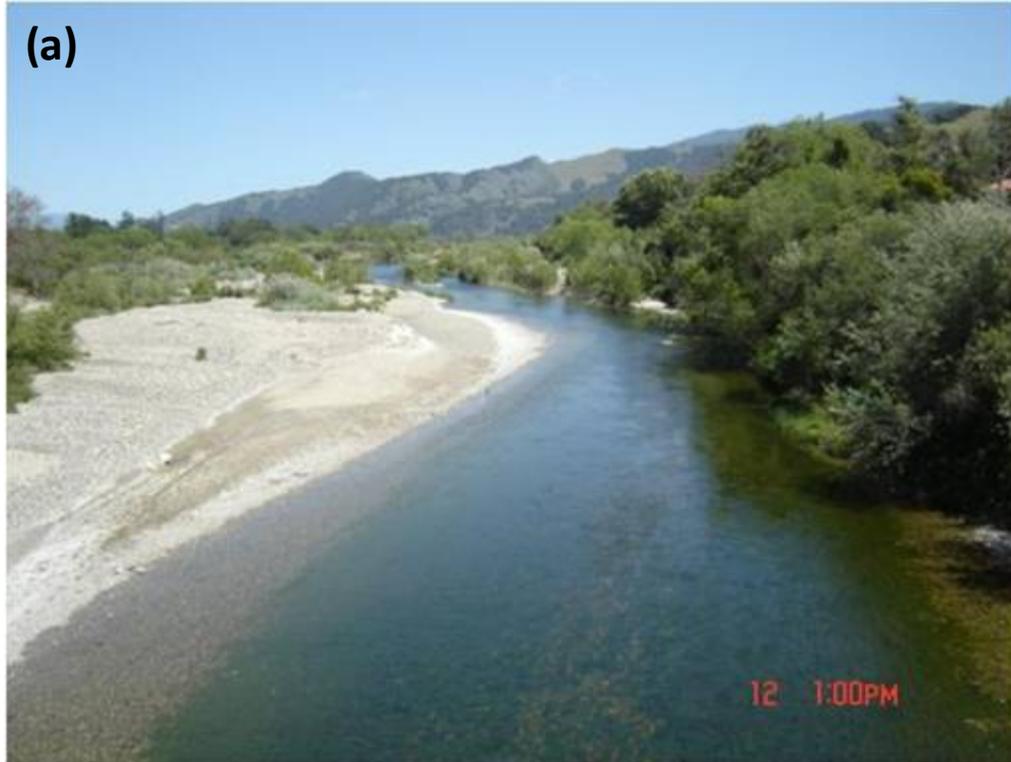
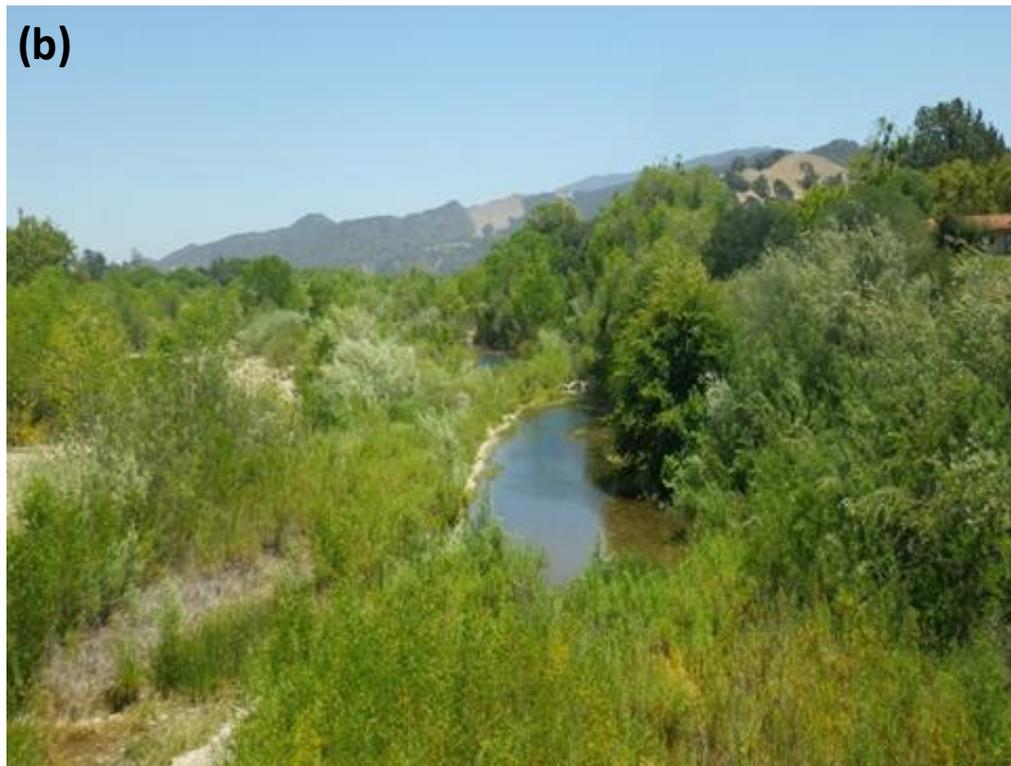
Figure 44: Photo point (M-12) collected at Refugio Bridge looking upstream in (a) May 2005, and (b) June 2015.

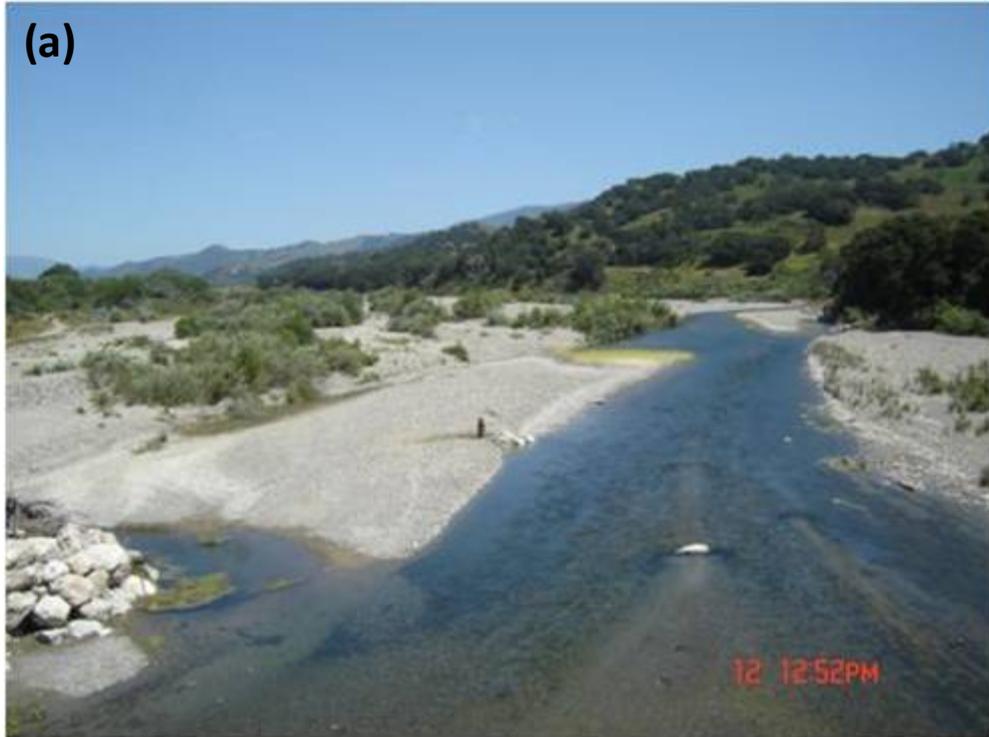
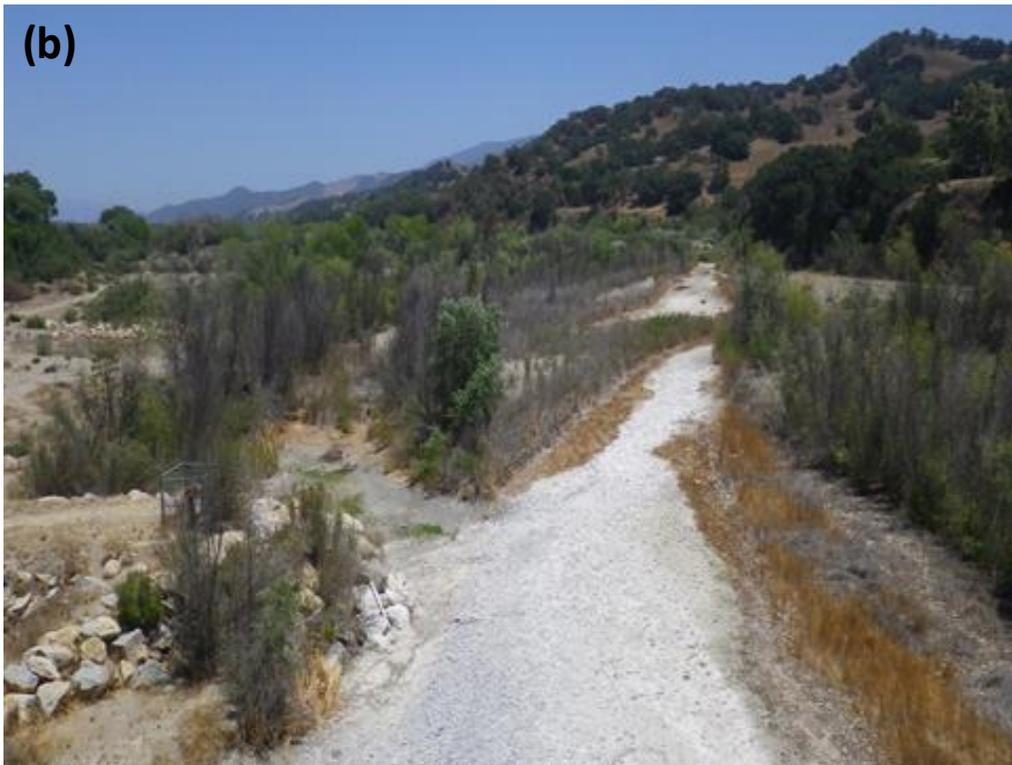
Figure 45: Photo point (M-14) collected at Alisal Bridge looking upstream in a) May 2005, and b) June 2015; note all the dead riparian vegetation.

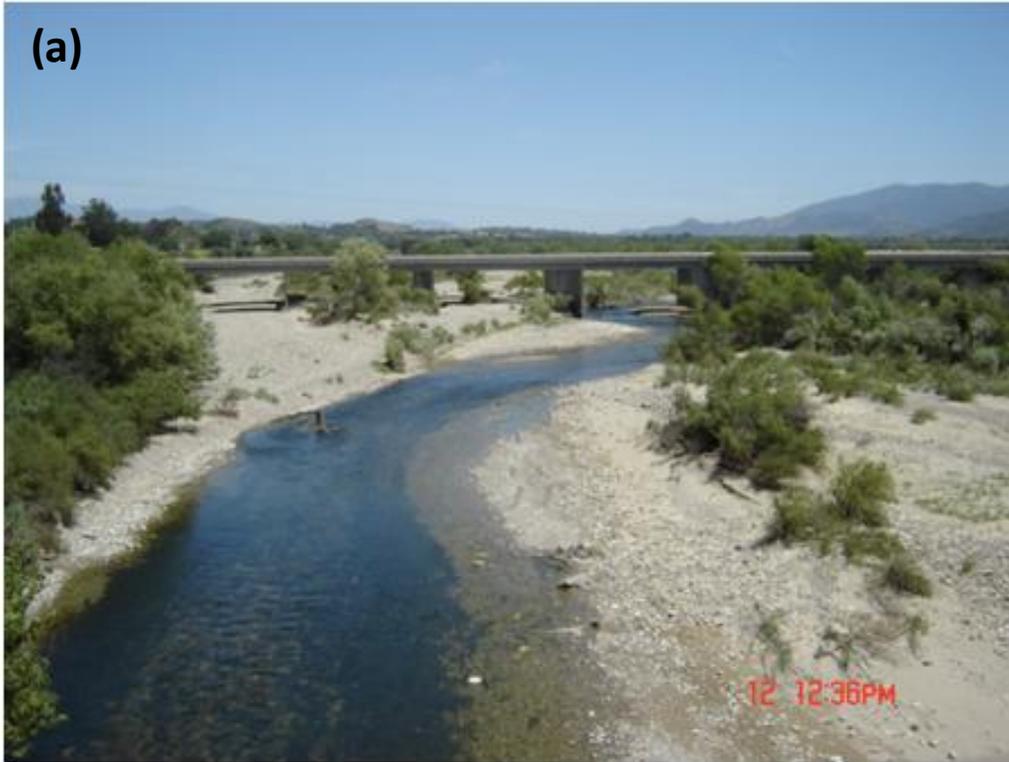
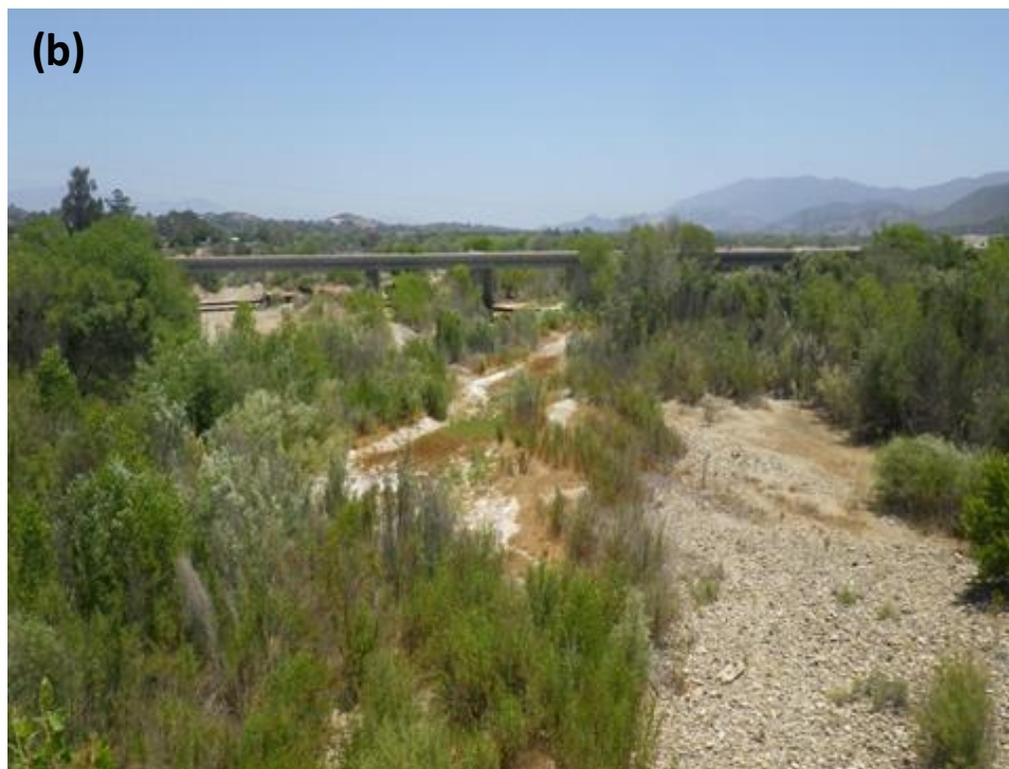
Figure 46: Photo point (M-19) collected at Avenue of the Flags Bridge looking upstream in (a) May 2005, and (b) June 2015.

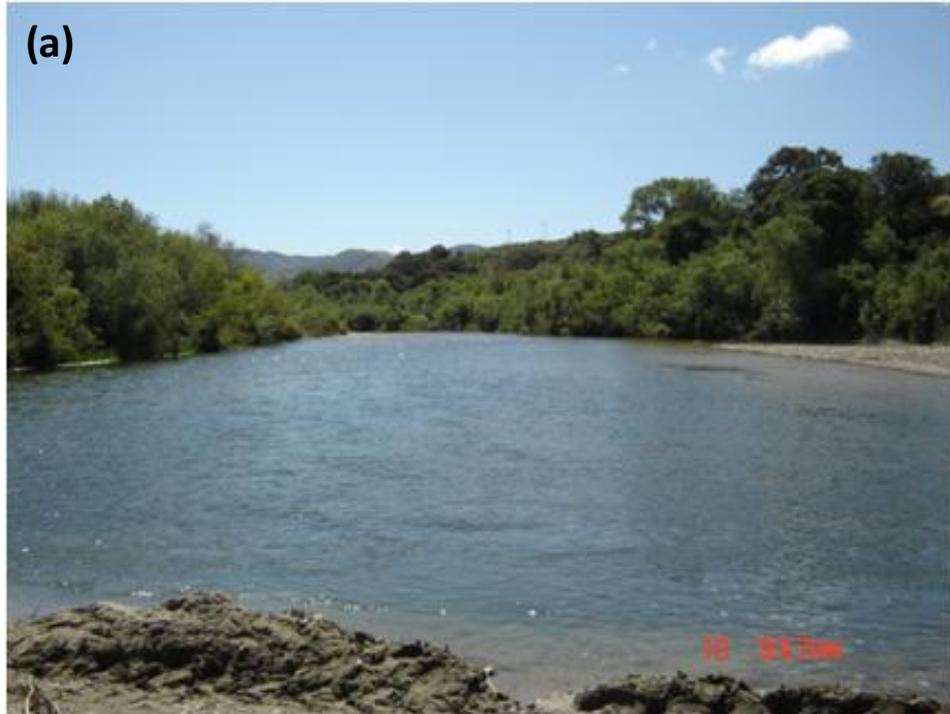
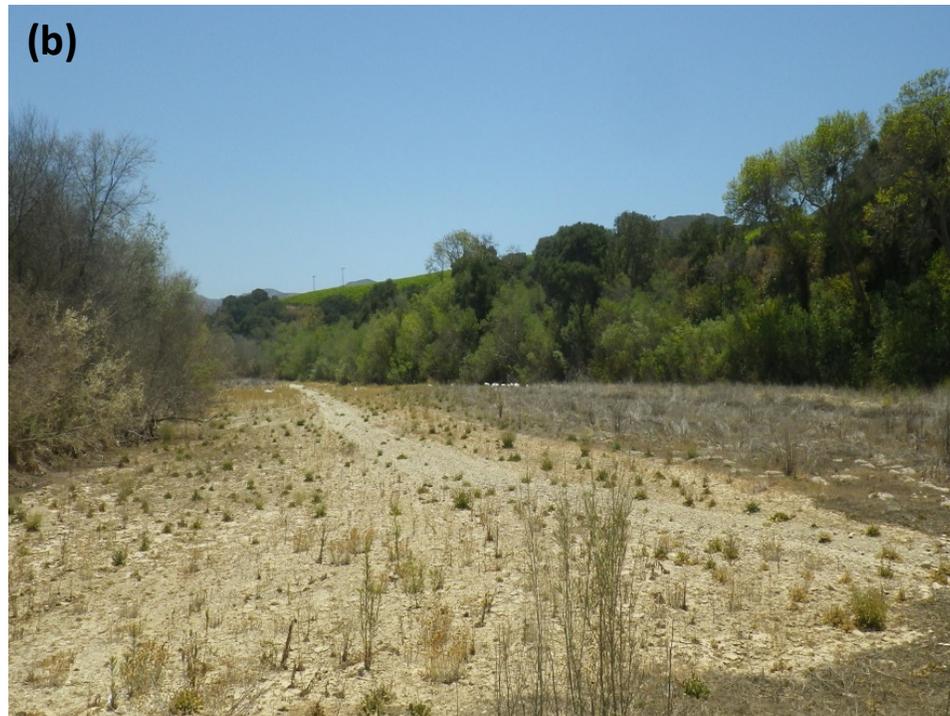
Figure 47: Photo point (M-21) collected at Sweeney Road Crossing looking upstream in (a) May 2005, and (b) June 2015.

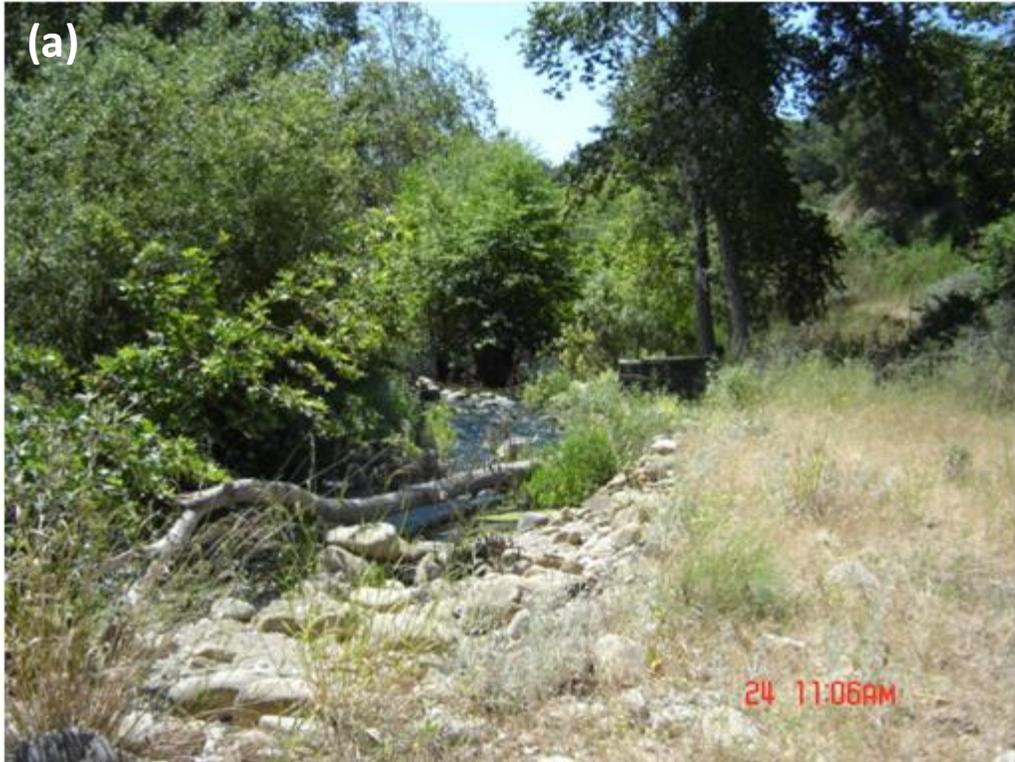
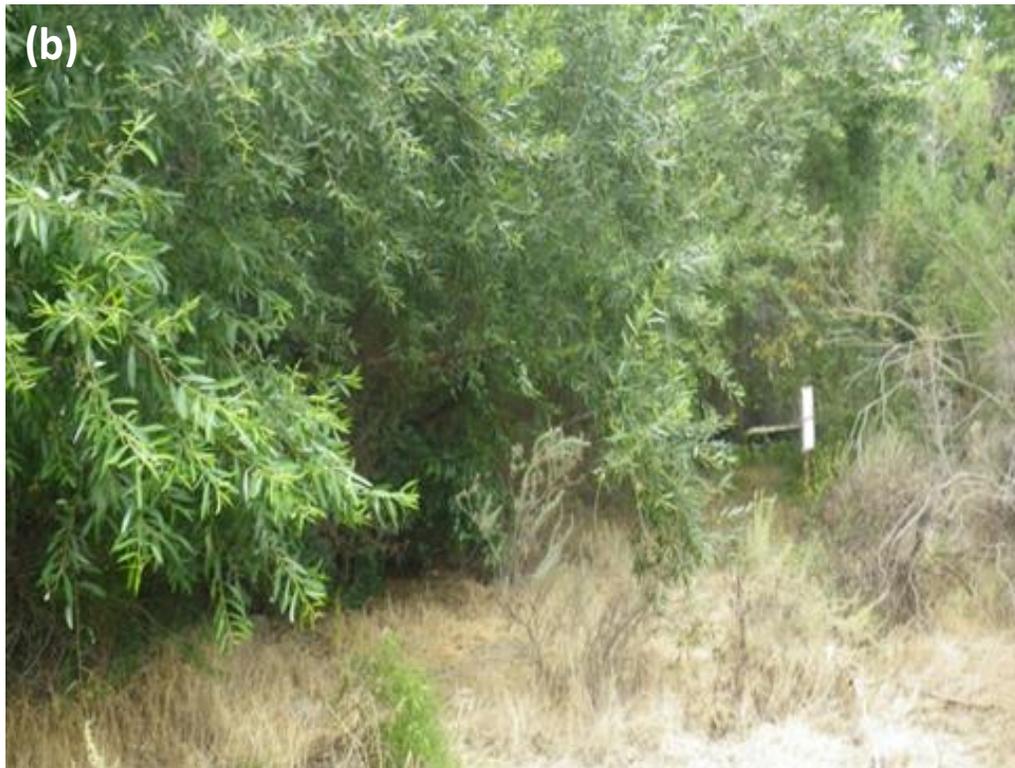
Figure 48: Photo point (T-1) collected at Hilton Creek looking upstream towards the trap site on (a) May 2005, and (b) June 2015.

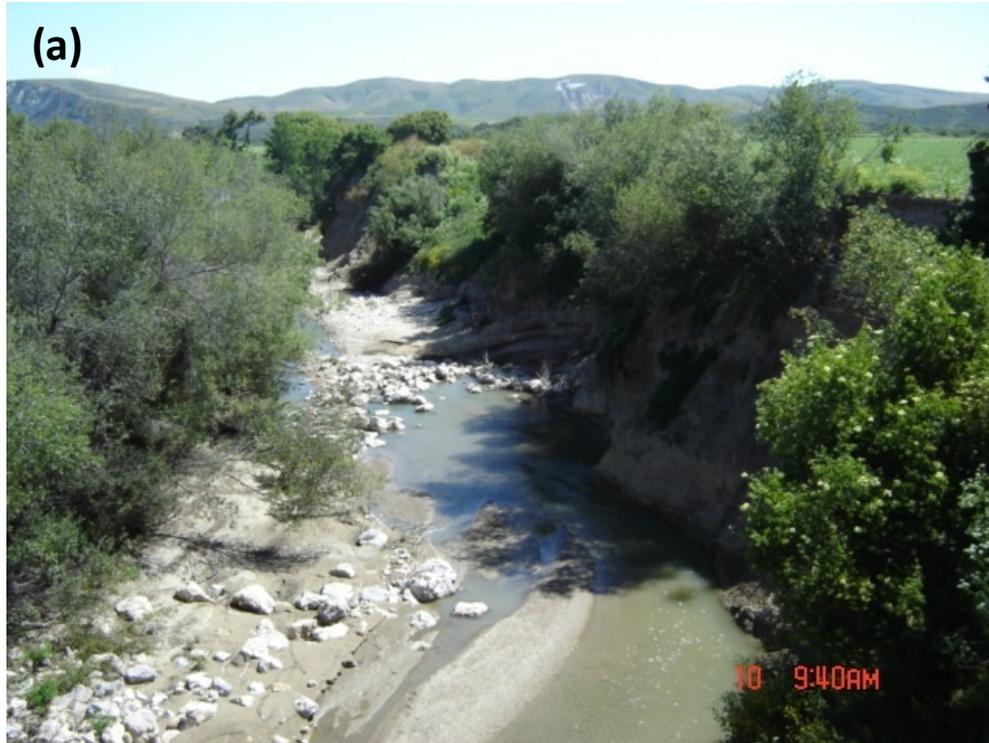
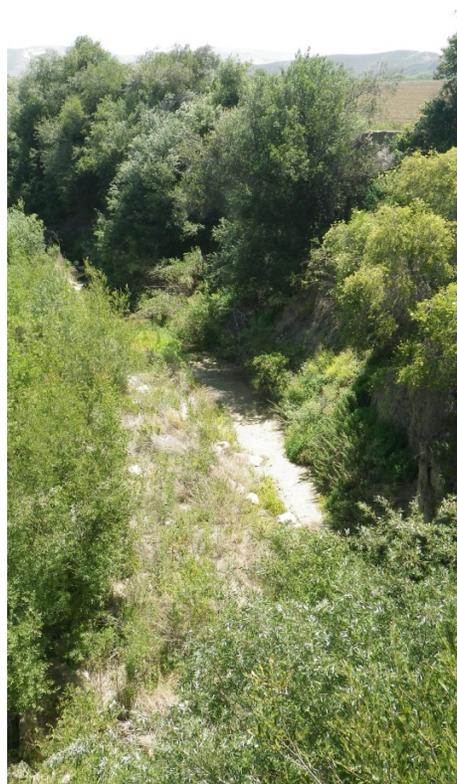
Figure 50: Photo point (T-28) collected at Salsipuedes Creek at Santa Rosa Bridge in (a) May 2005 and (b) June 2015.

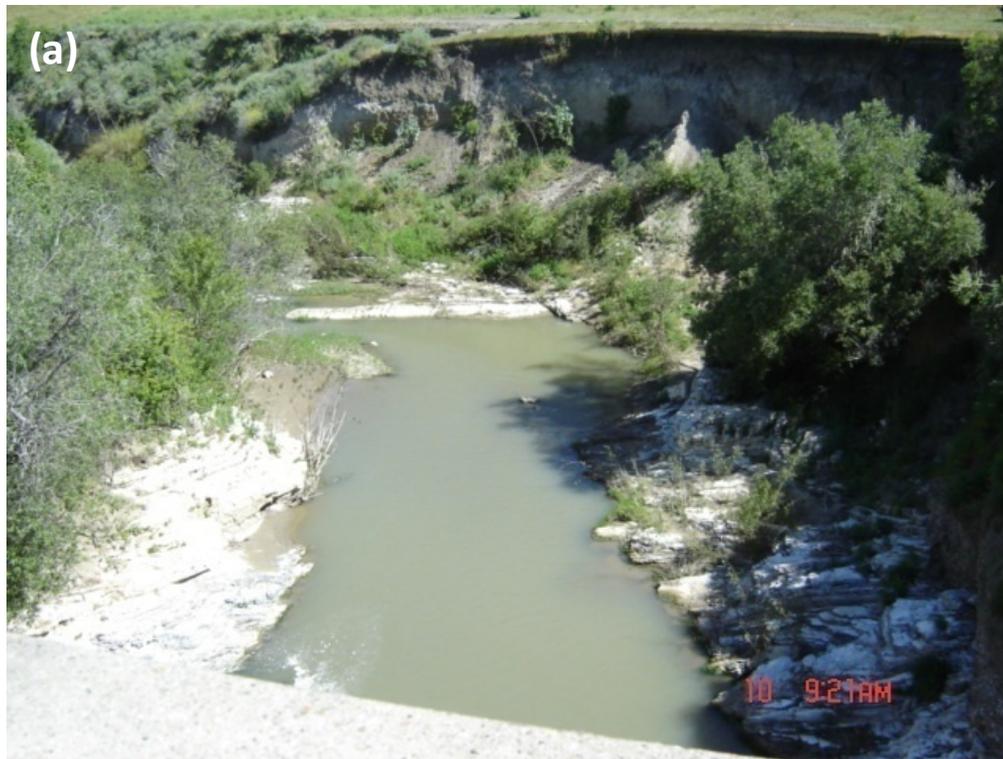
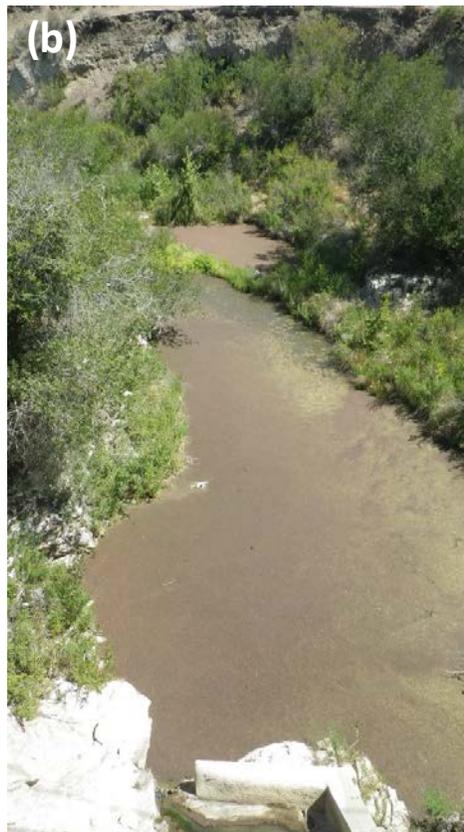
Figure 51: Photo point (T-39) collected at Salsipuedes Creek at Hwy 1 Bridge in May 2005 and (b) June 2015.

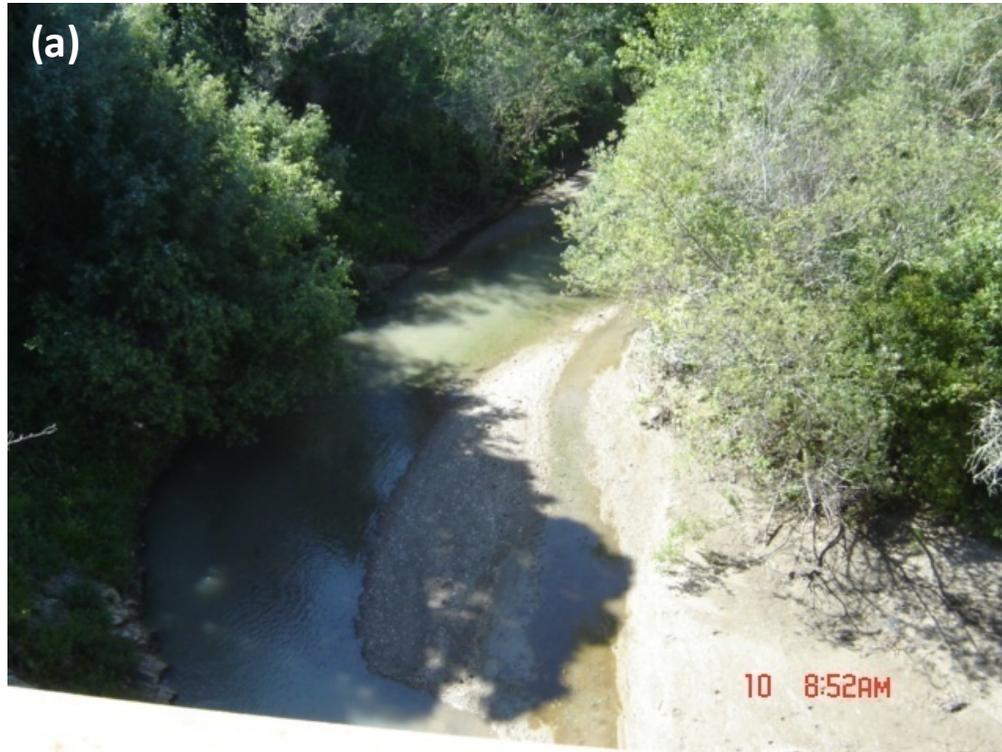
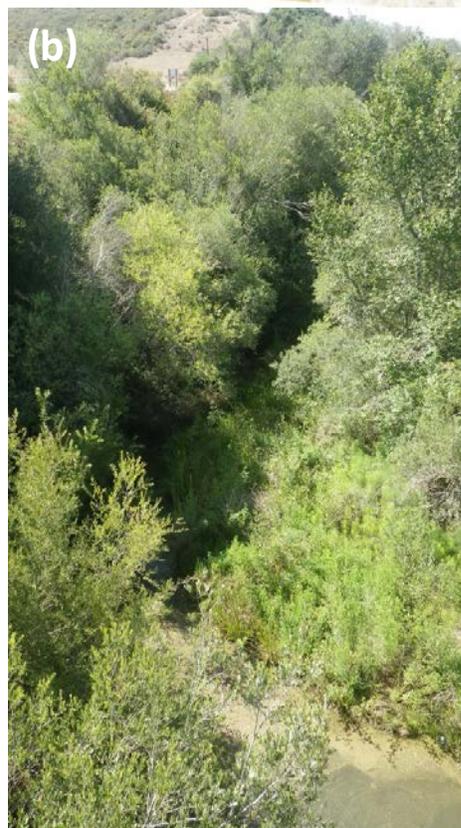
Figure 52: Photo point (T-42) collected at Salsipuedes Creek at Jalama Road Bridge in May 2005 and (b) June 2015.

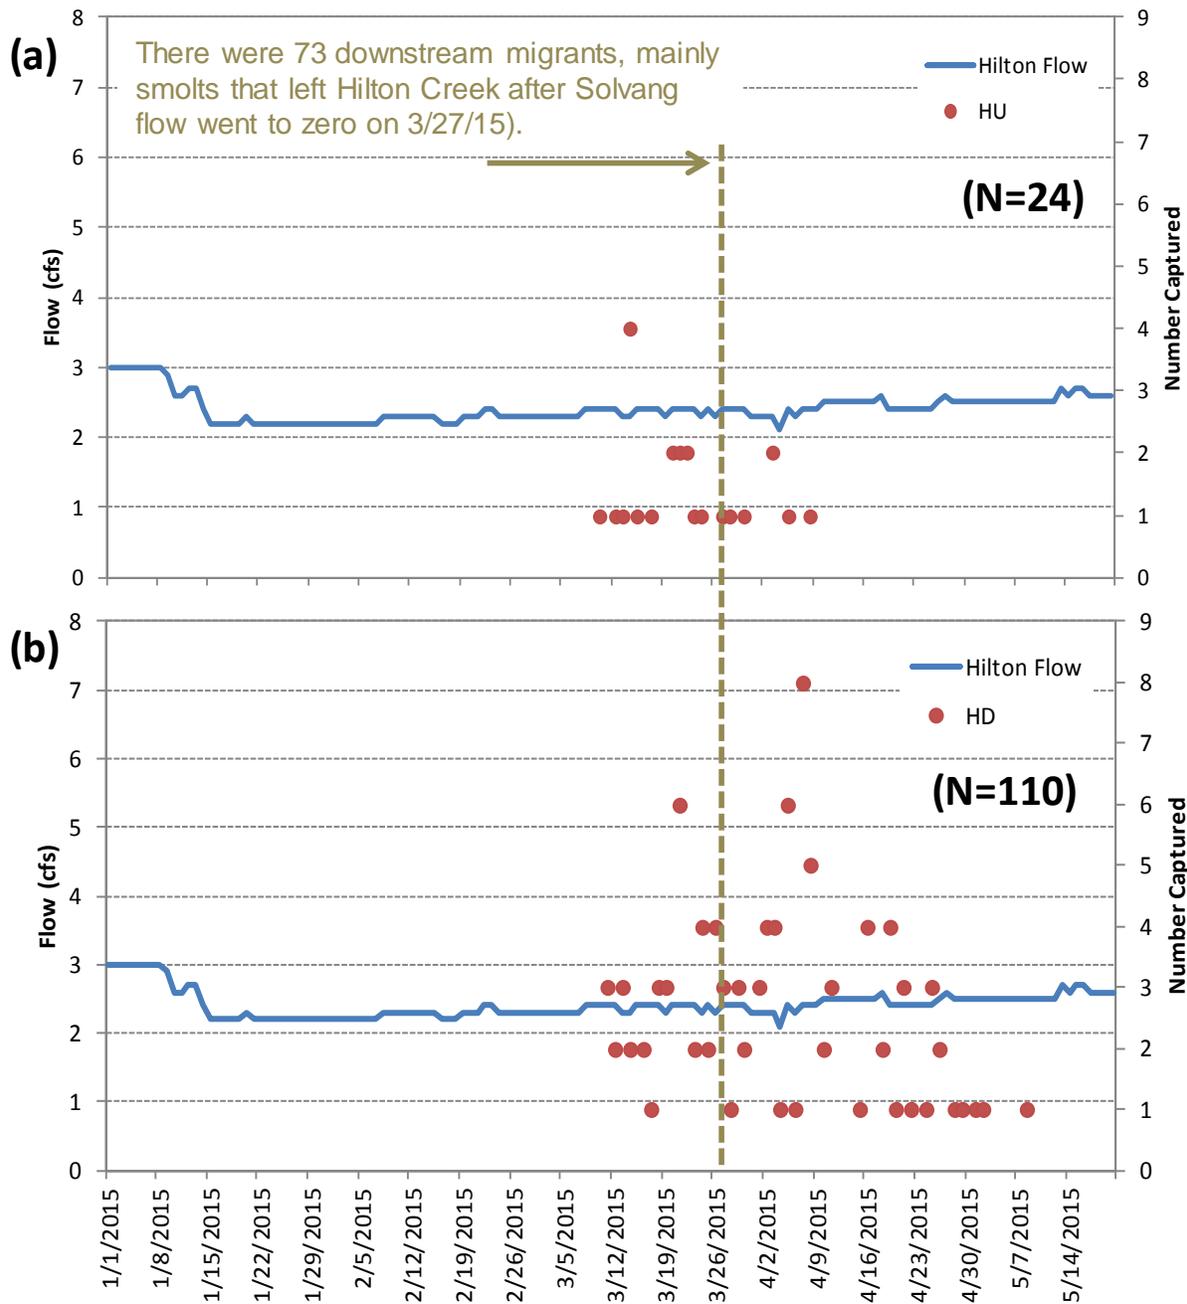
Figure 57: WY2015 Hilton Creek migrant captures (red dots) vs. flow: (a) upstream migrant captures and (b) downstream migrant captures; trapping started on 3/10/15 and ended on 5/15/15.

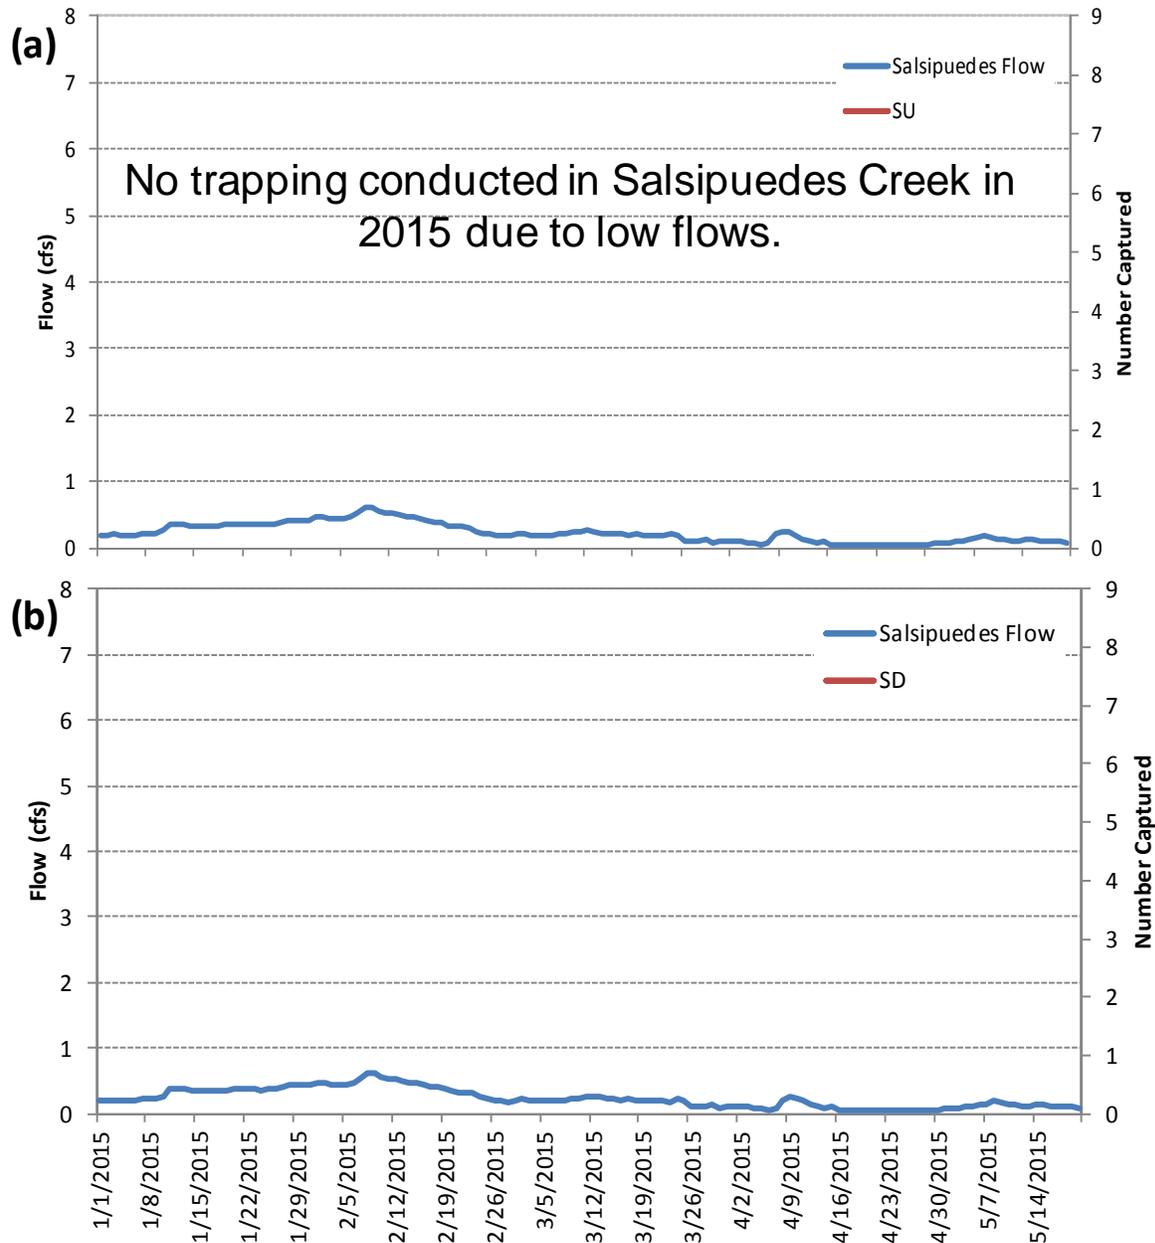
Figure 58: WY2015 Salsipuedes Creek migrant captures (red dots) vs. flow for (a) upstream and (b) downstream migrants. Flow was not greater than 0.6 cfs during the entire migration season.

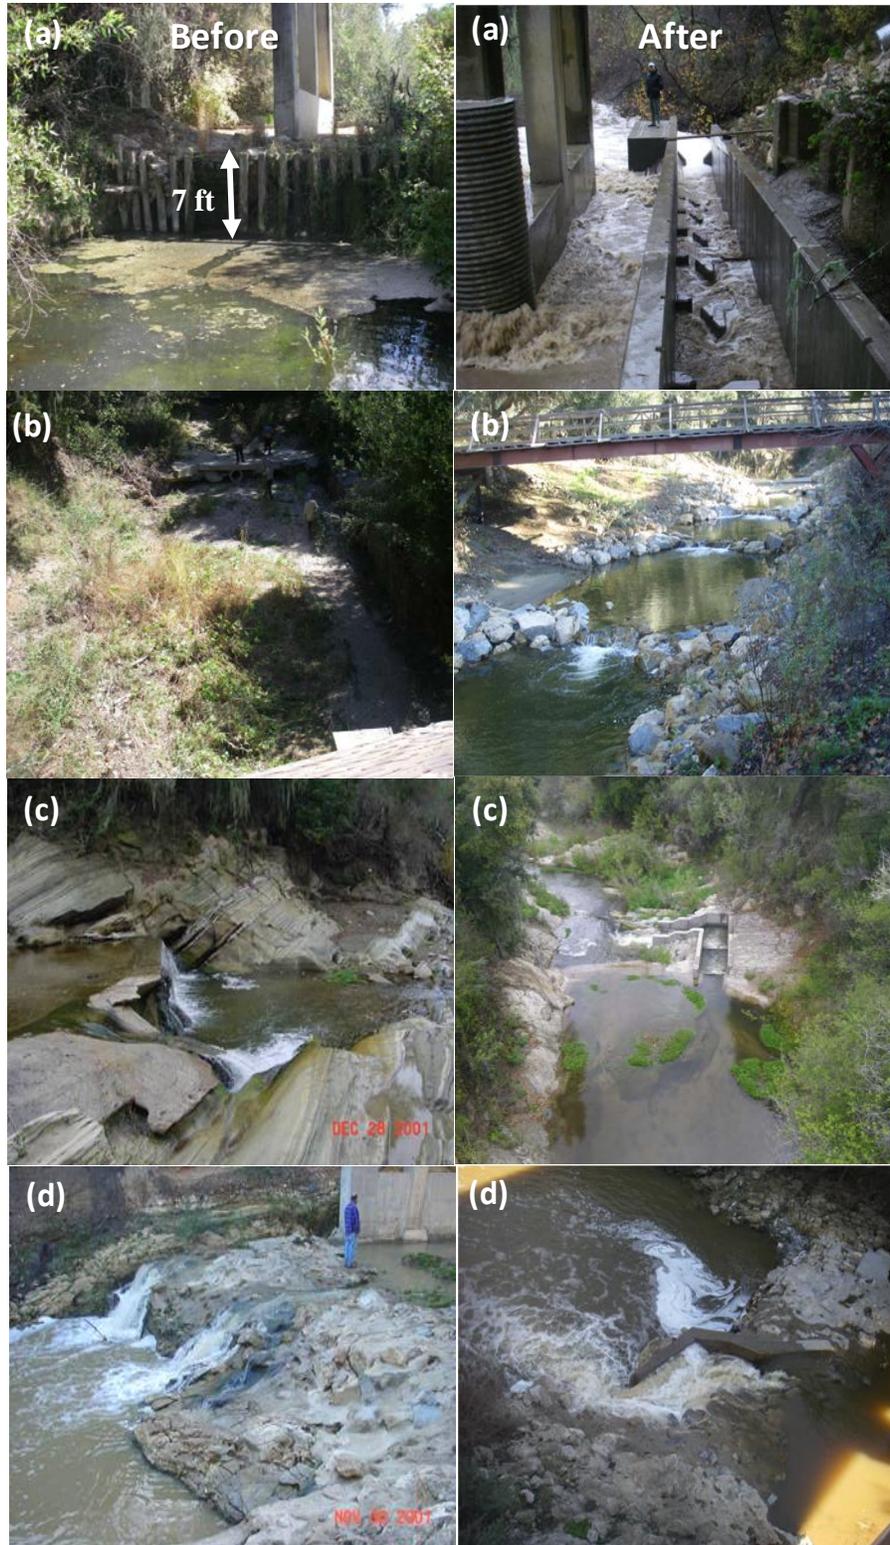
Figure 75: Fish passage and habitat restoration at: at (a) Rancho San Julian Bridge on El Jaro Creek (2008), (b) Cross Creek Ranch on El Jaro Creek (2009), (c) Jalama Road Bridge on Salsipuedes Creek (2004), and (d) Highway 1 Bridge on Salsipuedes Creek (2002).

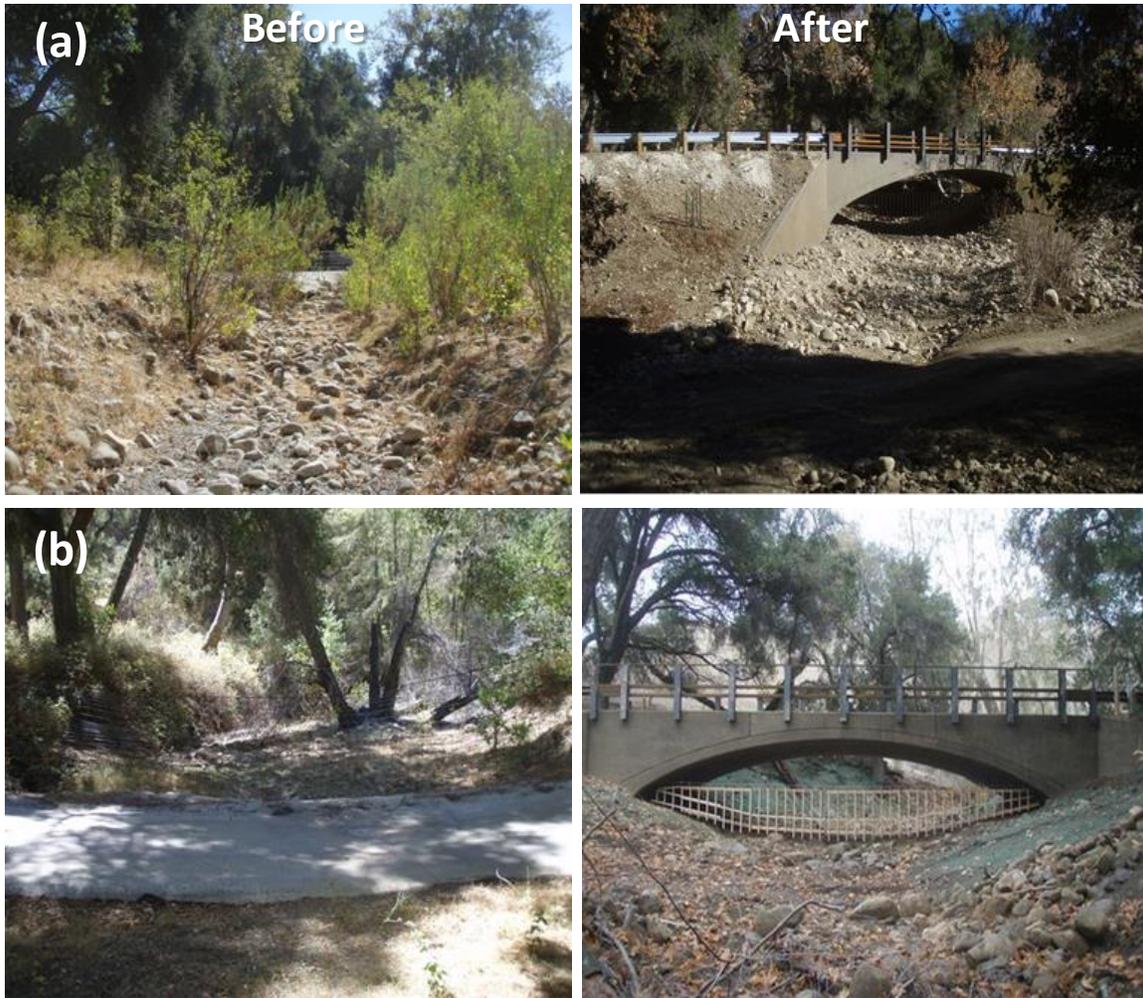
Figure 77: Fish passage and habitat restoration at (a) Quiota Creek Crossing 1 (in 2014) and (b) Quiota Creek Crossing 3 (in 2015).

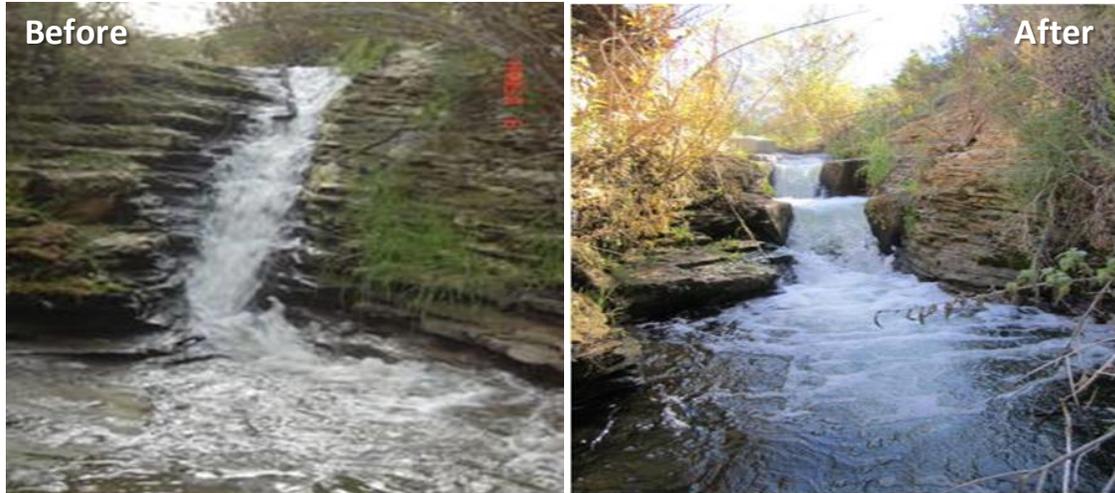
Figure 78: Fish passage and habitat restoration at Hilton Creek at the Cascade Chute Project that was completed in 2005.
