WY2015 ANNUAL MONITORING SUMMARY

**THE BIOLOGICAL OPINION FOR THE OPERATION
AND MAINTENANCE OF THE CACHUMA PROJECT
ON THE SANTA YNEZ RIVER
IN SANTA BARBARA COUNTY, CALIFORNIA**

**CACHUMA OPERATION AND MAINTENANCE BOARD
FISHERIES DIVISION**

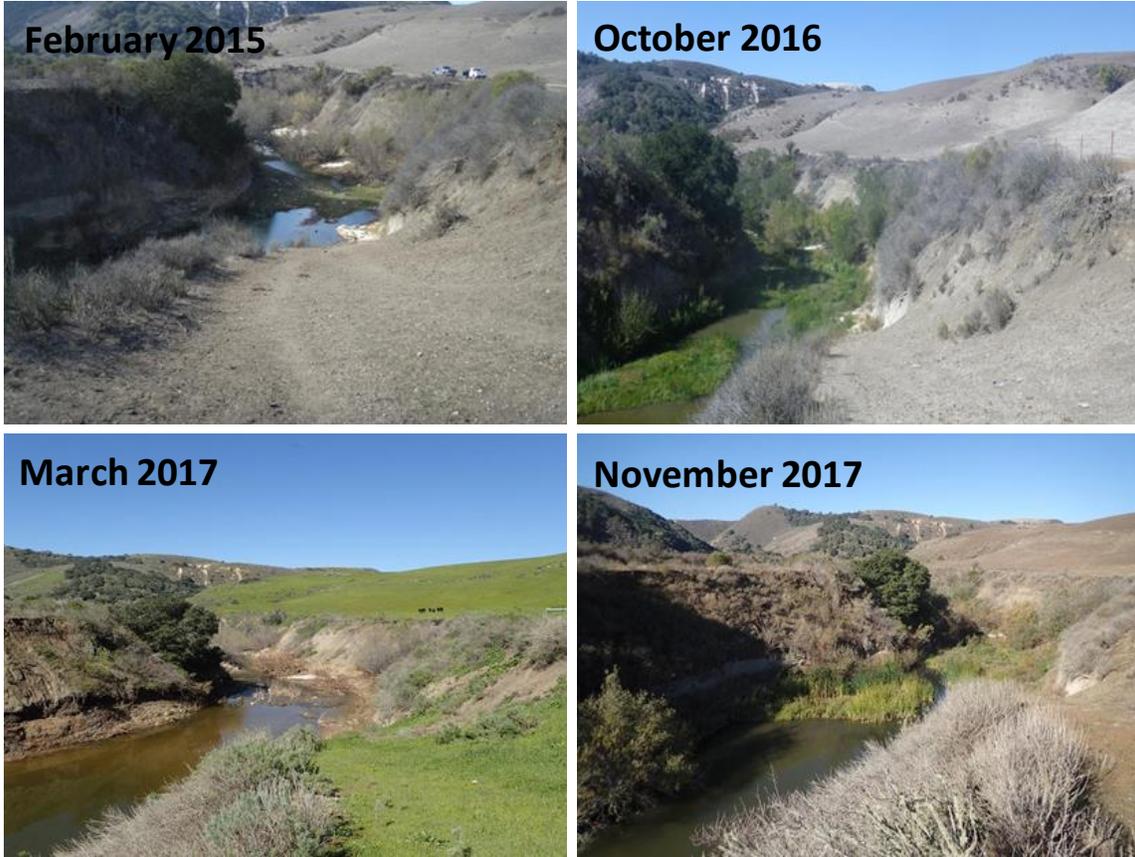
Figure 81: Salsipuedes Creek Cattle Exclusionary Fencing Project; photos at the upstream boundary of the project area showing reeds and grasses growing in the creek corridor where there were none in the past due to cattle activities prior to the project in WY2013.

Cattle Exclusionary Fencing Project: A cattle exclusionary fencing project was completed on Rancho Salsipuedes on the lower reaches of Salsipuedes Creek (Figures 80 and 81). Cattle were accessing the creek by isolated trails down the steep embankments into the creek and moving laterally up and down the stream negatively affecting the stream water quality and riparian corridor vegetation. The objective of the project was to cut off those access points for cattle and alternatively provide drinking water access through a few specific points with no potential for lateral creek movement. Cattle were successfully fenced out of approximately 2.5 stream miles and 3 watering corridors were installed for extremely limited access to the creek for cattle drinking. Also 2 large off-channel watering troughs were installed outside of the riparian corridor to further keep cattle out of the stream. The project was completed in the winter of 2014 (reported in this AMS for the first time) and the benefits to the aquatic habitats and riparian corridor have already been noticed. The project was funded through a Fish America Foundation grant and the Cachuma member units through COMB. The project had a high benefit-cost ratio due to the low cost of the project and extensive improvement to the health of the aquatic ecosystem for *O. mykiss* and other aquatic species. The project required a cooperative landowner and cattle rancher who the COMB-FD staff is in routine communication with to assure his cattle are safe and that the infrastructure of the project is functioning as designed.

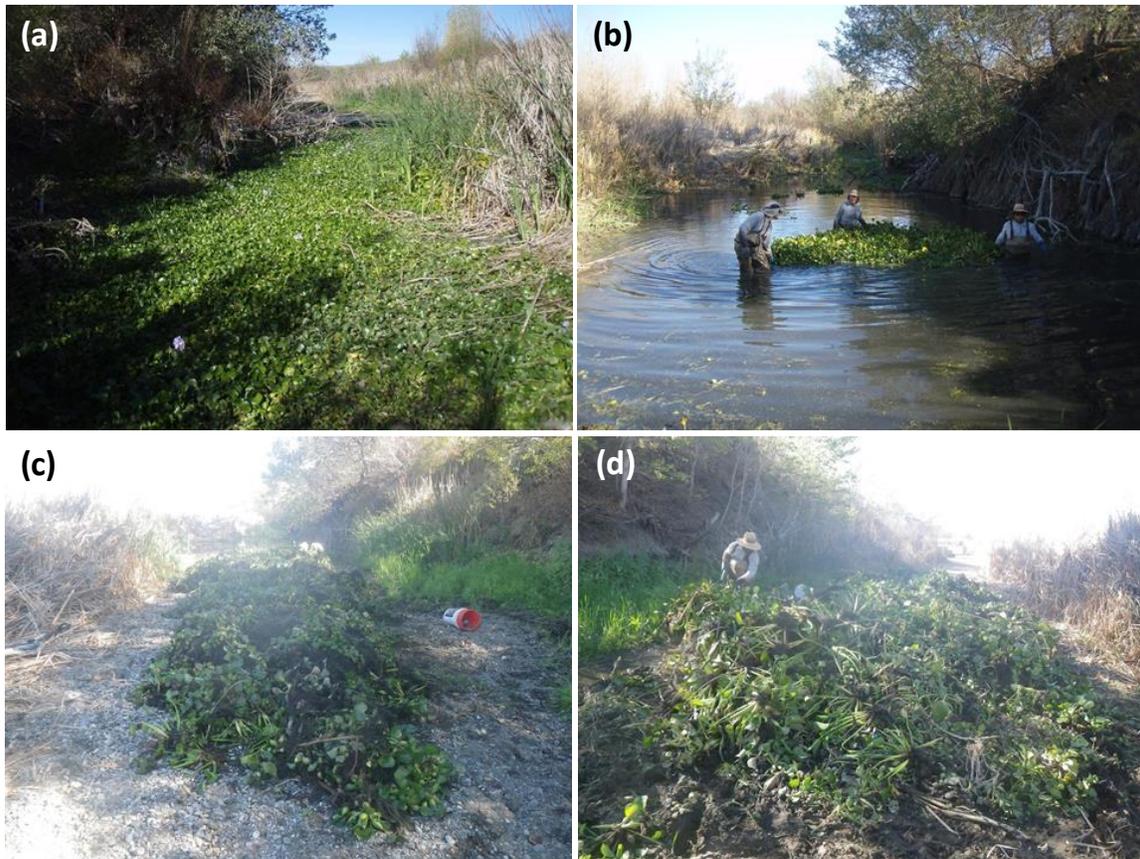
Figure 83: COMB-FD crew removing water hyacinth from: a) the upper infestation pool in October 2015, b) using ropes to tow a large patch to shore, and c-d) stockpiling water hyacinth on the shore for later excavator pick up.

Removal efforts by the COMB-FD started in October of 2014 at the upstream end of the infestation with crews working methodically in a downstream direction. Crews would use hands, rakes, nets, and ropes to detach the floating mats, pushing/pulling large sections of the weed to the shoreline where crews would remove it from the water and place it in piles or in large plastic bags for later pickup (Figure 83). All water hyacinth was disposed of in an agriculture field and tilled into the soil. Hand removal was determined to be the best option in removing the plants from the waterway due to the thick riparian corridor and difficulty in maneuvering vehicles adjacent to infestation patches. In December 2014, additional assistance was provided by California Conservation Corp personnel during two intensive field days (Figure 84).

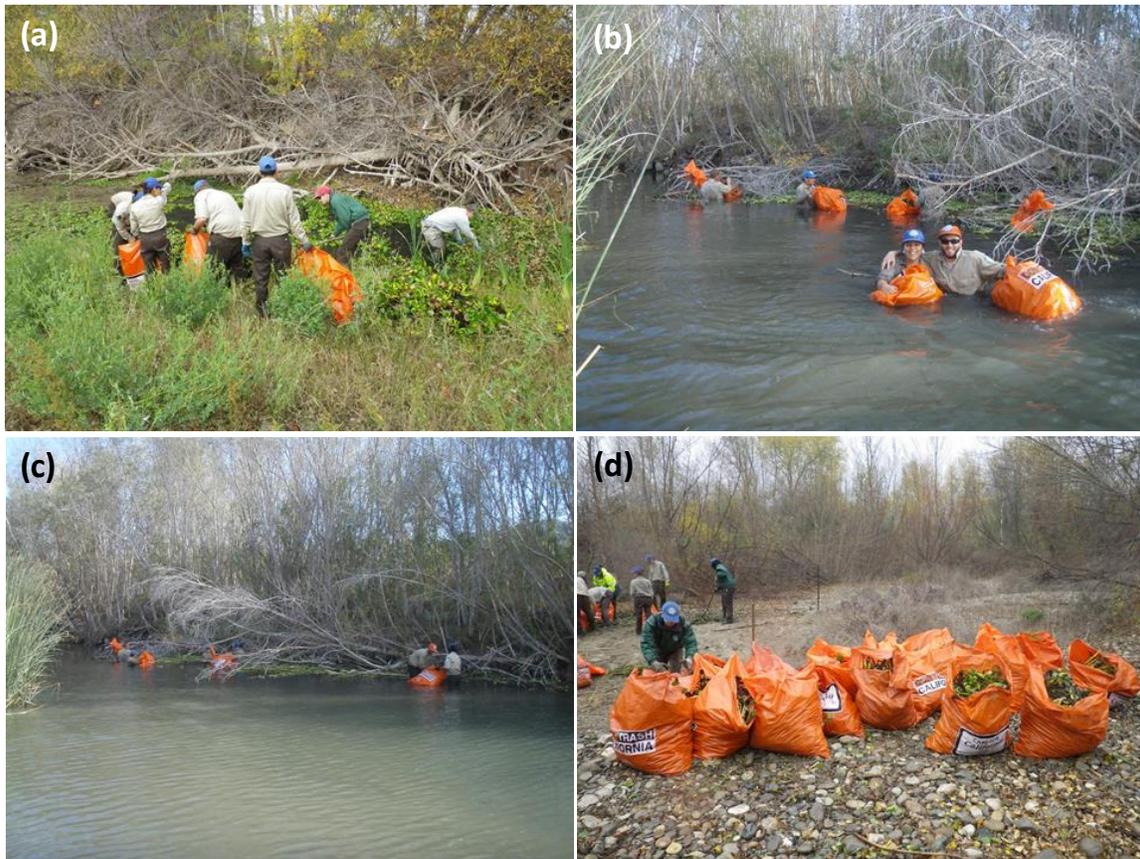
Figure 84: California Conservation Corp assistance in December 2015 showing: a) bagging of water hyacinth near shore, b-c) gathering and bagging on the far shore of a large pool habitat, and d) stockpiling of bags to be spread later into an agriculture field.
