WY2013 ANNUAL MONITORING SUMMARY AND TREND ANALYSIS

THE BIOLOGICAL OPINION FOR THE OPERATION AND MAINTENANCE OF THE CACHUMA PROJECT ON THE SANTA YNEZ RIVER IN SANTA BARBARA COUNTY, CALIFORNIA

**CACHUMA OPERATION AND MAINTENANCE BOARD
FISHERIES DIVISION**

JUNE 1, 2017

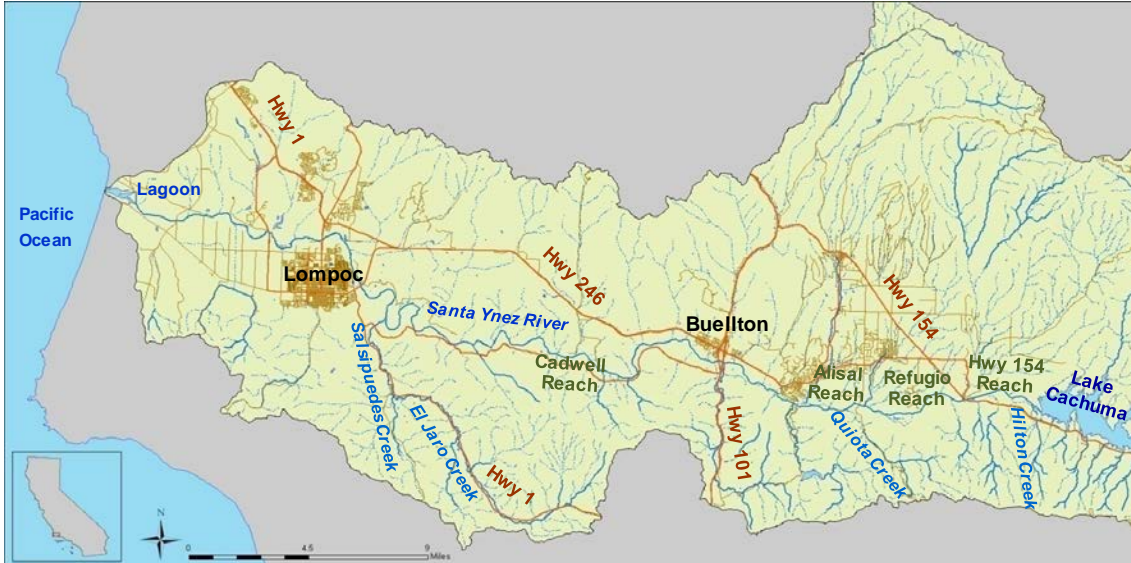
Figure ES-1: LSYR from Bradbury Dam and Lake Cachuma to the Pacific Ocean to the west of Lompoc showing tributary creeks and management reaches of interest for the LSYR Fisheries Monitoring Program.

The monitoring tasks completed in WY2013 were performed below Bradbury Dam in the LSYR watershed or in Lake Cachuma, which is approximately half the drainage area (450 square miles) and stream distance (48 miles) to the ocean compared to the entire watershed. The area is within the Southern California Steelhead Distinct Population Segment (DPS) and the Monte Arido Highland Biogeographic Population Group (BPG) in the Southern Steelhead Recovery Planning Area (NMFS, 2012). Monitoring focused on three management reaches (Highway 154, Refugio, and Alisal reaches) and the Cadwell Reach on the LSYR mainstem, and tributaries (Hilton, Quiota, El Jaro, and Salsipuedes creeks) known to support suitable habitat for *O. mykiss* (Figure ES-1).

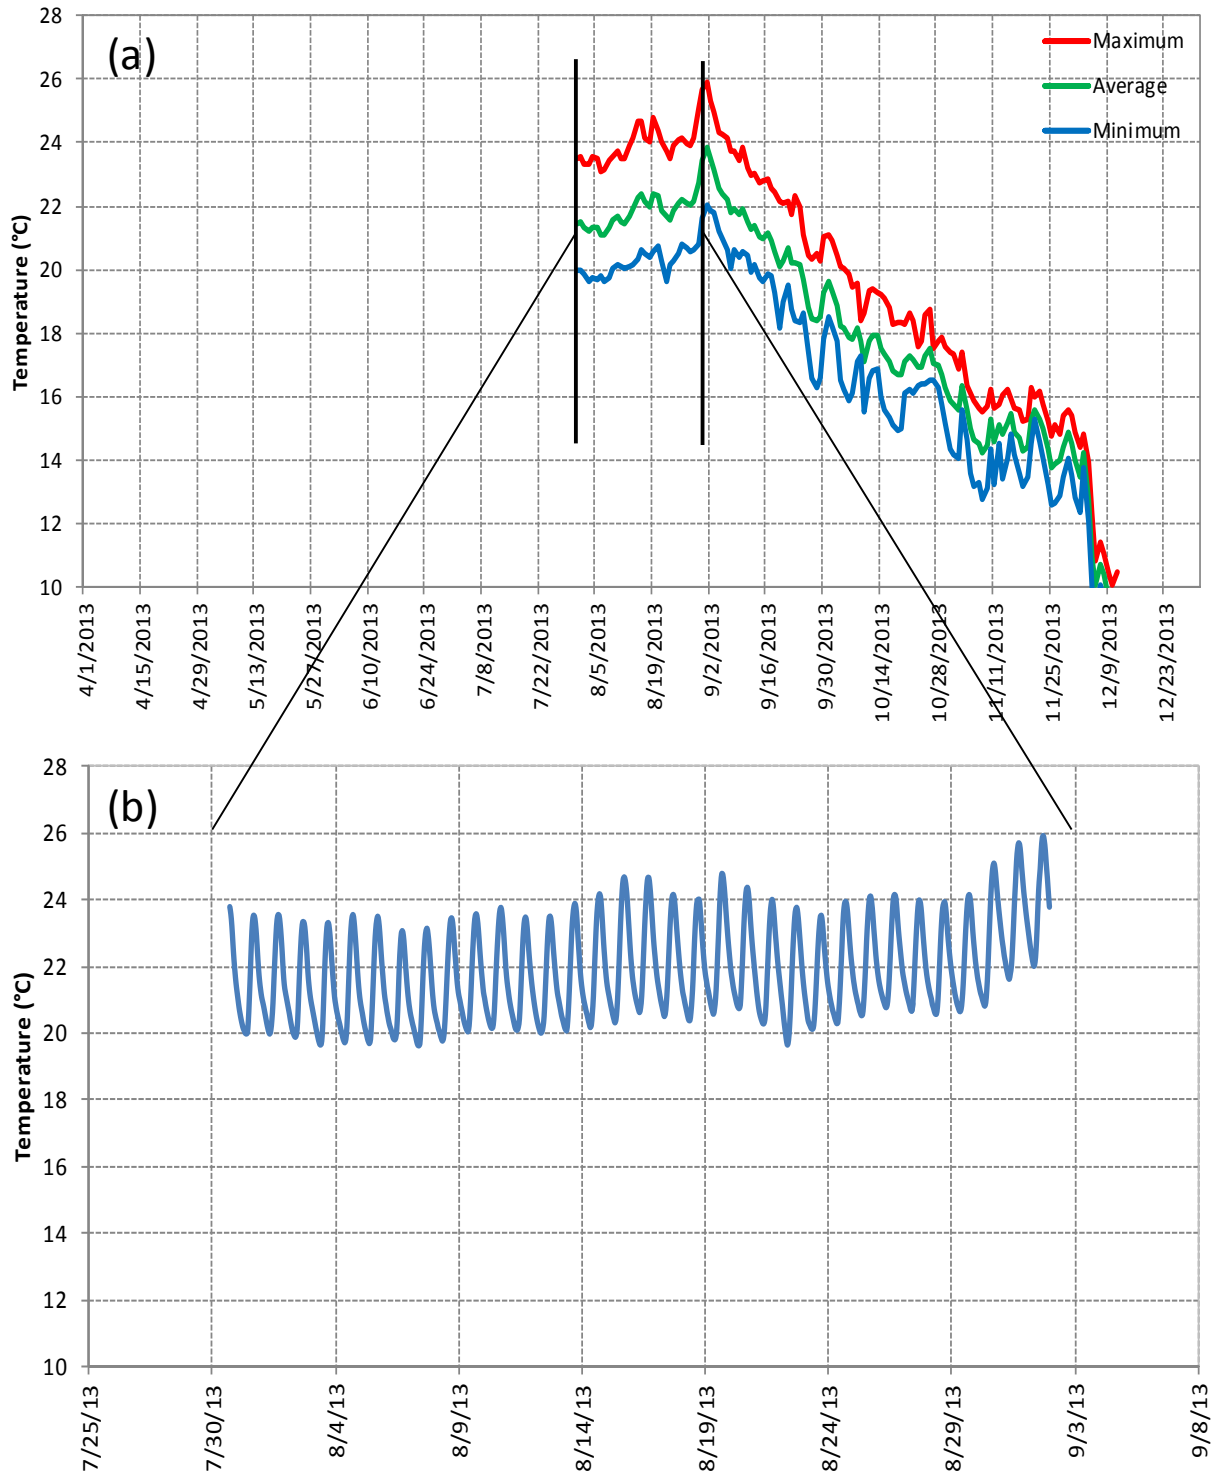
Figure 25: 2013 LSJR-22.68 (Cadwell Pool) middle (6.0 feet) thermograph for (a) daily maximum, average, and minimum daily values and (b) hourly data for the period of 7/31/13-9/2/13; this unit was an isolated pool habitat prior to the arrival of the WR89-18 release.

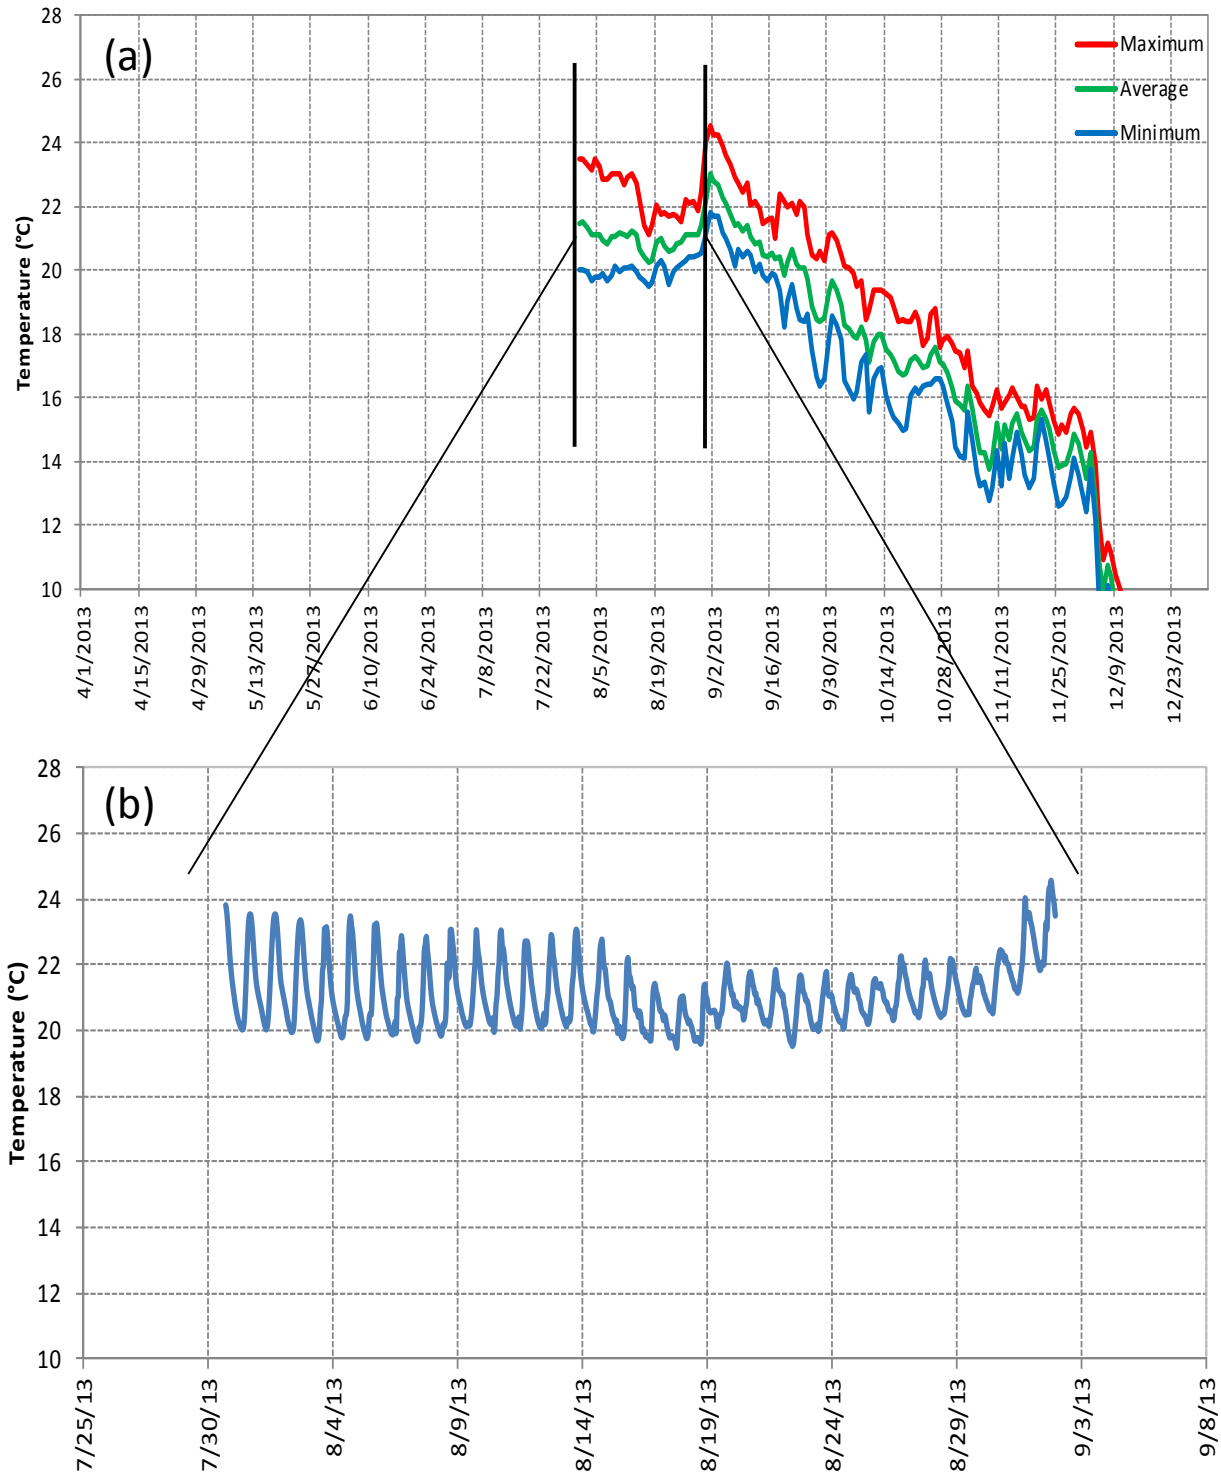
Figure 26: 2013 LSJR-22.68 (Cadwell Pool) bottom (12.0 feet) thermograph for (a) daily maximum, average, and minimum daily values and (b) hourly data for the period of 7/31/13-9/2/13; this unit was an isolated pool habitat prior to the arrival of the WR89-18 release.

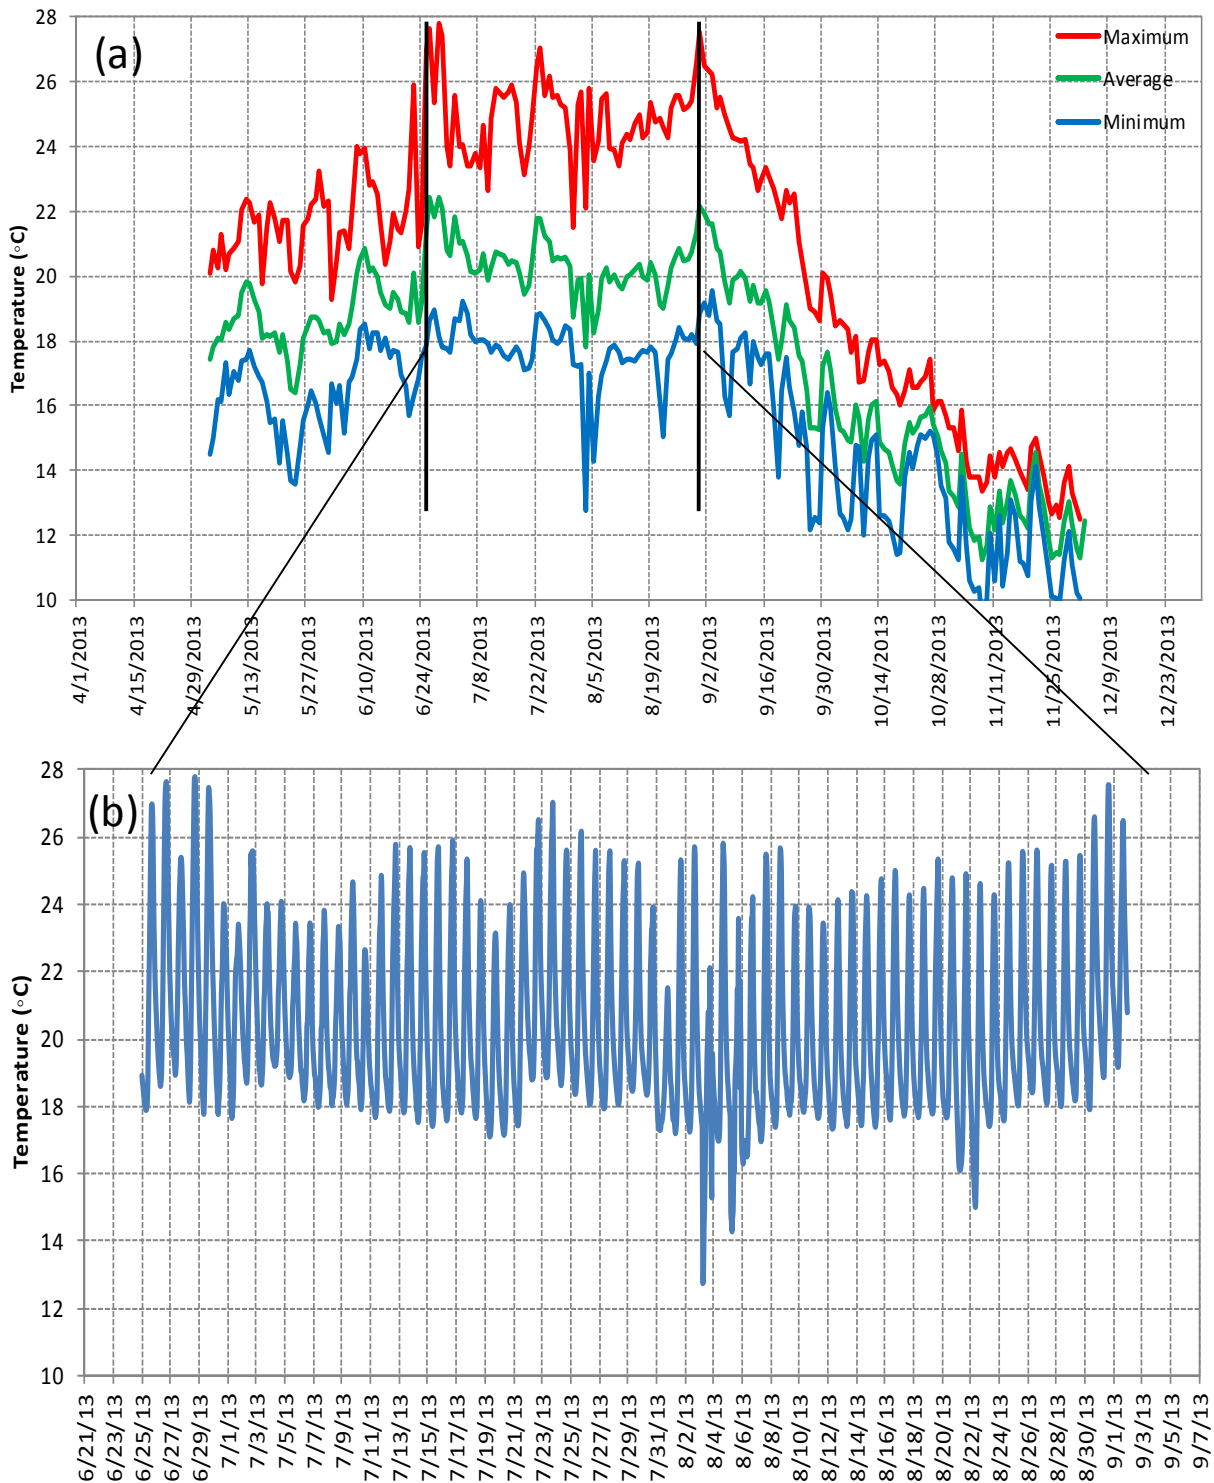
Figure 31: 2013 Salsipuedes Creek (SC-0.77 – Lower Creek) bottom (0.5 feet) thermograph for (a) daily maximum, average, and minimum daily values and (b) hourly data for the period of 6/25/13-9/2/13.

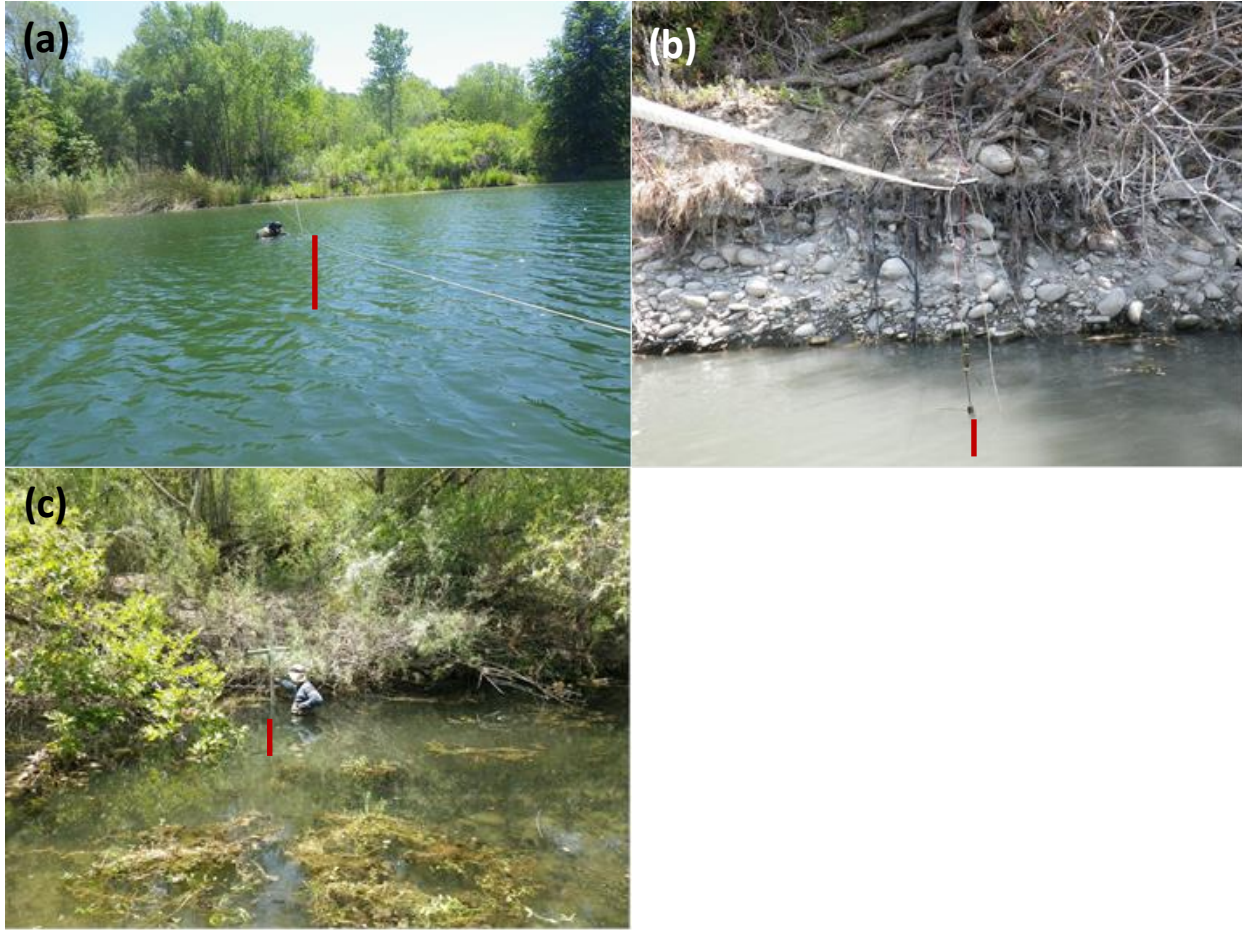
Figure 42: WY2013 Sonde vertical array locations at (a) LSYR-0.51, (b) LSYR-4.95, and (c) LSYR-7.65; the red line indicates the instrument tower location.

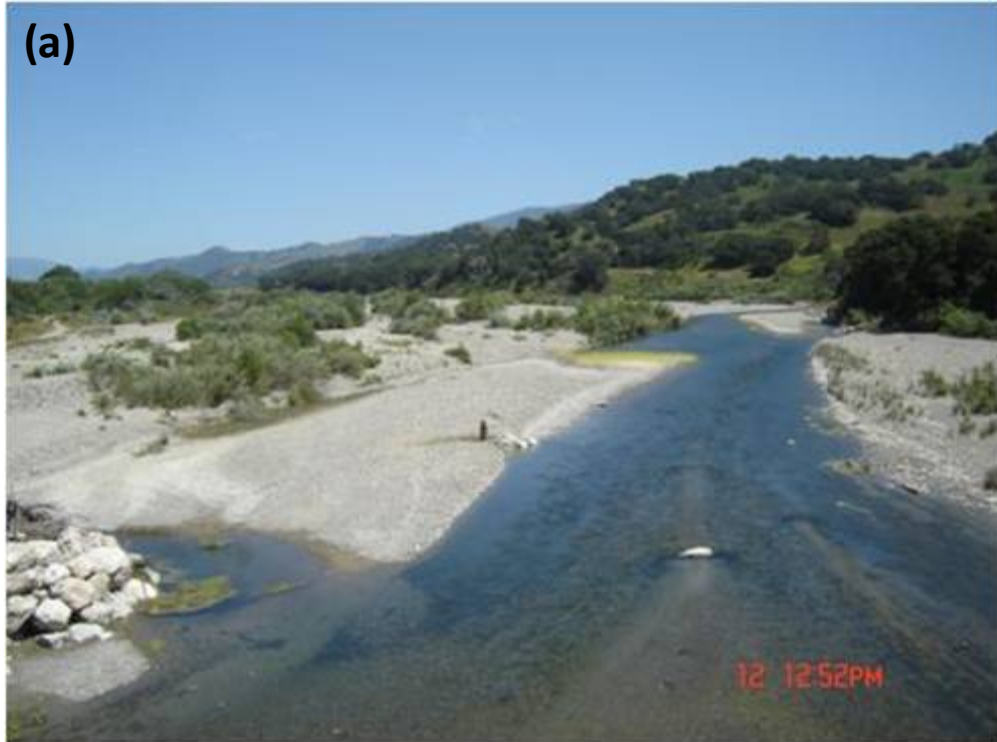
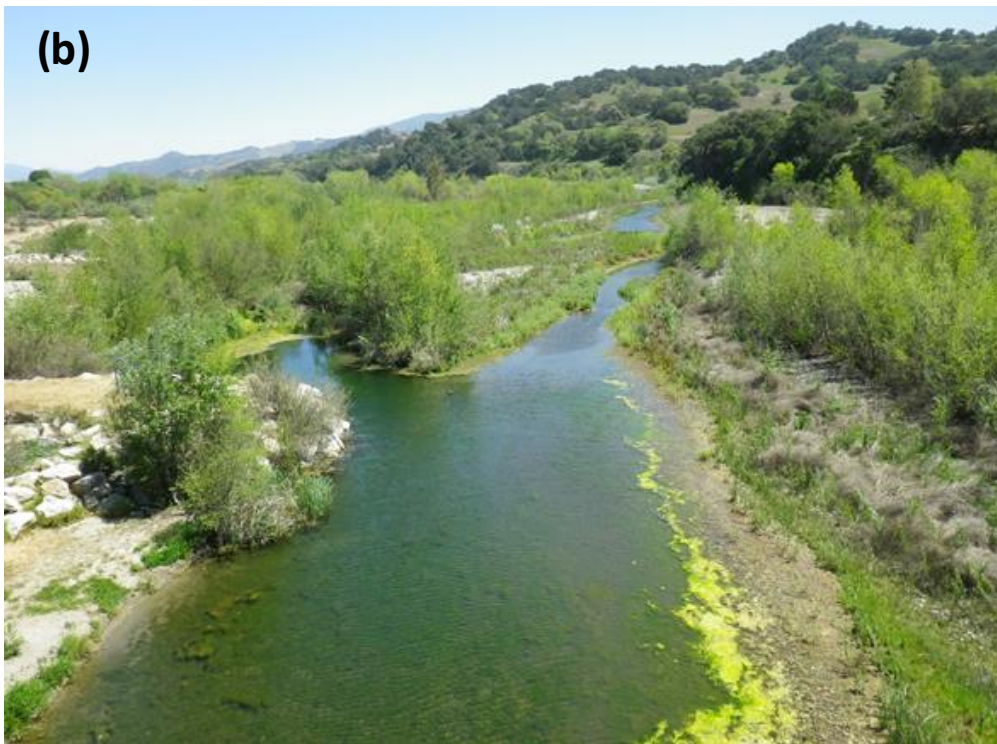
Figure 47: Photo point (M-12) collected at Refugio Bridge looking upstream in (a) May 2005, and (b) April 2013.

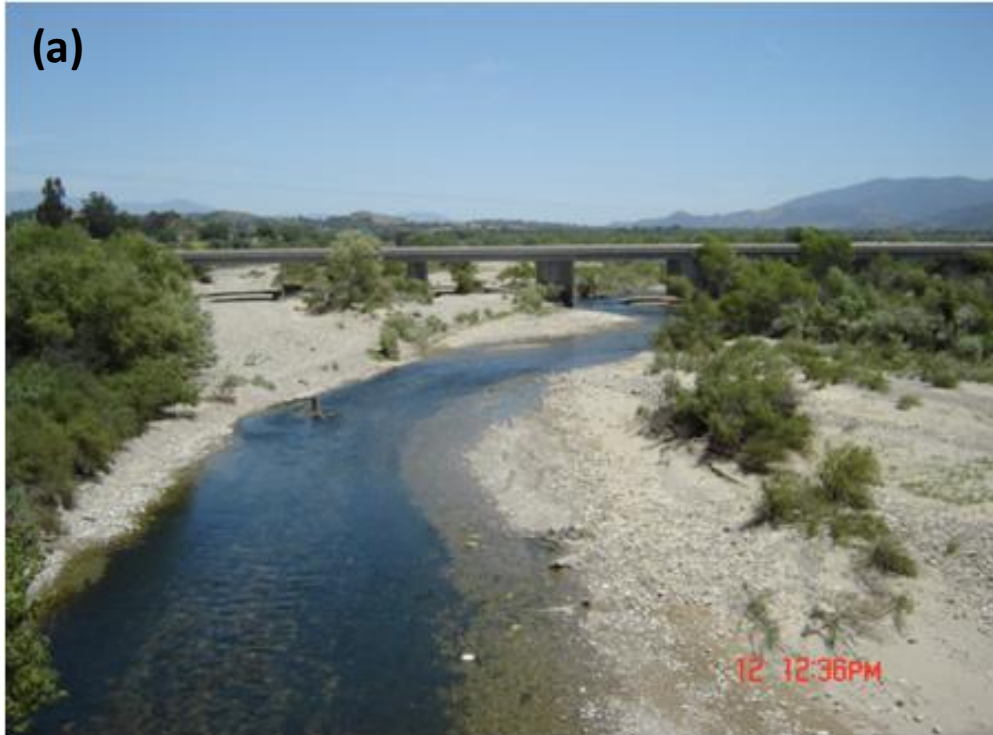
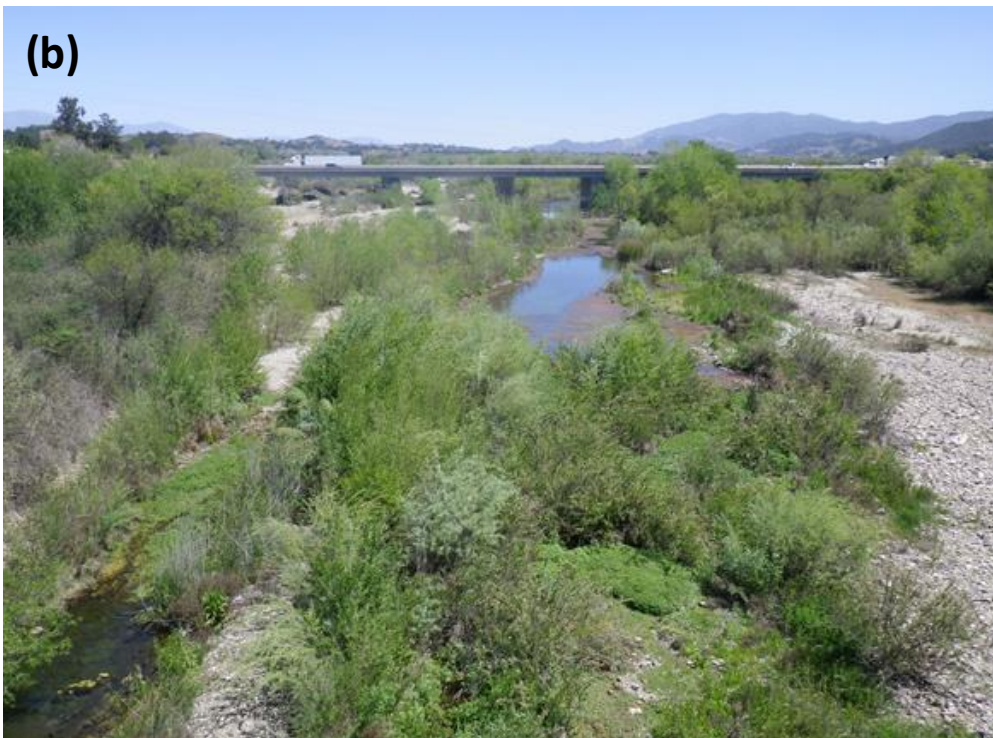
Figure 48: Photo point (M-14) collected at Alisal Bridge looking upstream in a) May 2005, and b) April 2013.

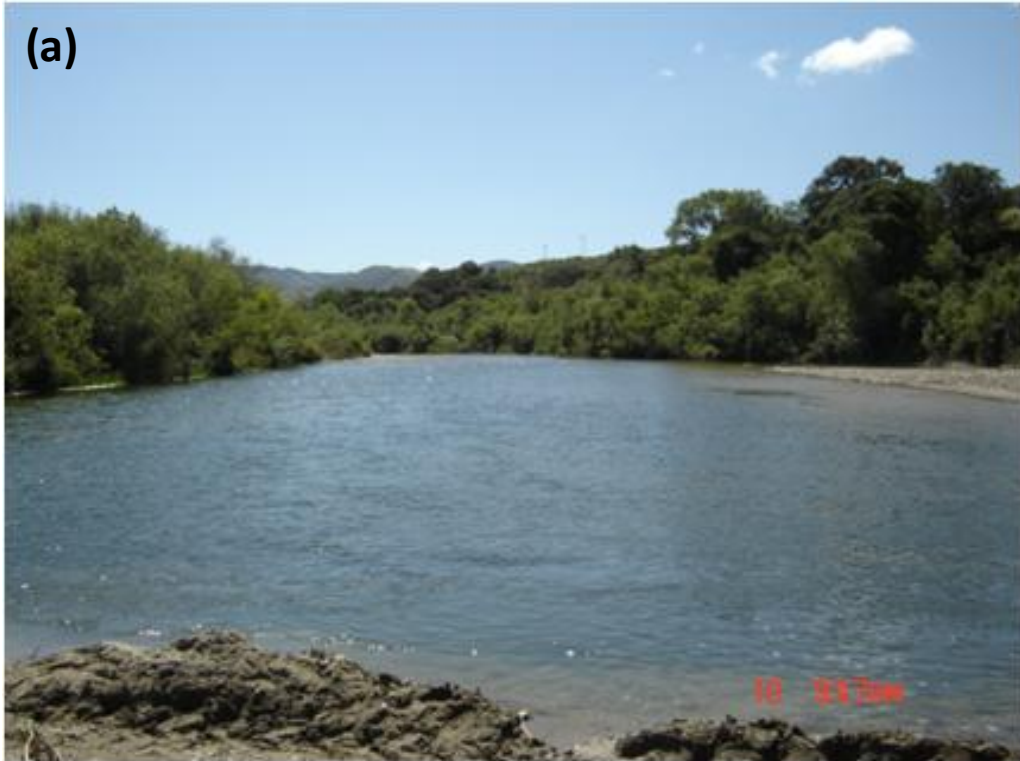
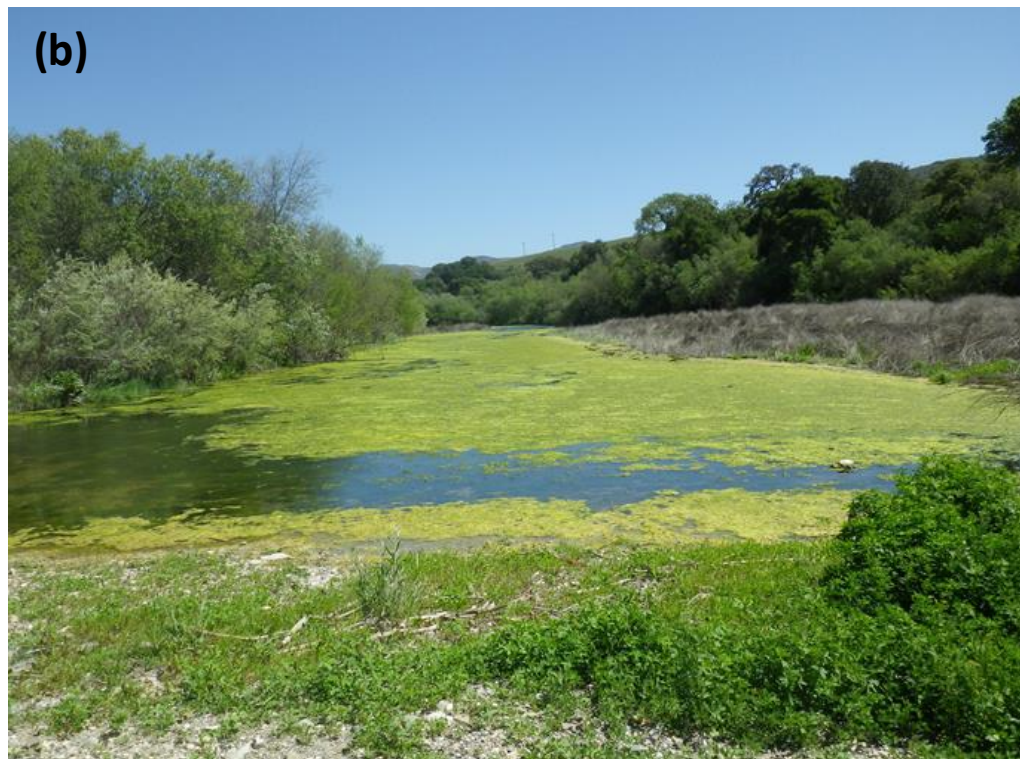
Figure 49: Photo point (M-19) collected at Avenue of the Flags Bridge looking upstream in (a) May 2005, and (b) April 2013.

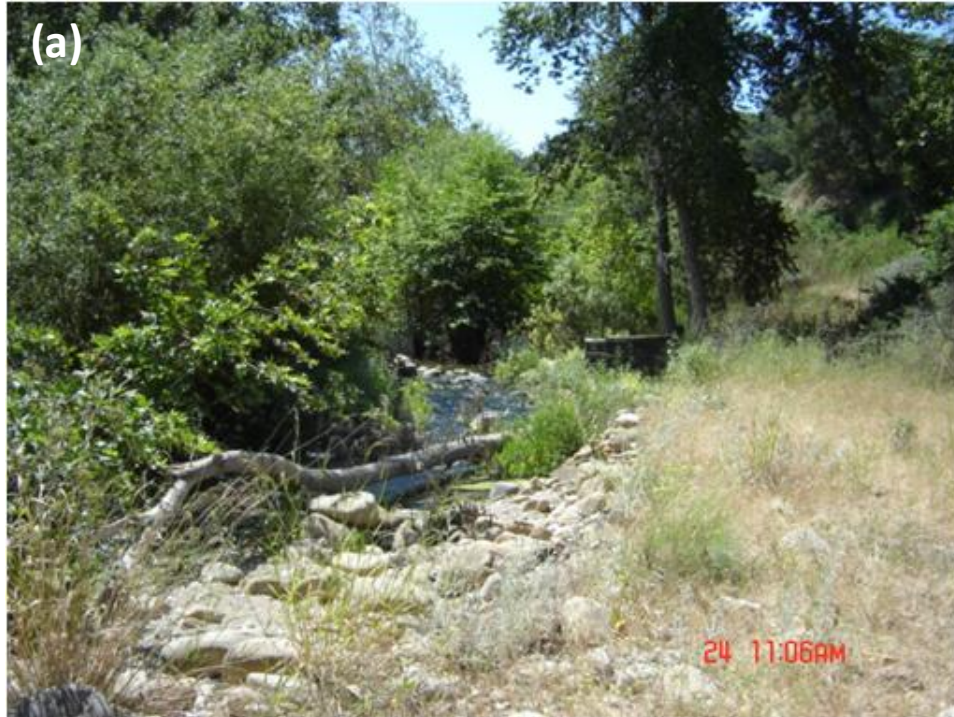
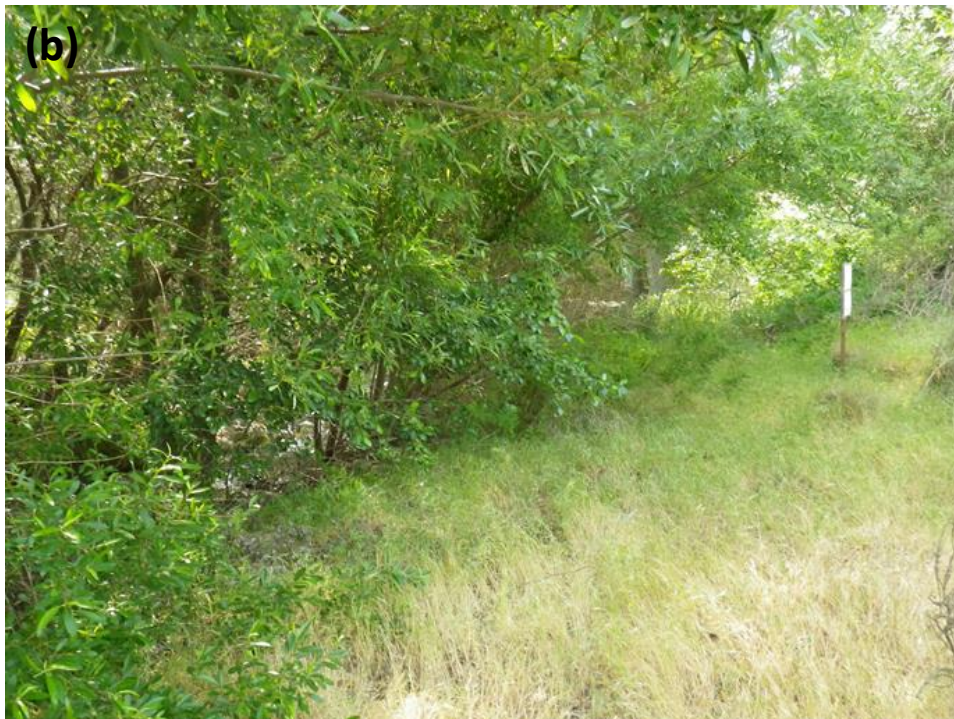
Figure 50: Photo point (M-21) collected at Sweeney Road Crossing looking upstream in (a) May 2005, and (b) April 2013.

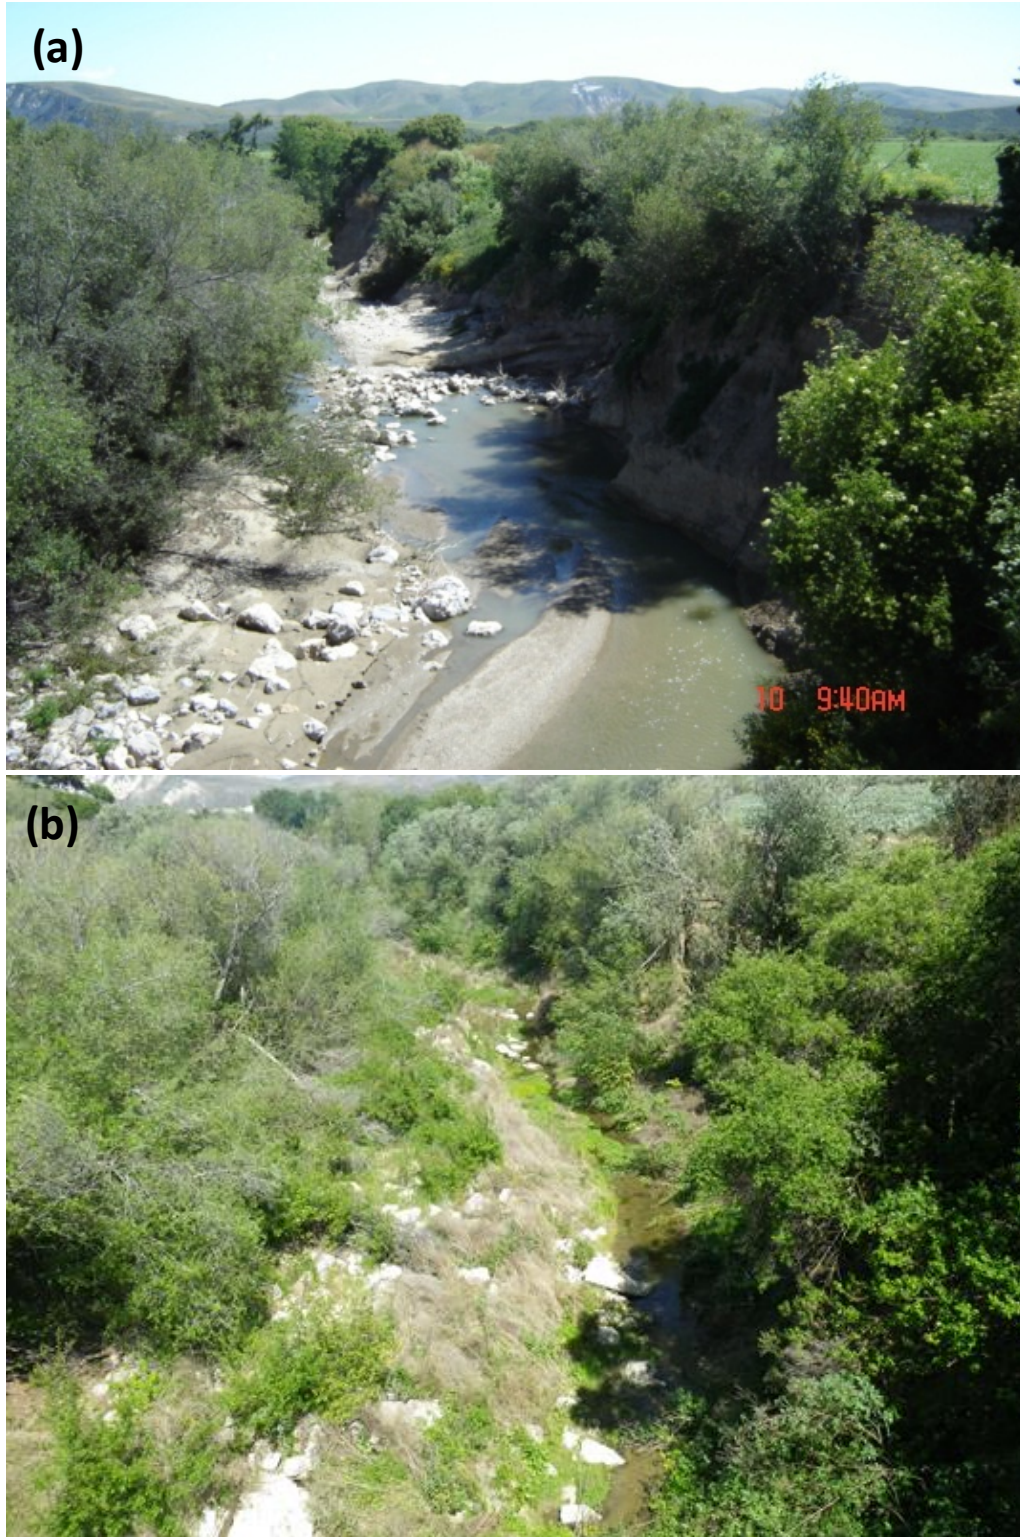
Figure 52: Photo point (T-6) collected at the Hilton Creek ridge trail looking upstream in (a) March 1999, (b) May 2005, and (c) April 2013.

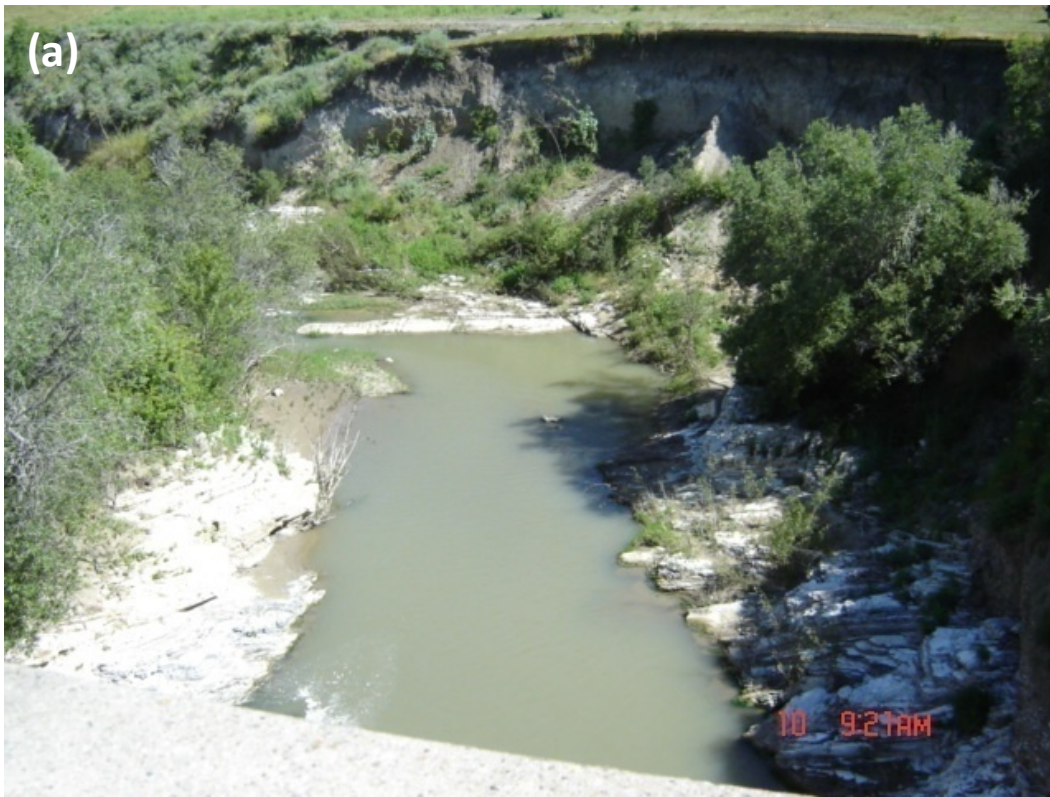
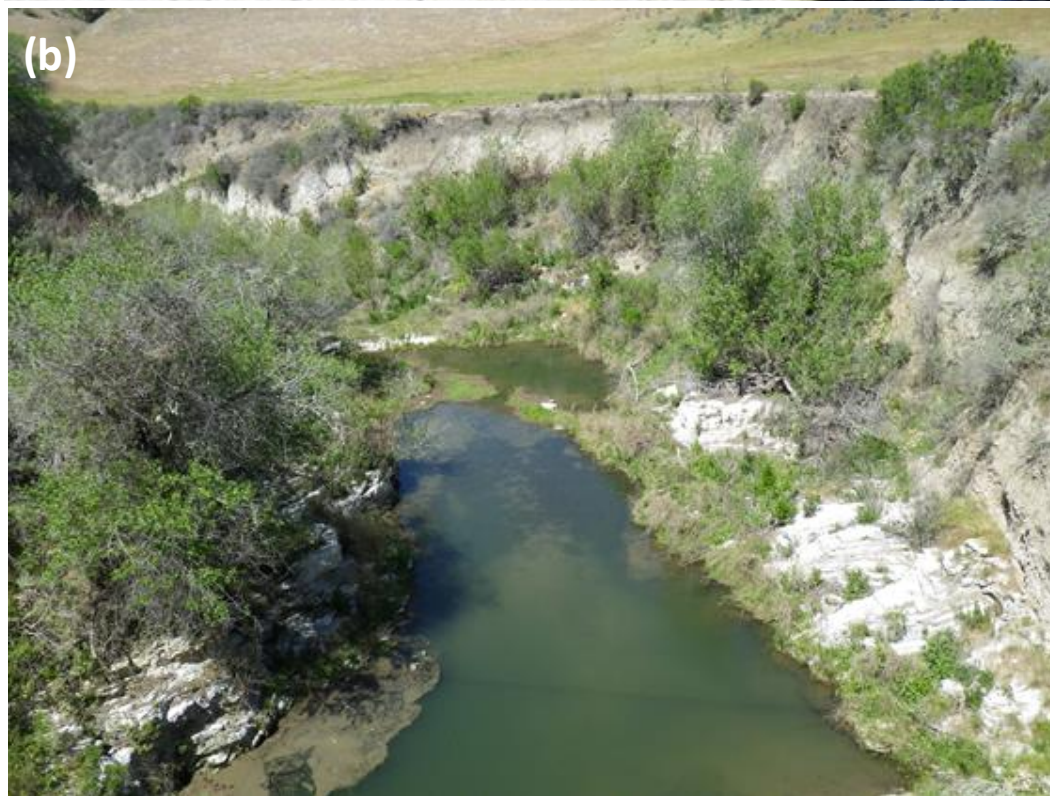
Figure 53: Photo point (T-28) collected at Salsipuedes Creek at Santa Rosa Bridge in (a) May 2005 and (b) April 2013.

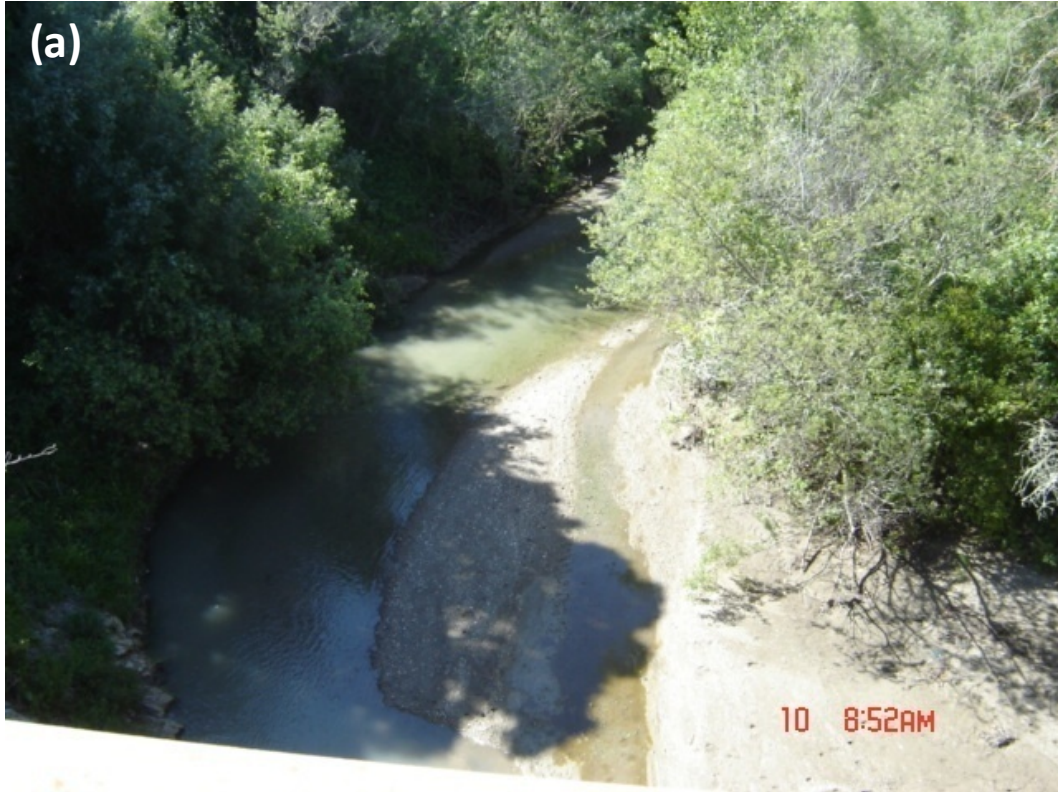
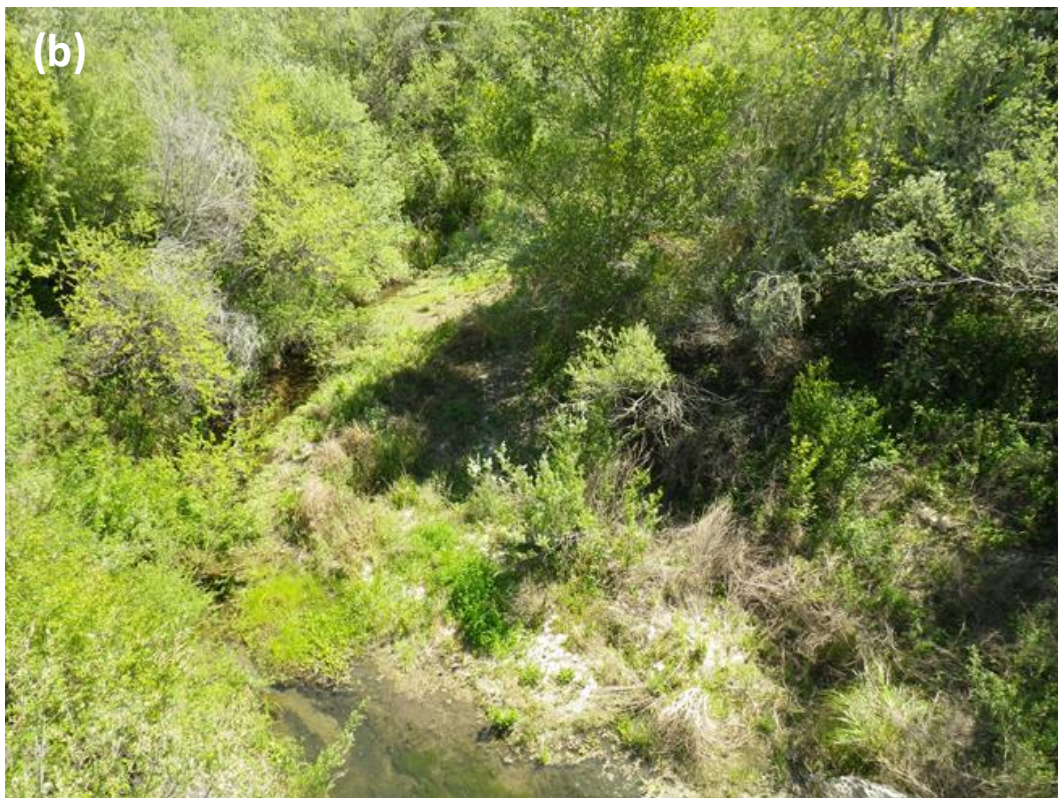
Figure 54: Photo point (T-39) collected at Salsipuedes Creek at Hwy 1 Bridge in May 2005 and (b) November 2008; no photo point was taken in April 2013.

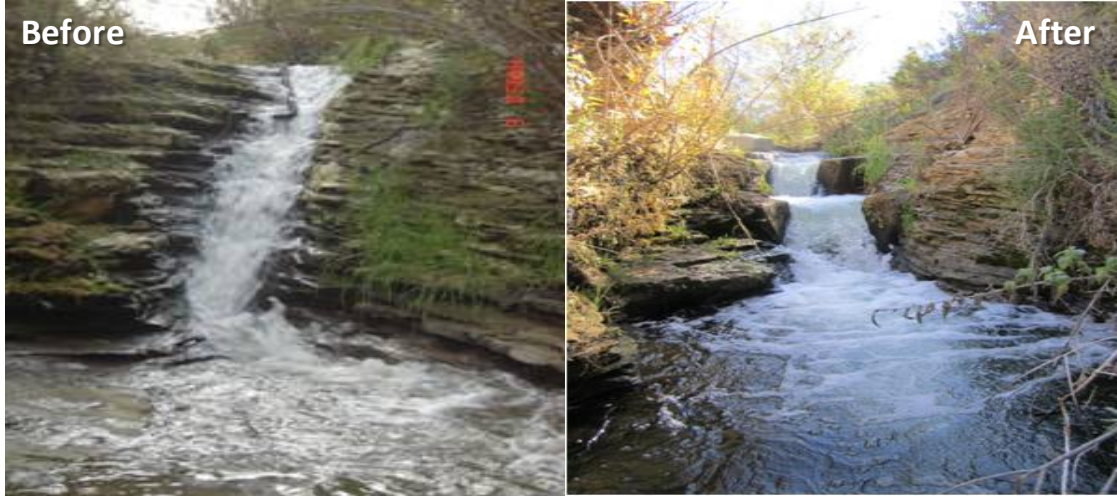
Figure 72: Fish passage and habitat restoration at Hilton Creek at the Cascade Chute Project that was completed in 2005.

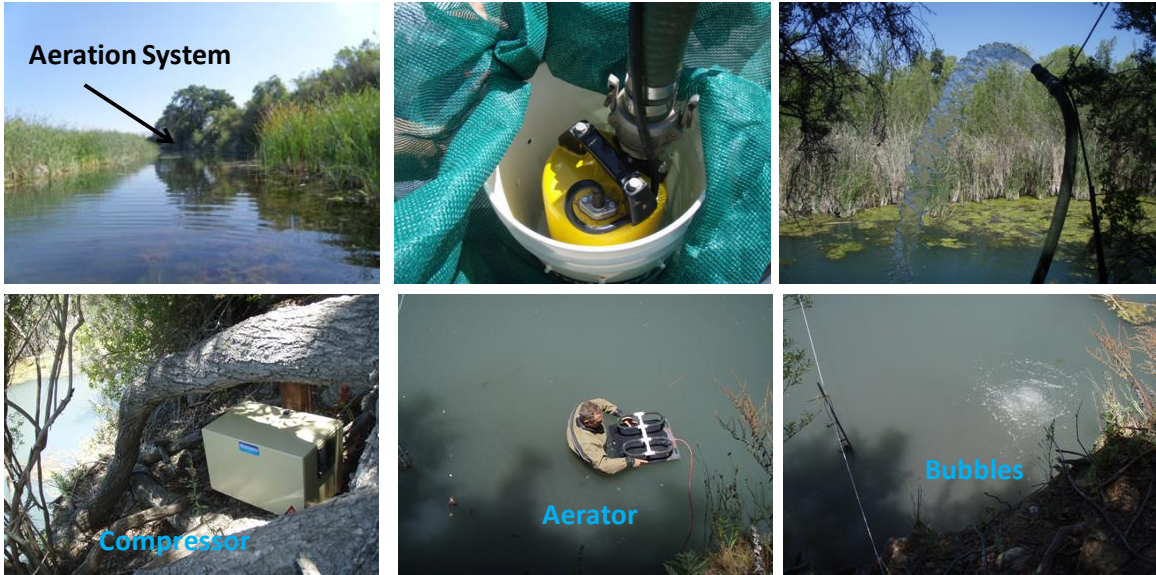
Figure 81: Aeration efforts at the Encantado Pool (LSYR-4.95) during the summer of WY2013.
