2012 ANNUAL MONITORING SUMMARY AND TREND ANALYSIS

THE BIOLOGICAL OPINION FOR THE OPERATION AND MAINTENANCE OF THE CACHUMA PROJECT ON THE SANTA YNEZ RIVER IN SANTA BARBARA COUNTY, CALIFORNIA

CACHUMA OPERATION AND MAINTENANCE BOARD FISHERIES DIVISION

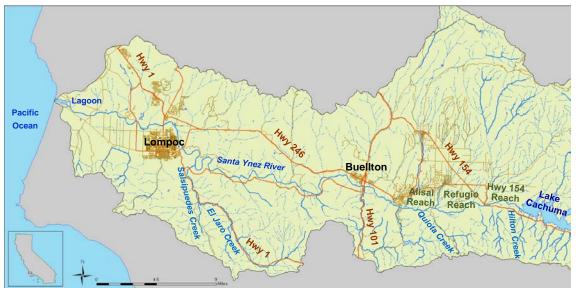
Figure ES-1: LSYR from Bradbury Dam and Lake Cachuma to the Pacific Ocean to the west of Lompoc showing tributary creeks and management reaches of interest for the LSYR Fisheries Monitoring Program.

The monitoring tasks completed in WY2012 were performed below Bradbury Dam in the LSYR watershed or in Lake Cachuma, which is approximately half the drainage area (450 square miles) and stream distance (48 miles) to the ocean compared to the entire watershed. The area is within the Southern California Steelhead Distinct Population Segment (DPS). Monitoring focused on three management reaches (Highway 154, Refugio, and Alisal reaches) and Cadwell Reach on the LSYR mainstem, and tributaries (Hilton, Quiota, El Jaro, and Salsipuedes creeks) known to support suitable habitat for *O. mykiss* (Figure ES-1).

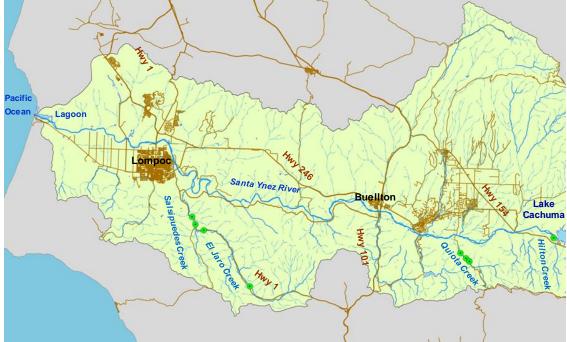
Figure 82: Completed fish passage enhancement and habitat restoration projects within the Salsipuedes Creek (including El Jaro Creek), Quiota Creek and Hilton Creek.

There were 3 habitat and passage enhancement projects completed from WY2001 to WY2005 and 5 projects were completed from WY2006 to WY2012 with a noticeable *O. mykiss* population increase across the period particularly at Hilton Creek (Tables 22 and 23, Figure 82). By December 2012, eight tributary passage enhancement projects had been completed within the LSYR basin: Salsipuedes Creek Highway 1 Bridge Fish Ladder, Salsipuedes Creek Jalama Road Bridge Fish Ladder, Hilton Creek Cascade Chute Step Pools, El Jaro Creek Rancho San Julian Fish Ladder, Quiota Creek Crossing 6 Bridge, Cross Creek Ranch Fish Passage Project on El Jaro Creek Backwatering with Step Pools, Quiota Creek Crossing 2 Bridge, and Quiota Creek Crossing 7 Bridge as well as the HCWS which supplies water year round to Hilton Creek from Lake Cachuma (Figures 83-87, Quiota Creek Crossing 7 was not depicted since it was completed in calendar not water year 2012). The HCWS has transformed Hilton Creek into a dense riparian zone where there is little thermal heating from the URP to the confluence with the LSYR mainstem (Figures 48 and 49). In addition to the enhancements mentioned

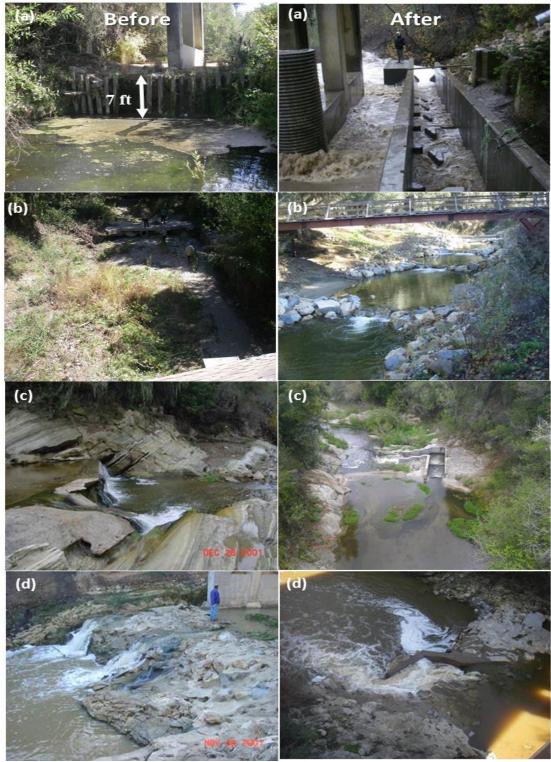
Figure 83: Fish passage and habitat restoration projects within the Salsipuedes Creek (including El Jaro Creek) watershed at (a) Rancho San Julian Bridge on El Jaro Creek (completed in 2008), (b) Cross Creek Ranch on El Jaro Creek (completed in 2009), (c) Jalama Road Bridge on Salsipuedes Creek (completed in 2004), and (d) Hwy 1 Bridge on Salsipuedes Creek (completed in 2002).

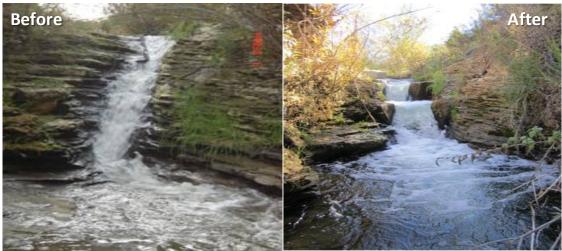
Figure 84: Fish passage and habitat restoration at the cascade chute barrier on Hilton Creek (completed 2005); this project doubled the available restored habitat within the creek drainage.
