# **Infrastructure Improvement Plan FY 2021-2025**

**Engineering - Operations Division**

#### **EXECUTIVE SUMMARY**

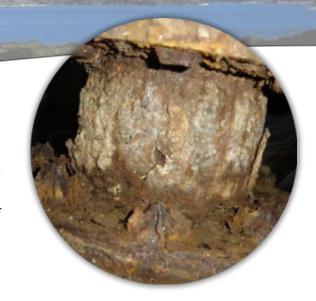
Combination air vacuum air release valves (AVARs) are located at high points along the pipeline and act to automatically expel air and relieve vacuum accumulation in pipes. If air is not adequately expelled, air pockets can constrict flows. If the vacuum is not relieved, serious damage or collapse of the pipeline can occur. If AVAR vaults become flooded or if a negative pressure is experienced within the pipeline, the AVAR valves could allow contaminated water to enter the pipeline. It is now required to install these valves above grade, where flooding is less likely. COMB has been upgrading the AVAR valves in the system such that all are above grade. The AVAR valve structures consist of a manhole cover, riser pipe, valve, and AVAR valve. Over time, the original valves, riser, and manhole covers have also been corroded and pose an operational risk.

Fifteen AVAR valves were rehabilitated in 2018 and 2019 on the Lower Reach. There are six remaining AVAR valve structures that need rehabilitation as they pose an operational risk and/or do not meet Section 64576 of Titles 17 and 22 California Code of Regulations, which requires "each new air-release, air vacuum, or combination valve, and any such valve installed to replace an existing valve shall be: (a) installed such that its vent opening is above grade." In addition, there are nine AVAR located on the lateral turnouts that require replacement. Replacement and/or relocation of the AVARs and riser pipes will ensure the functionality of this system component. The consequence of not completing this project may be major facility failure in multiple locations and potential water contamination.

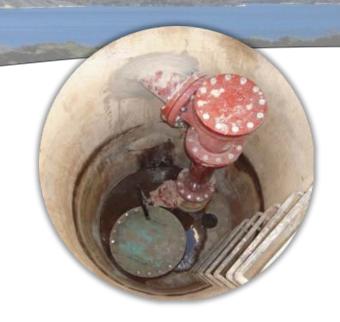
The project consists of replacing the man hole covers, blow-off nozzles, gate valves, upper spools, and discharge piping within the Lower Reaches of the SCC. The project would be completed in conjunction with the AVAR valve replacement and relocation project and coordinated with the affected Member Agencies during the required system shutdown. The design for this project is complete. Six scheduled shutdowns remain to be completed to replace 15 remaining blow-off nozzles and valves.

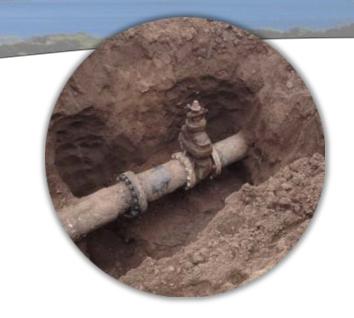
This project would replace corroded pipe and inoperable valves and air vents on lateral connections. The project will require shutdowns for the specified turnout distribution supply areas and would be coordinated with the impacted Member Agencies. The project requires retention of engineering and contractor services. Due to each site's differing conditions, engineering would be required for each individual structure. The initial phase of the project is to perform an engineering assessment and design for all lateral structures.

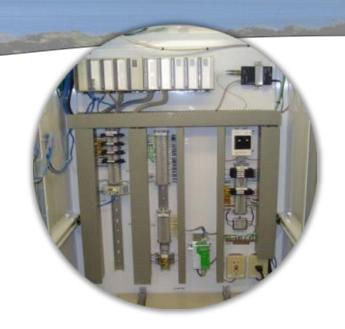
This project would involve the replacement of all legacy PLC(s) in their existing control panels. New PLC processors, software, and I/O modules. COMB has a total of nine PLCs. As part of the upgrades, additional sensors will be added to monitor to the system for potential leaks or breaks. Several of these PLCs are also locations were data is shared with COMB's Member Agencies. Upgrades at these sharing locations would need to be coordinated with each Member Agency. The project would also involve upgrading the SCADA server hardware and software to support the latest operating system and version of the SCADA software.

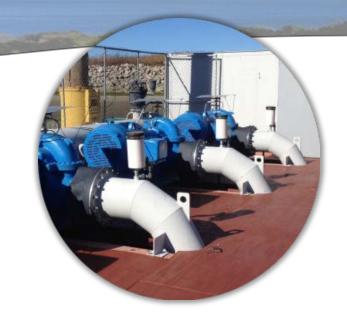
A contractor provided COMB with a Long-Term Pumping Facility Alternatives Study in March 2017 which discusses two concepts for a new secured pump station: (1) a shore-mounted, slant-well facility and (2) a prefabricated submerged facility. The shore-mounted slant-well facility would include placing vertical turbine pumps with submersible motors at the bottom of a slanted steel casing pipe, which draws water from the lake through fish screens. Six 100-HP pumps are envisioned. The pumps would be powered by the same variable-frequency drives (VFD) and electrical switchgear used to power the existing barge.

The prefabricated submerged facility is an alternative concept, which would be assembled on shore, floated into position, and then lowered to the lake bottom. The advantage of such a facility is that it could be constructed well in advance of when it is needed, however, the pumping equipment would not be as easily accessible.

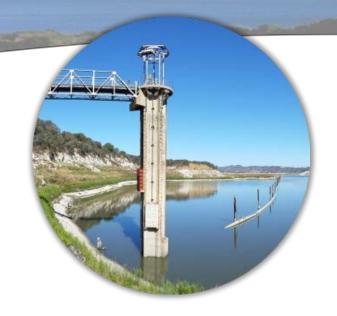
The project would consist of a 36-inch diameter, 3,700' DR-17 HDPE pipeline secured to the lake bottom with concrete pipe weights. A fish screen could be installed at the end of the pipeline to allow water deliveries from a deeper portion of the lake for better management of delivered water quality. In times of drought, the pipeline would be connected to a pumping system to allow deliveries of water to the Tecolote Tunnel. The preferred elevation to install the pipeline is at 700', although deeper install may be possible. The project could be installed during the next drought when the appropriate lake level is reached for construction (Makai Ocean Engineering, Inc. 2019).

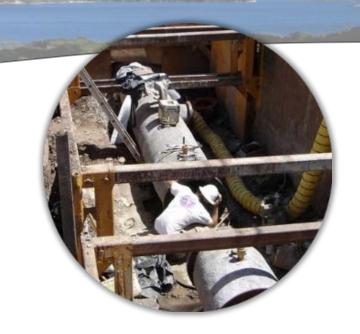
A line valve between the Montecito Water District (MWD) Office Pump Station and East Valley Pump Station would allow the SCC to be isolated in the Montecito reach while continuing to allow water service from the SCC to MWD customers. A new 30 inch butterfly valve would be installed at South Coast Conduit (SCC) Lower Reach Station 494+54, separating the pipeline into two reaches. The 30 inch bar-wrapped concrete cylinder pipe in this section is assembled in bell and spigot segments. Line stops would be installed and the segment at Station 494+54 would be removed. 12-inch port plugs with a bypass line would be installed on either side of the removed segment to avoid need for a service outage. A new segment with butterfly valve would be inserted and the pipeline would be disinfected, tested, and put back in service.

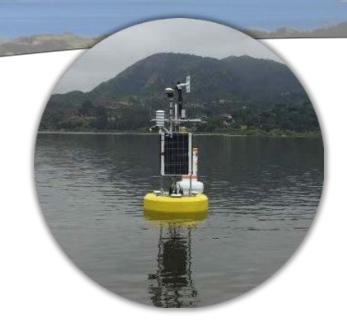
Setting up the anchoring system, evaporation buoy and sensors, and safety buoys is expected to take 1-2 weeks. A consultant would initiate the web portal and data relay system approximately 2-3 weeks after buoy installation. The relative ease of installation would allow Reclamation, COMB, and Member Agencies to begin using the buoy system immediately. Specific variables to be monitored could include, water temperature profiles (4 units down to 70 feet), dissolved oxygen, chlorophyll, phycocyanin, nutrients, wind speed, humidity, air temperature, barometric pressure, and incoming solar radiation.

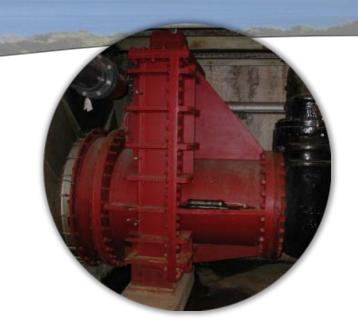
Located at the base of the Tecolote Tunnel, the Jet Flow Control Valve is the primary control for flow from Lake Cachuma into the South Coast Conduit. The valve is located within the red piping component as pictured to the right. The adjacent gate valve (black) is utilized to shutdown flows from Lake Cachuma. The Jet Flow Control valve was replaced in 1990 and has a useful life of approximately thirty years. As part of this project, COMB would purchase new parts and utilize previously acquired internal components to build a new valve to be installed during a planned shutdown. The current valve, after being removed, would be rebuilt using new components and would be kept on site and used as a redundant valve in case of failure.

The consequence of not completing the project includes using a valve beyond the expected useful life, coupled with a lack of redundancy for one of the most critical flow control valves within the system. Because the North Portal Jet Flow Control Valve controls the flow into the Tecolote Tunnel, failure could prevent or impact water deliveries to the cities of Goleta, Santa Barbara, Montecito, Summerland and Carpinteria. This is a proactive replacement based upon the expected service life at purchase, as the valve in its current state is functioning adequately. Because of the important function of the valve, it is critical that it not be used beyond the manufacturer's recommended service life, and that redundancy exists on site.

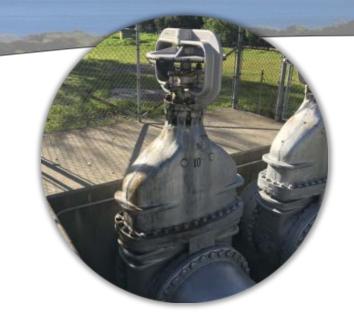
A majority of the valves located at control stations along the South Coast Conduit are original and were installed in the 1950s. There are over 50 large diameter valves in the system, ranging in size from 24" to 48". Several of these valves are critical for operations, but many of the valves are obsolete and are not utilized for operations. During previous maintenance work and shutdowns, key valves in the system have been characterized as exhibiting excessive leak-by. This program would replace critical valves in the system at key control station locations.

In-line isolation and control valves are needed to properly operate and maintain the system. Valves with excessive leak-by or poor operability impact system operations. The system is operated differently than designed with the installation of Cater Treatment Plant. Many of the system valves are no longer needed for operations. Obsolete valves and piping are potential points of failure and increase maintenance needs. The consequences of not completing this project could include loss of control within control stations and excessive leak-by, which could especially impact operations during repair work requiring pipeline shutdown.

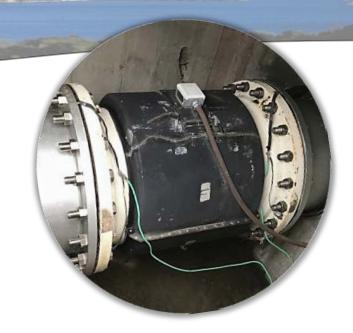
COMB operates several electronic mag-meters that are critical to the water accounting and system operations that have reached limited-life cycle phase and are likely in need of replacement in the next five years. COMB operates electronic magmeters at Glen Anne Turnout Meter, Goleta West Meter, Ortega Inflow meter, Ortega Southflow meter, and the Boundary meter which are utilized to manage system operations on a day to day basis and for monthly accounting of water use.

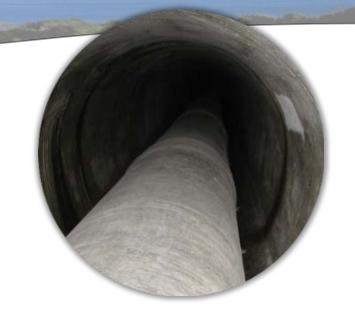
An engineering firm would conduct a condition assessment to determine the structural integrity and reliability of the connecting and support structures of the Sheffield Tunnel. The engineering evaluation will include recommended repairs and determine how to eliminate areas of heavy seepage. It is possible the engineering evaluation could find a lower cost remedy to that recommended by USBR. Upon completion of the evaluation, COMB would retain a qualified contractor to repair the deteriorated mortar joints and pipe supports at locations identified.

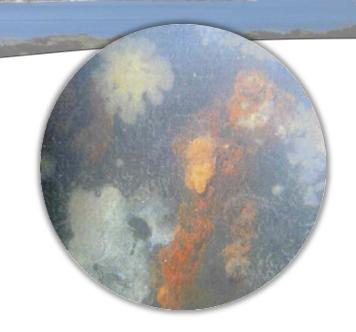
The Lauro Reservoir intake structure was modified in 1981 by adding a stainless steel circular intake screen connected to a steel pipe which was inserted in the original concrete intake structure. A 1/2 inch thick steel circular bearing plate was installed on top of the existing concrete intake structure to cover the opening between the intake structure and vertical pipe and provide structural support. The 2018 dive report, prepared by USBR, states the intake structure is in satisfactory condition with the exception of the bearing plate. The bearing plate was observed to be fully covered with corrosion and rust nodules.

The steel bearing plate on the intake structure has deteriorated because of corrosion and poses an operational risk for both the protection against outside intrusion of elements penetrating through the opening or structural support of the intake pipe and screen.

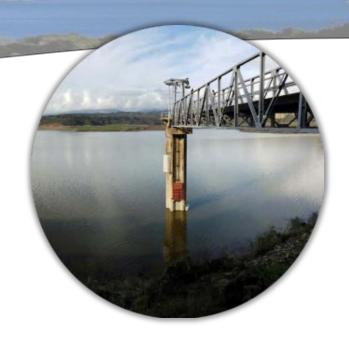
This initial phase of the project consists of acquiring the consulting services of a qualified structural engineering firm to perform a Seismic Reliability Analysis and Physical Condition Assessment of the North Portal Intake Tower located at the North Portal of the Tecolote Tunnel. It shall include a report of all findings and propose recommendations for structural rehabilitation to increase and/or ensure continued reliability of the structure in the occurrence of a large seismic event. An assessment of the tower is easier to perform when the lake level is low. This project is scheduled to be performed when the lake level exposes a large portion of the intake tower.

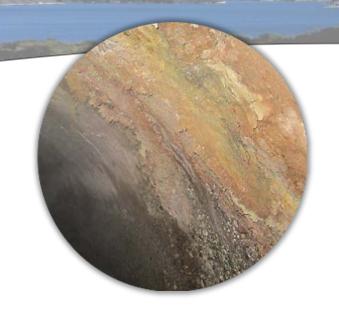
The Tecolote Tunnel was completed in 1956 to divert water from Lake Cachuma to the South Coast Conduit. The tunnel provides water delivery through the mountain to the South Portal. The tunnel structure consists of a modified circular horse-shoe shaped cross section constructed of steel encased in 12 inches of concrete, and operates in open channel flow that is approximately 7' inside and is 6.4 miles long with a gradual shallow slope to enable gravity feed. The only ingress and egress are at the North Portal and South Portal. During periodic inspections by the USBR, deteriorations have been observed in the tunnel lining due to long-term exposure to hydrogen sulfide gas.

Hydrogen sulfide has caused some deterioration of the concrete lining of the tunnel. In areas, the interior concrete surface has peeled in sheets approximately 3/8 of an inch thick and fallen into the invert, creating sediment. The majority of the tunnel is in acceptable condition, however, a few locations have small areas where leaching could affect the structural integrity of the concrete. Review is necessary, as the consequence of not completing this project is uncertain in terms of structure reliability. A tunnel failure could interrupt 40 MGD during peak demand time if not addressed, and would be very technically difficult to repair.

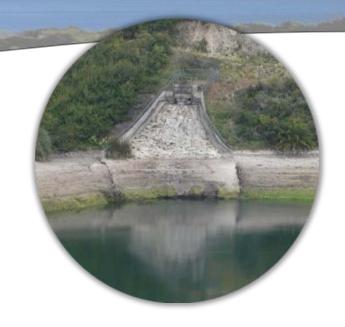
A structural engineering firm would conduct an evaluation to determine an appropriate repair to maintain the essential support and integrity of the rip rap channel. The reservoir would need to be lowered to accommodate inspections and repairs.

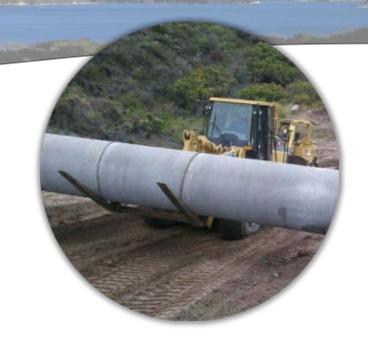
Completed in 2012, Phase I of the Upper Reach Reliability Project installed a new 48" diameter pipeline from the South Portal of the Tecolote Tunnel to the Glen Anne Turnout structure. Phase II will complete the project, installing approximately 10,000 additional linear feet of 48" diameter welded steel pipe from the Phase I endpoint at the Glen Anne Turnout structure, through to the Corona del Mar Filtration Treatment Plant.

The completion of Phase II is essential in order to benefit from the project as it was originally designed. The project would improve both reach and region-level drought resiliency during summer peak demand, and would allow for routine maintenance on the existing pipeline. In addition, the operational flexibility of emergency failure response along the SCC Upper Reach would improve. Currently, COMB heavily relies on storing water in Lauro, Ortega, and Carpinteria Reservoirs to meet the full water needs of the region. Because the Upper Reach of the SCC has the largest demand deficit, a redundant pipeline would safeguard downstream users as well, improving the water supply reliability for recipients along the Lower Reach.

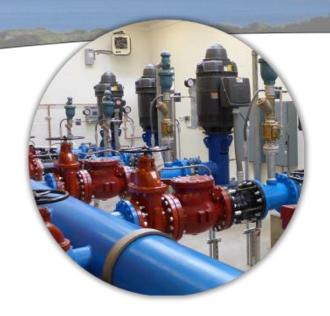
The project would include the installation of two parallel and similar pumping units, complete with electrical controls for variable speed pumping and appurtenant piping, wiring, and mountings. Each pumping unit will be a split-case, horizontal centrifugal pump designed for operation up to 1150 RPM. In addition, a new flow meter and pressure transducer on the discharge of the booster pump station will be installed.

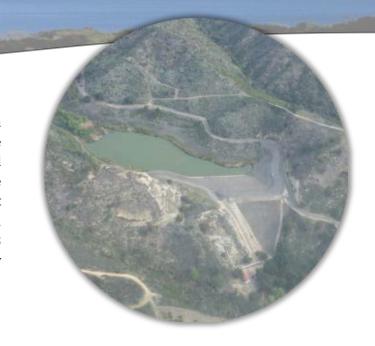
Dam seismic safety and other operational problems that exist because of deterioration would be addressed. Adjacent pumps and delivery system piping will be restored to operability. Remediation components will likely include removing the silt to allow operation at designed capacity and replacement of deteriorated 12 inch thick asphaltic concrete liner. Seismic retrofit will like include installation of shear key and berm installed down to the bedrock to resolve the existing potential for liquefaction.

Glen Anne is one of four regulating reservoirs on the Cachuma Project facilities. Glen Anne Reservoir had an initial storage capacity of 500 AF. Due to seismic stability requirements and risk of failure potentially causing catastrophic damage downstream, the maximum capacity was limited to 375 acre feet in 1988. In 2002 it was limited again to 175 AF maximum capacity. Glen Anne Reservoir is no longer in service, but COMB continues regular maintenance and inspections as required by the USBR.
