RESOLUTION NO. 724

RESOLUTION OF THE GOVERNING BOARD OF THE CACHUMA OPERATION & MAINTENANCE BOARD ADOPTING AN AMENDMENT TO THE COMB 2021-2025 INFRASTRUCTURE IMPROVEMENT PLAN

Change (\$888,000) (\$57,000) \$2,210,000 (\$250,000) (\$1,015,000)	\$0
---	-----

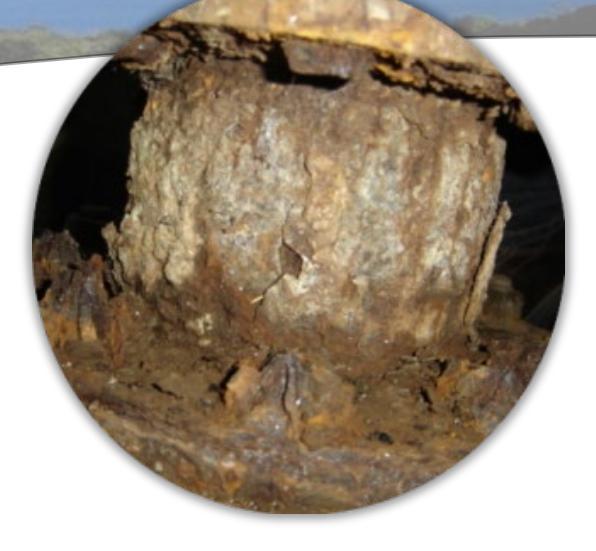
Combination air vacuum air release valves (AVARs) are located at high points along the pipeline and act to automatically expel air and relieve vacuum accumulation in pipes. If air is not adequately expelled, air pockets can constrict flows. If the vacuum is not relieved, serious damage or collapse of the pipeline can occur. If AVAR vaults become flooded or if a negative pressure is experienced within the pipeline, the AVAR valves could allow contaminated water to enter the pipeline. It is now required to install these valves above grade, where flooding is less likely. COMB has been upgrading the AVAR valves in the system such that all are above grade. The AVAR valve structures consist of a manhole cover, riser pipe, valve, and AVAR valve. Over time, the original valves, riser, and manhole covers have also been corroded and pose an operational risk.

There are twenty-six AVARs on the Lower Reach of the SCC. Most AVAR structures were rehabilitated from 2018 to 2021. There are two remaining AVAR valve structures in Highway 192 that need rehabilitation as they pose an operational risk and/or do not meet Section 64576 of Titles 17 and 22 California Code of Regulations, which requires "each new air-release, air vacuum, or combination valve, and any such valve installed to replace an existing valve shall be: (a) installed such that its vent opening is above grade." In addition, three air vents were partially rehabilitated and require replacement of the valve and riser pipe when a coordinated shutdown can occur. The consequence of not completing this project may be major facility failure in multiple locations and potential water contamination.

Replace and relocate to above ground AVARs, and replace riser pipes in the Lower Reach. Consistent with other AVAR replacements, manhole covers, valves, risers, laterals would be replaced at the same time. The project would require coordination with impacted Member Agencies during the required shutdown of the SCC. For efficiency and to minimize cost, phases of this project will be performed concurrently with similar phases of the South Coast Conduit Blow-Off Nozzle/Valve Replacement. Project implementation will occur over time and during low water demand months to reduce the impact of system shutdown.

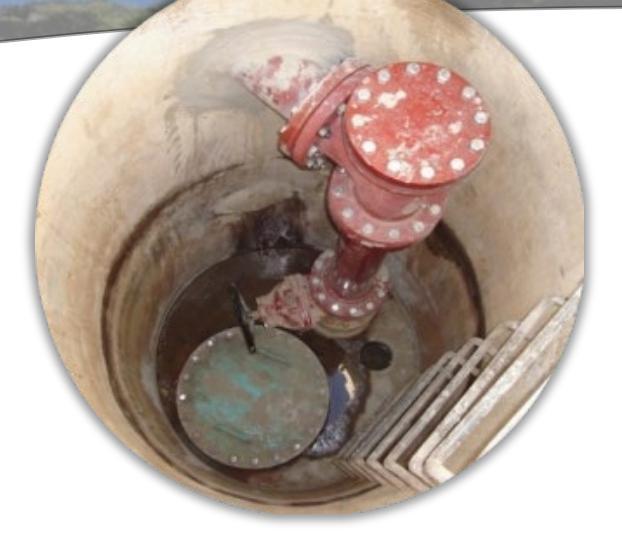
Blow-off structures exist on all low points of a water distribution system. The components included in these structures include access-hole covers, blow-off nozzles, a gate valve and blow-off piping. There are a total of sixty-five blow-off structures in South Coast Conduit system.

The project consists of replacing the man hole covers, blow-off nozzles, gate valves, upper spools, and discharge piping within the Lower Reaches of the SCC. The project would be completed in conjunction with the AVAR valve replacement and relocation project and coordinated with the affected Member Agencies during the required system shutdown. The design for this project is complete. Six scheduled shutdowns remain to be completed to replace 15 remaining blow-off nozzles and valves.

The existing blow-off components are in need or rehabilitation due to extensive corrosion. The dependability of these components is necessary to allow the system to be dewatered for maintenance and response to an emergency break in the pipe. Blow-off valves and piping have been replaced in the Upper Reach and 21 blow-off nozzles/valves have been replaced in the Lower Reach. Five blow-off nozzles in the Montecito and Carpinteria areas are in need of replacement. The original nozzles and valves are in need of replacement because of corrosion. The consequence of not completing this project could result in a major facility failure in multiple locations and potential risk of water contamination.

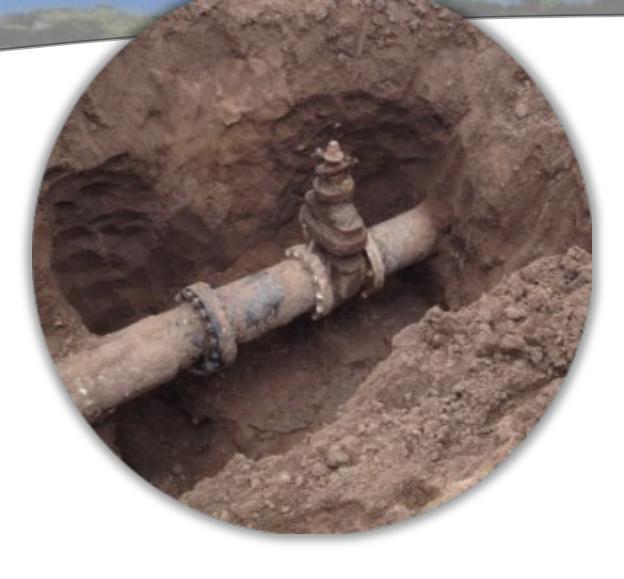
There are forty-four lateral connections housed in concrete cylinder structures on the Lower Reach of the South Coast Conduit. The function of these connections is to provide water to sections of the Montecito Water District and Carpinteria Valley Water District. Each connection generally contains two gate valves, a meter, and an air vent component. Most laterals have been abandoned and air gapped in the Upper Reach of the South Coast Conduit with the exception of the Goleta West Conduit.

This project would replace corroded pipe and inoperable valves and air vents on lateral connections. The project will require shutdowns for the specified turnout distribution supply areas and would be coordinated with the impacted Member Agencies. The project requires retention of engineering and contractor services. Due to each site's differing conditions, engineering would be required for each individual structure. The initial phase of the project is to perform an engineering assessment and design for all lateral structures.

Thirty-five of the existing lateral appurtenances in the lower reach pose an operational risk due to age, corrosion, and unreliable valve operating conditions. The dependability of these valves is necessary to provide reliable water service to customers served in sections of the Montecito and Carpinteria Water District Boundary areas. The consequence of not completing project could result this in lateral failure/inoperability limiting deliveries to customers served by those laterals or complicating operations if leak-by or a major failure occurred. The lateral valves need to be replaced prior to anticipated shutdowns of the South Coast Conduit in the Carpinteria area.

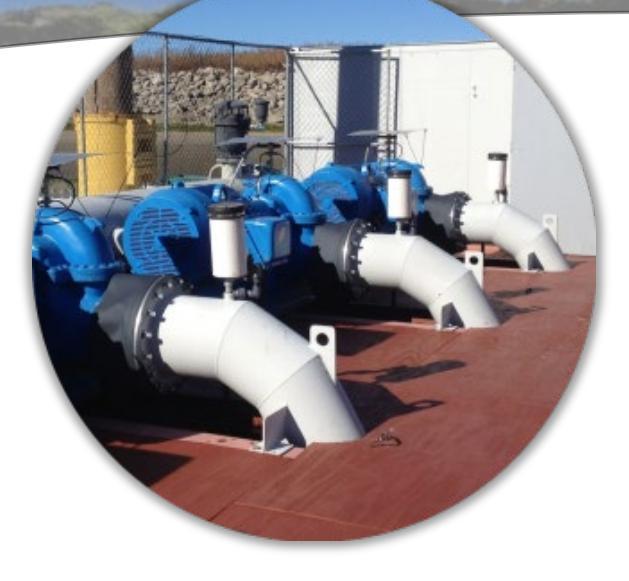
The floating pump station that is currently in storage consists of seven electrical pumps with fixed drum fish screens set on Flexifloat and Quadrafloat system. The pump station is powered by electricity through a temporary power line connected to PG&E system. A backup generator would be available on shore in case there was a power outage.

Two concepts for a submerged pump system have been considered: (1) a shore-mounted, slant-well facility and (2) a prefabricated submerged facility. The shore-mounted slant-well facility would include placing vertical turbine pumps with submersible motors at the bottom of a slanted steel casing pipe, which draws water from the lake through fish screens. The prefabricated submerged facility is an alternative concept, which would be assembled on shore, floated into position, and then lowered to the lake bottom. The costs are based on the installation and operation of the floating pump system that is currently in storage, under contract.

A pump-system has been installed three times in Lake Cachuma in 1957, 1990-91, and 2015-2017. In 1990-91 and 2015-17, the pumps were installed on a floating barge. Key components of the pumping barge from 2015-2017 EPF are currently being stored at a storage facility in Paso Robles. A land-based pump system was installed at Site 1 in 1957.

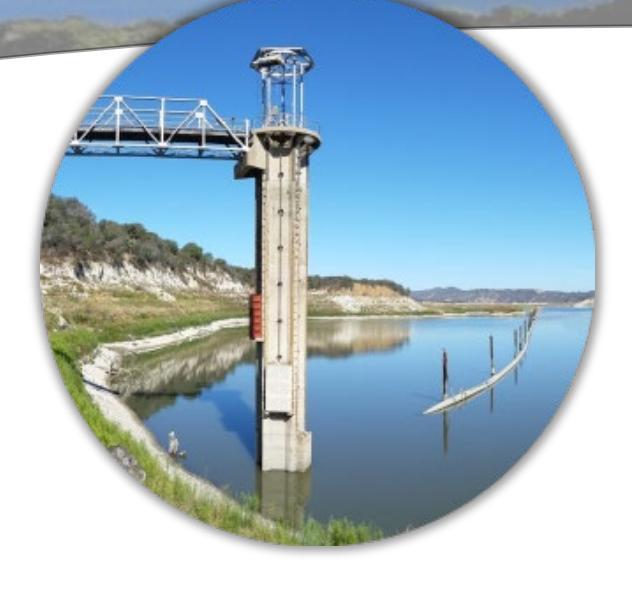
The project would consist of a 36-inch, 3,600' DR-17 HDPE pipeline secured to the lake bottom with concrete pipe weights. A fish screen installed at the drafting end would allow water deliveries from deeper portions of the lake for better management of delivered water quality. In times of drought, the pipeline would be connected to a pumping system to allow deliveries of water to the Tecolote Tunnel. The preferred elevation to install the pipeline is at 710' or less. The project could be installed during the next drought when the appropriate lake level is reached for construction (Makai Ocean Engineering, Inc. 2019).

The Secured Pipeline Project - Gate 5 Extension is currently in the design phase. The North Portal Intake Tower is normally operated as a gravity flow system. However, when the lake level recedes below the lowest gates, water is unable to be transported to the South Coast. Under these conditions, water must be pumped from deeper parts of the lake to the Intake Tower.

Sedimentation has buried the lowest gate (Gate 5) on the North Portal Intake Tower. A pumping system is needed when lake levels recede below the Gate 4 elevation (678'). Without a pipeline and pumping system, Cachuma Project and State Water Project (SWP) water cannot be transported to the South Coast, causing a widespread immediate threat to public health during drought. This project would consist of a pipeline secured to the lake bottom with a connection at Gate 5, and a gravity intake with fish screen at an alternate drafting location (Site 1). Should water quality become poor at the Intake Tower (temp, algae, turbidity, TOC, etc.), the alternative Site 1 intake could also be utilized.

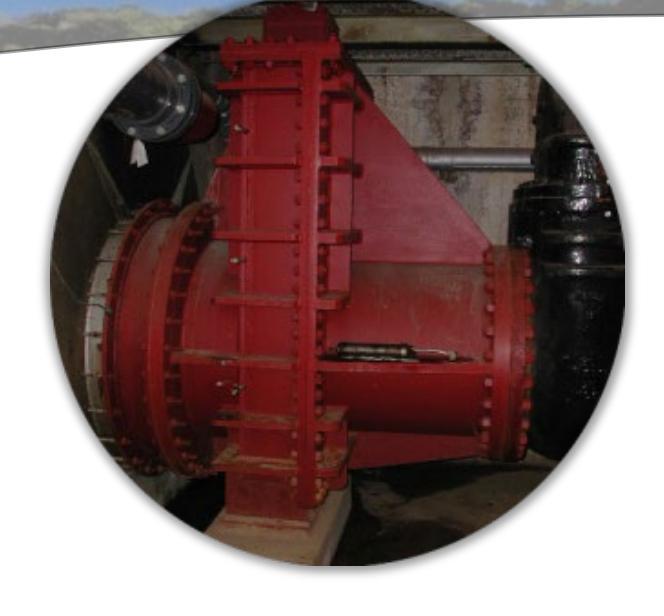
Located at the base of the Tecolote Tunnel, the Jet Flow Control Valve is the primary control for flow from Lake Cachuma into the South Coast Conduit. The valve is located within the red piping component as pictured to the right. The adjacent gate valve (black) is utilized to shutdown flows from Lake Cachuma. The Jet Flow Control valve was replaced in 1990 and has a useful life of approximately thirty years. As part of this project, COMB would purchase new parts and utilize previously acquired internal components to build a new valve to be installed during a planned shutdown. The current valve, after being removed, would be rebuilt using new components and would be kept on site and used as a redundant valve in case of failure.

This project consists of producing designs and specifications to manufacture a new valve body and to rebuild using new and previously purchased internal components. Once the jet flow valve is ready for installation, a coordinated shutdown would occur using the gate valve. The current jet flow valve would be removed from service and the new valve would be lowered by crane into the lower gallery of the North Portal through the elevator shaft for installation.

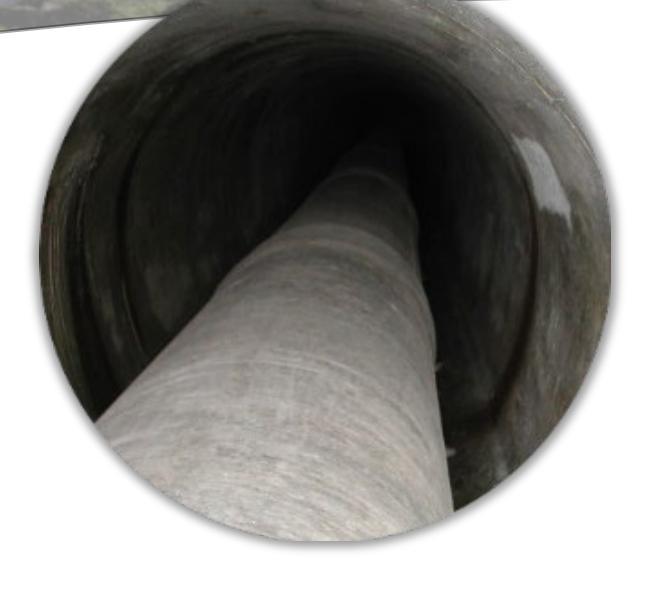
The USBR inspection report of the Sheffield Tunnel identified and recommended remediation of cracked pipe collars and adjoining deterioration of mortar joints and pipe supports. Deterioration potentially compromises the integrity of the tunnel and poses an operational risk. Heavy seepage appears to be a contributing factor to deterioration.

An engineering firm would conduct a condition assessment to determine the structural integrity and reliability of the connecting and support structures of the Sheffield Tunnel. The engineering evaluation will include recommended repairs and determine how to eliminate areas of heavy seepage. It is possible the engineering evaluation could find a lower cost remedy to that recommended by USBR. Upon completion of the evaluation, COMB would retain a qualified contractor to repair the deteriorated mortar joints and pipe supports at locations identified.

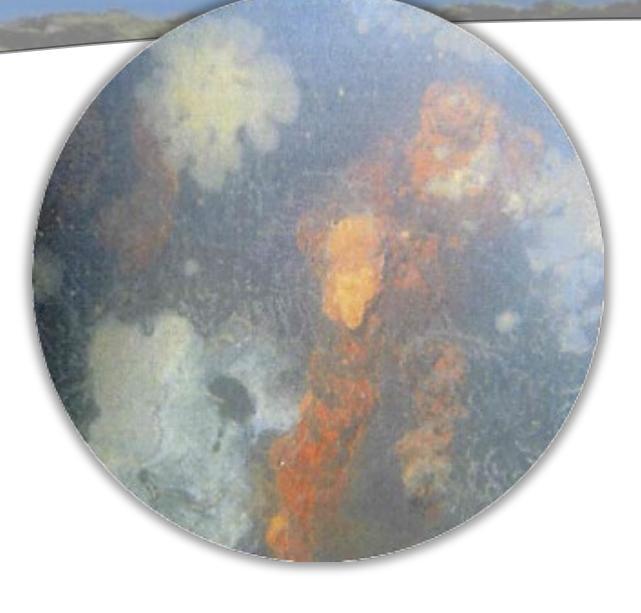
The Lauro Reservoir intake structure was modified in 1981 by adding a stainless steel circular intake screen connected to a steel pipe which was inserted in the original concrete intake structure. A 1/2 inch thick steel circular bearing plate was installed on top of the existing concrete intake structure to cover the opening between the intake structure and vertical pipe and provide structural support. The 2018 dive report, prepared by USBR, states the intake structure is in satisfactory condition with the exception of the bearing plate. The bearing plate was observed to be fully covered with corrosion and rust nodules.

The steel bearing plate on the intake structure has deteriorated because of corrosion and poses an operational risk for both the protection against outside intrusion of elements penetrating through the opening or structural support of the intake pipe and screen.

Engineering services will be retained to determine the expected level of performance from the steel bearing plate (protection from outside element intrusion or structural). Engineering will need to be conducted by a structural engineer to determine if the steel bearing plate is necessary for support, and if required, a method to design a repair that will allow for continued structural support of intake structure. The reservoir may need to be lowered to accommodate inspections and repairs.

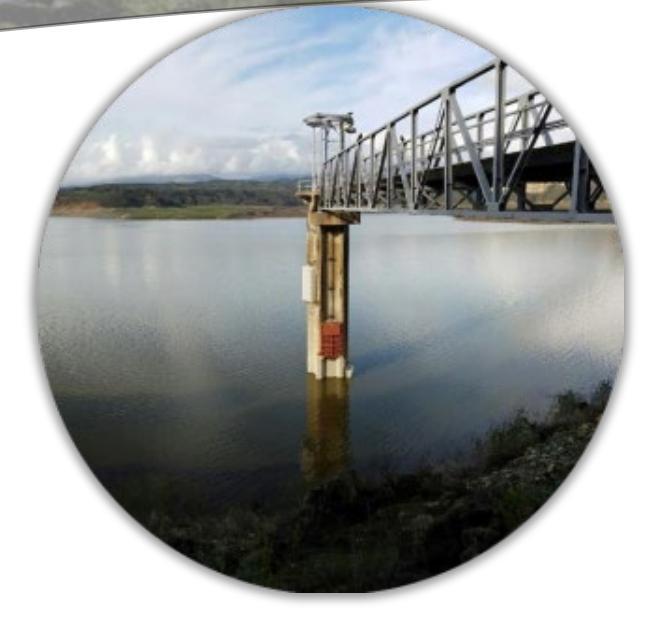
The North Portal Intake Tower was constructed by the Bureau of Reclamation in the 1950's, at which time, the standards for structural design requirements were not as stringent as today's compliance requirements. Structural elements of the intake structure would be examined to determine the general reliability of the tower, and recommendations for upgrades and refurbishments would be provided if needed. The consequence of not completing this project would be uncertainty in structure reliability during a seismic event, which could result in losing ability to deliver water to the South Coast while emergency repairs are made.

This initial phase of the project consists of acquiring the consulting services of a qualified structural engineering firm to perform a Seismic Reliability Analysis and Physical Condition Assessment of the North Portal Intake Tower located at the North Portal of the Tecolote Tunnel. It shall include a report of all findings and propose recommendations for structural rehabilitation to increase and/or ensure continued reliability of the structure in the occurrence of a large seismic event. An assessment of the tower is easier to perform when the lake level is low. This project is scheduled to be performed when the lake level exposes a large portion of the intake tower.

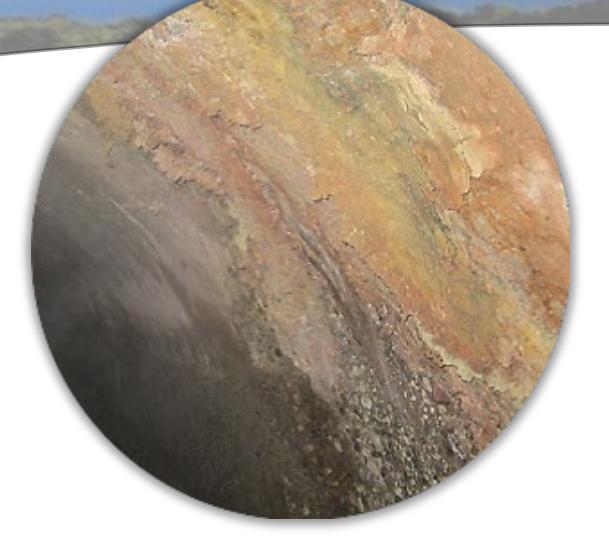
The Tecolote Tunnel was completed in 1956 to divert water from Lake Cachuma to the South Coast Conduit. The tunnel provides water delivery through the mountain to the South Portal. The tunnel structure consists of a modified circular horse-shoe shaped cross section constructed of steel encased in 12 inches of concrete, and operates in open channel flow that is approximately 7' inside and is 6.4 miles long with a gradual shallow slope to enable gravity feed. The only ingress and egress are at the North Portal and South Portal. During periodic inspections by the USBR, deteriorations have been observed in the tunnel lining due to long-term exposure to hydrogen sulfide gas.

Hydrogen sulfide has caused some deterioration of the concrete lining of the tunnel. In areas, the interior concrete surface has peeled in sheets approximately 3/8 of an inch thick and fallen into the invert, creating sediment. The majority of the tunnel is in acceptable condition, however, a few locations have small areas where leaching could affect the structural integrity of the concrete. Review is necessary, as the consequence of not completing this project is uncertain in terms of structure reliability. A tunnel failure could interrupt 40 MGD during peak demand time if not addressed, and would be very technically difficult to repair.

The project requires engineer evaluation of concrete deterioration, and recommended remediation. A thorough investigation and monitoring program needs to be implemented to determine if the concrete deterioration presents risk of structural failure. The program should be designed to address the specific questions raised by the 1999 RO&M Reclamation Report, action 2012-2-Q, which recommends COMB "prepare and implement a repair plan to perform all necessary repairs to address all damaged concrete and remediate the widespread concrete deterioration in the Tecolote Tunnel to restore safe and reliable service of the facility."
