**Clean Clogged Weep Holes in Tecolote Tunnel
(2005-2-31)**

(To be performed in conjunction with Tecolote Tunnel Investigation Project)

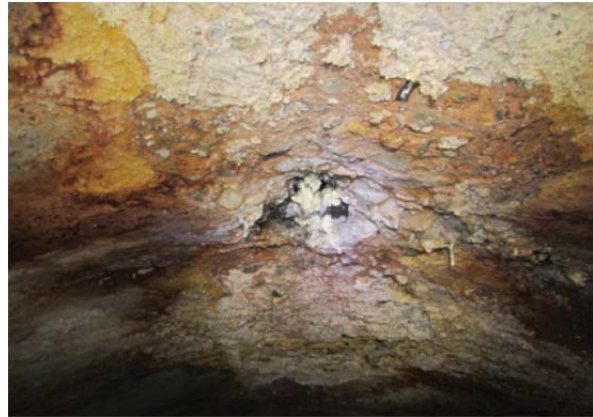
There are numerous weep holes within the Tecolote Tunnel that have been subjected to mineral accumulation creating deposits. Hydrogen sulfide has contributed to corrosion of the concrete structure adjacent to the weep holes. The mineral accumulation and corrosion have eliminated or reduced the ability of the weep holes to function, thereby potentially affecting the stability of the structure. The weep holes need to be cleaned to allow proper water drainage into the tunnel to protect the Tunnel structure.

The project would be conducted concurrent with the concrete lining repair and will require a shutdown of the tunnel and all safety precautions necessary for tunnel access because of hydrogen sulfide exposure and confined space issues.
