CACHUMA OPERATION AND
MAINTENANCE BOARD

INFRASTRUCTURE IMPROVEMENT PLAN FY 2027-2031

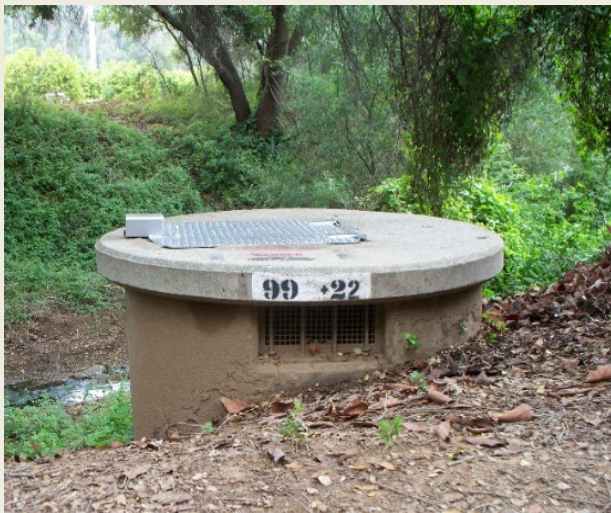
Figure 7. Blowoff Structure at Station 99+22

COMB operates and maintains approximately 200 SCC structures throughout the system. This includes 62 blowoff vaults, 57 air-vacuum air-release (AVAR) vaults, and 68 turnouts through the peaks and valleys of SCC system. Each structure is unique, but generally consists of a concrete vault structure, metal lid with lock box, ladder rungs, SCC access hole with lid, and either blowoff pipe plumbing, AVAR plumbing, or turnout plumbing with risers and valves. The purpose of these appurtenant structures is to allow staff access to system components, in order to release/admit air for pipeline protection, release water for maintenance purposes or emergencies, and to service internal assembly and/or valves. Over 20% of these components are over fifty years old. Significant progress has been made within the last five years, and now almost 90% of the structures have been rehabilitated as part of a structure rehabilitation program started in the early 2000s, with 16 turnouts in the Carpinteria Reach being rehabilitated in FY 2024-2025 alone.

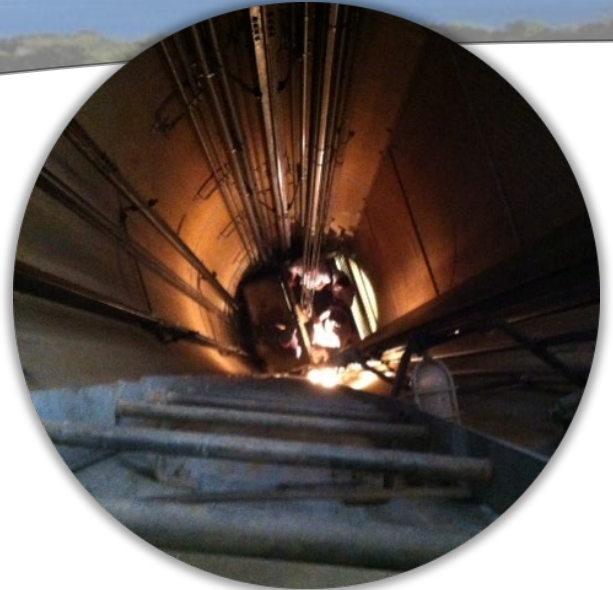
Figure A.1 North Portal Elevator Shaft

The existing elevator has been a longstanding concern due to its limited escape options and narrow shaft design. The study will consider improved escape features, a secondary escape shaft, installation of modernized extraction systems, exterior stairs to the elevator control room, sealing / grouting to prevent unwanted water entry and electrical malfunction, or other safety improvements as recommended. The overarching need is to modernize the elevator and extraction capabilities in the North Portal, ensuring that in case of an emergency, personnel can swiftly and safely evacuate the gate chamber.

The study is a comprehensive assessment considering design flaws of the existing elevator system. This project will include a detailed analysis of the elevator's limitations and its escape features. A suite of potential solutions will be explored, and the best solution will be recommended. Smaller scale common sense safety modifications have begun and will continue to occur. With the lake at higher elevation, increased water intrusion will be slowed using sealants and grouts. An exterior staircase and door will be constructed to facilitate simpler access to the elevator control room instead of the existing ladder and fall-arrest system to the top floor.

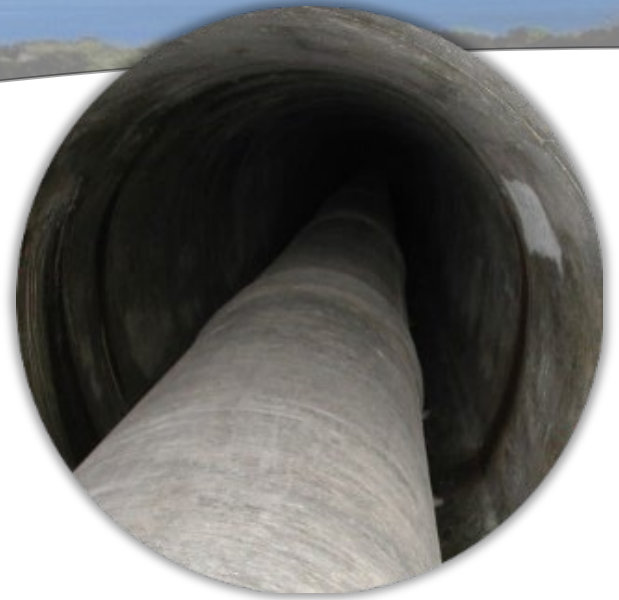
Figure A.2 Sheffield Tunnel and Pipeline

The Sheffield Tunnel is a concrete tunnel housing the 30" Centrifugal Concrete Pipe (CCP) South Coast Conduit (SCC) that extends 6,100 feet in 12-ft segments between the Sheffield Control Station east of Mission Creek to Parma Park. Within the tunnel, sections of concrete pipe are connected and joined with steel bands, double gaskets, and mortar to maintain the integrity of the pipe collar connections. Water collected within Sheffield Tunnel accumulates and is routed into a creek drop inlet culvert downstream of the west portal of the tunnel.

In 2025, the Sheffield Tunnel was inspected by Reclamation, COMB, and support staff and the condition of each joint was assessed and documented. Some of the joints were found to be deteriorated; 1% with no mortar and the steel joint ring crack or compromised, 4% with mortar separating from the pipe, and 10% with severe cracks or separation of mortar. Reclamation issued a Category 1 to develop and implement a plan to address deficiencies at the pipeline joints in Sheffield Tunnel (note that this changed the Project ID; formerly 2007-2-B). The 6,100-foot tunnel does not have redundancy and any damage to the SCC in this area would cause potential water supply disruptions, significant access challenges for repair work, and environmental damage in the uncontrolled release of water from the pipeline.

The overall plan includes an emergency contingency, Sheffield Control Station improvements, East Portal line valve, hydraulic modeling, conceptual design and alternative study, environmental compliance, financing, and project implementation. Planned for FY 2026 are improvements to the Sheffield Control Station, an east portal line valve installation, and an internal inspection. Several options for the repair have been identified including internal seals, semi-structural liner, HDPE liner/bypass, grouting the tunnel, horizontal directional drilling of new pipe, etc. The best alternative will be considered for construction.

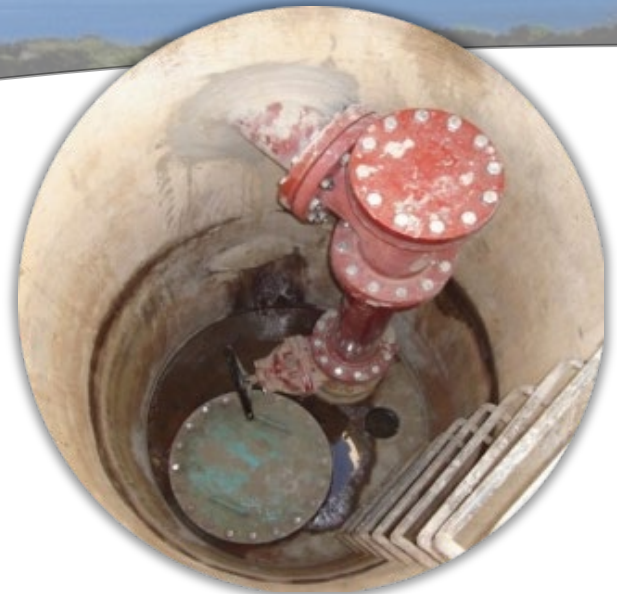
Figure A.3 Inside of Blowoff Structure

The remaining original and partially rehabilitated blowoffs need full rehabilitation due to extensive corrosion. The dependability of these components is necessary to allow the system to be dewatered for maintenance and response to an emergency break. Three blowoff structures are original (STA 698+55, 732+72, and 880+05) plus two additional blowoffs requiring replacement of the first valve (STA 804+24 and 902+96). Although all the AVARs are now above grade and coated, there are four (4) AVARs which require a shutdown to replace the first valve at STA 703+00, 755+84, 874+00, and 900+15. Not completing this project could result in an unplanned outage and a major release of water.

The project would require coordination with impacted Member Agencies during the required shutdowns of the SCC. The project consists of replacing manhole covers, blowoff nozzles, gate valves, upper spools, and discharge piping for original blowoffs and replacing first valves for partially rehabilitated structures. The work would be phased throughout four shutdowns (F2, F3, F4, and F5).

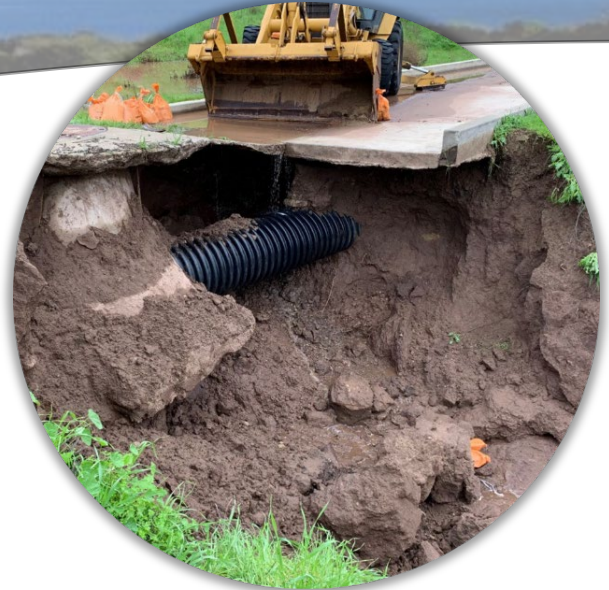
Figure A.4 Lauro Reservoir Bypass Channel Washout January 2023 Winter Storms

The need for this project is illustrated through repeated damages and public safety concerns since the 1960s. Damages have occurred in the following years: 1962, 1964, 1965, 1967, 1969, 1973-74, 1977-78, 1980, 1983-85, 1991-92, 1993-94, 1995, 1998, 2000, 2005, and 2023. Damages from excessive storm inputs included slides, washouts, erosion, high turbidity levels, water quality concerns, and the need to take Lauro Reservoir offline for varying periods. These storm events caused disruptions to water supply and quality and necessitated repairs. There remains 800ft of unimproved bypass channel with asphalt and gravel vulnerable to damage.

Includes removal of the current asphalt and gravel sections and installation of a significantly more robust concrete bypass channel with curbs and retaining walls to match previously improved sections. The total length of the improved bypass channel would be approximately 800ft and would include retaining walls to hold back the slope and prevent shallow landslides onto the bypass channel and washouts of the road. The project would complete the bypass channel around Lauro Reservoir and prevent repetitive damages.

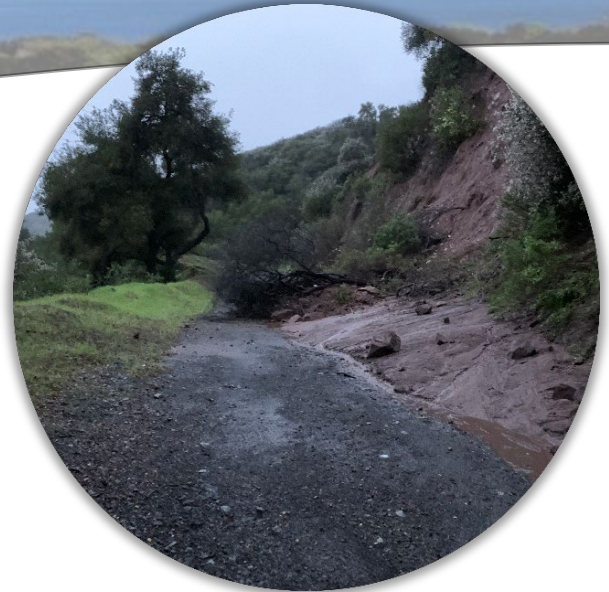
Figure A.5 Glen Annie Road Damage following January 2023 Winter Storms

COMB maintains a network of critical access roads, often in remote locations, which allow passage to vital water conveyance facilities. Maintaining these access roads is a challenge due to the rugged terrain, steep surrounding hillslopes, periodic natural hazards, and natural weathering. Recent events, such as the damages inflicted by California Severe Winter Storms, Flooding, Landslides, and Mudslides (DR-4683-CA) in early January 2023, and in Winter 2025-26 underscore the urgent need for elevated maintenance and improvements in these areas.

COMB staff will prioritize fixing or improving roads in clear disrepair, those that provide non-redundant access to key facilities, and low-cost improvements. Solutions are site-specific, but will include erosion control measures, landslide mitigation, regrading, road resurfacing, and improvements to drainage systems at target locations including the North Portal Road, Glen Annie Road, Lauro Dam access roads, Lauro Yard, Sheffield Control Station Road, and North Portal Intake Tower access bridge decking replacement. Additionally, the improvements will incorporate measures to enhance the roads' resilience to extreme weather events and natural disasters, thereby reducing the risk of future damage.

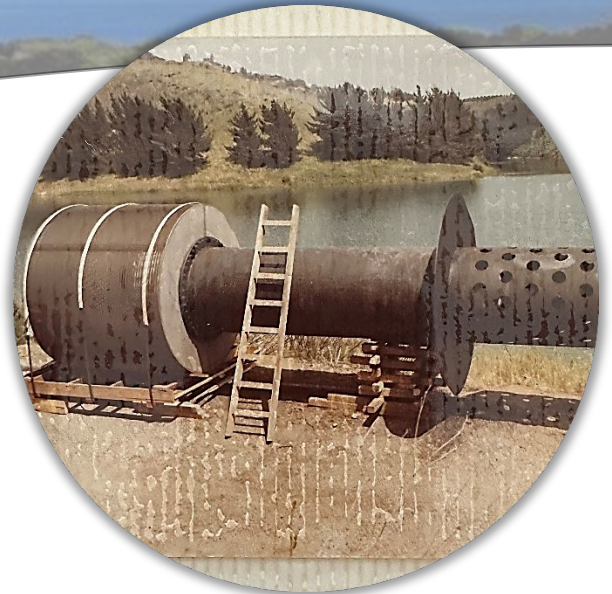
Figure A.6 Intake Structure Extension to be Placed in Lauro Reservoir April 5, 1981

The Lauro Reservoir intake structure was modified in 1981 by adding a stainless steel circular intake screen connected to a steel pipe which was inserted in the original concrete intake structure. A ½-inch thick steel circular bearing plate was installed on top of the existing concrete intake structure to cover the opening between the intake structure and vertical pipe and provide structural support. The 2018 dive report prepared by Reclamation states the intake structure is in satisfactory condition with the exception of the bearing plate. The bearing plate was observed to be fully covered with corrosion and rust nodules.

The steel bearing plate on the intake structure has deteriorated because of corrosion and poses an operational risk for both the protection against outside intrusion of elements penetrating through the opening or structural support of the intake pipe and screen. Failure of the intake structure would cause immediate operational challenges in maintaining deliveries to Cater Water Treatment Plant, who treats water for the City of Santa Barbara, Montecito Water District, and Carpinteria Valley Water District through the potable section of the South Coast Conduit.

Engineering services were procured, and the current structure is seismically inadequate and the consultant is currently drafting plans to replace the intake support structure. A diver or remotely operated underwater vehicle will need to complete an inspection of the intake structure prior to finalization of the replacement plans. The reservoir may need to be lowered to accommodate inspections and repairs.

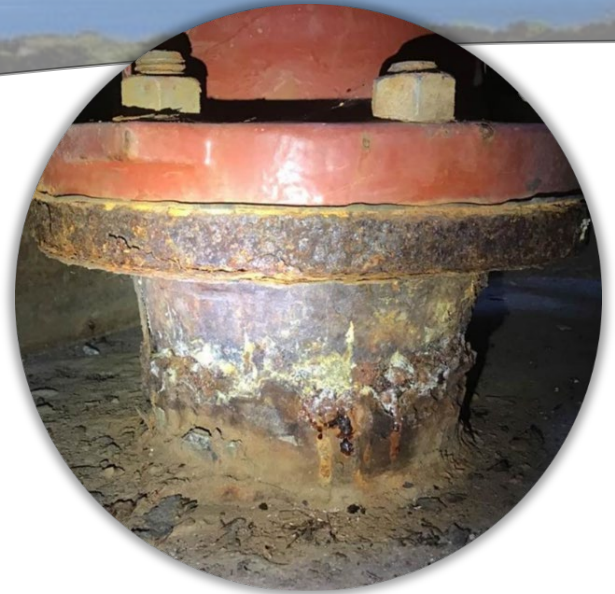
Figure A.7 Corroded Blowoff Riser Nozzle at SCC Upper Reach Station 639+50 Before Repairs

Blowoff structures exist on all low points of a water distribution system and are important features of the South Coast Conduit (SCC) for draining the pipe during maintenance and emergency activities. There are 34 blowoff structures in the SCC Upper Reach. Most of the blowoff structures were rehabilitated from 2003 to 2007, however in many cases the blowoff riser nozzles were left in their existing condition. On October 20, 2022, a leak caused by several pinholes and cracks in the SCC Upper Reach blowoff riser nozzle at STA 639+50 was discovered and repaired. This event led to the broader discovery of several riser nozzles severely corroded and in need of repair.

There are 34 blowoffs in the upper reach, of which 17 could be recoated and anode installed without a shutdown. Fifteen blowoff risers appear to be corroded where an internal sleeve would need to be welded on the inside similar to the emergency work completed at STA 639+50. Two blowoff risers were fully rehabilitated following a leak in 2022. The internal sleeve rehabilitation would require a shutdown of sections of the SCC to facilitate repair, which would be coordinated with Goleta Water District and other affected Member Agencies. A contractor would then weld a smaller diameter pipe sleeved inside the corroded blowoff riser nozzle from the inside of the SCC, and clean, coat, and protect with a sacrificial anode prior to recharge.

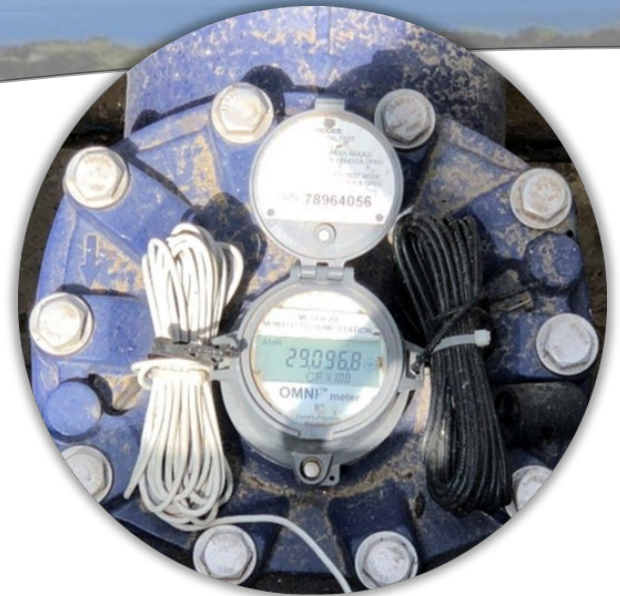
Figure A.8 Montecito Pump Station Meter

COMB operates several magmeters critical to operations and water accounting that have reached limited-life cycle phase and are in need of replacement in the next five years. COMB operates magmeters at Glen Anne Turnout, Goleta West, Ortega Inflow, Ortega Southflow, and Boundary which are utilized to manage operations on a day-to-day basis and for monthly accounting of water use. Replacements would be purchased and installed for the Ortega Inflow, Ortega Southflow, and Boundary meters as the most critical, with additional meter replacement locations chosen based on priority. In addition, the venturi meter at Sheffield Control Station will be replaced with a magmeter during the Critical Control Valve Replacement (2019-C-4) in preparation for the Sheffield Tunnel Evaluation and Repair (2025-1-A).

Figure 6. Montecito Pump Station Meter

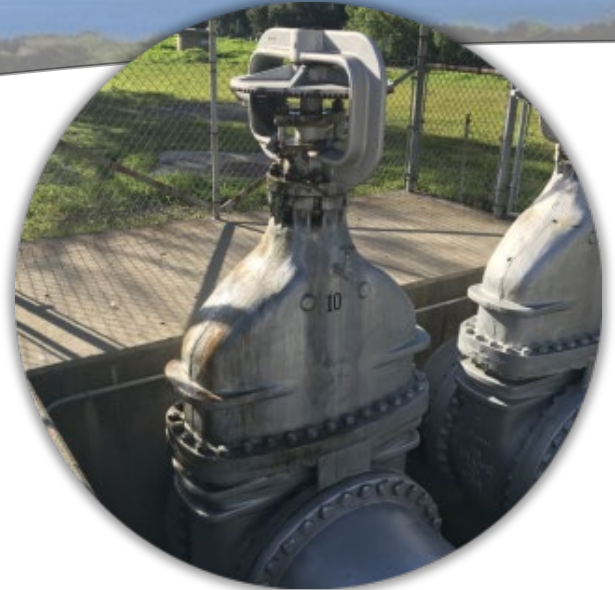
Figure A.9 Lauro Control Station Gate Valve

This project would involve the systematic replacement of key control valves in the system with known operational deficiencies. Control station piping would be streamlined to reflect current operations, and obsolete valving would be removed from the control stations. Lauro and Sheffield Control Stations will be prioritized as they have not been recently evaluated and have not had any original valves replaced. Sheffield Control Station in particular has known leak-by and the work is being planned in preparation for the Sheffield Tunnel Evaluation and Repair (2025-1-A) to allow isolation of the tunnel and for double block and bleed best practices for eventual manned entry into the Sheffield Tunnel if required.

Figure 4. Lauro Control Station Gate Valve

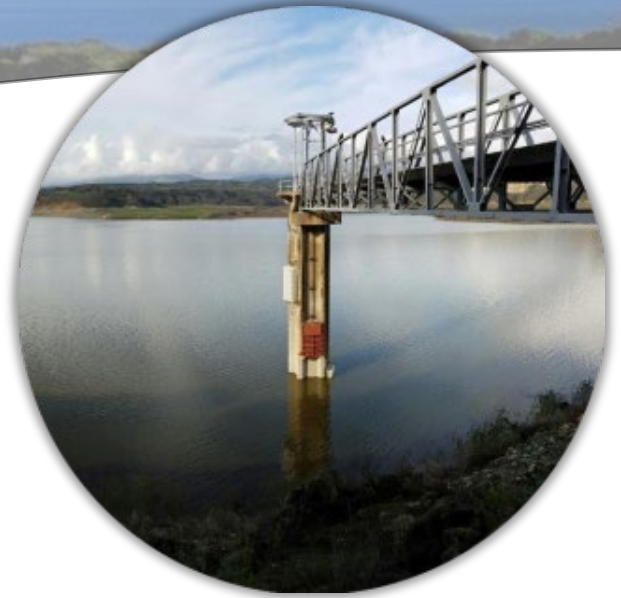
Figure A.10 North Portal Intake Tower

This initial phase consists of acquiring consulting services of a qualified structural engineering firm to perform a Seismic Reliability Analysis and Physical Condition Assessment of the North Portal Intake Tower and Gate Chamber. It shall include a report of all findings and propose recommendations for structural rehabilitation to increase and/or ensure continued reliability of the structure in the occurrence of a large seismic event. It should also include recommendations for a temporary pump system from the lake to the gate chamber in the event of earthquake damage. An assessment of the intake tower is easier to perform during low lake levels, however the lake is currently full and is scheduled to begin in Fiscal Year 2026-27.

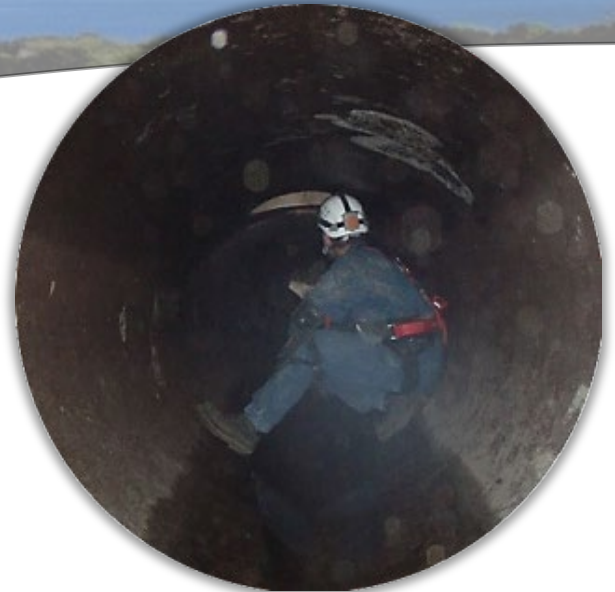
Figure A.11 Previous Inspection of SCC Interior

Contracted services would be procured for confined space inspection and related deliverables. The project will generally consist of an internal examination of sections of the South Coast Conduit. The inspection would require a shutdown of the SCC, which will be coordinated with Member Agencies. After inspection is complete, a full report including detailed inspection notes, photos, and recommendations would be provided to COMB. In the Upper Reach, manned inspections would be performed in a similar fashion as was completed in 2007 and 2009. However, due to the smaller pipe diameter and potable water transmission, the Lower Reach would need to be inspected via a remotely operated vehicle. The inspection of the Lower Reach is also challenging due to the limited available windows for a shutdown.

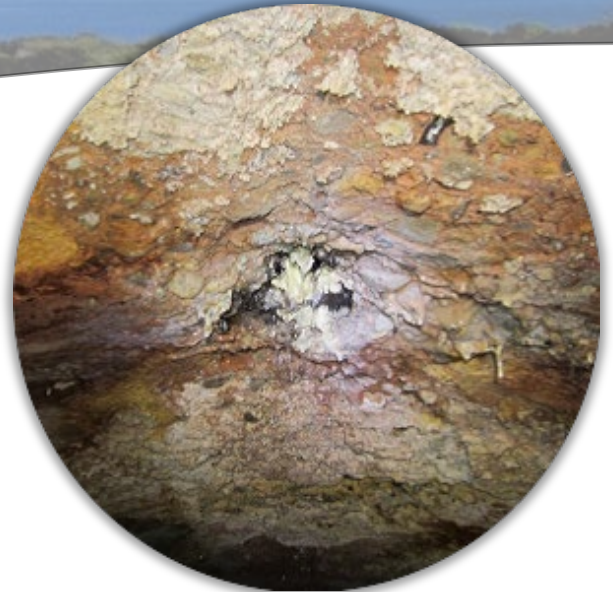
Figure A.12 Clogged Weep hole in Tecolote Tunnel

The project will require a shutdown of the tunnel and all safety precautions necessary for tunnel access due to increased temperatures and geothermal activity, hydrogen sulfide exposure, and confined space issues. Entry would require coordination with Reclamation and specialized safety personnel. An electric tunnel utility vehicle could be used to power specialized hand-held drills and vacuums to clear the hardened mineral deposits and dislodge debris. A pilot program would be conducted in the winter 2026-27 and if flow increases were measured additional effort would be undertaken to drill out the weep holes in subsequent years. Work would be limited to a 2-3 day shutdown during the winter months.

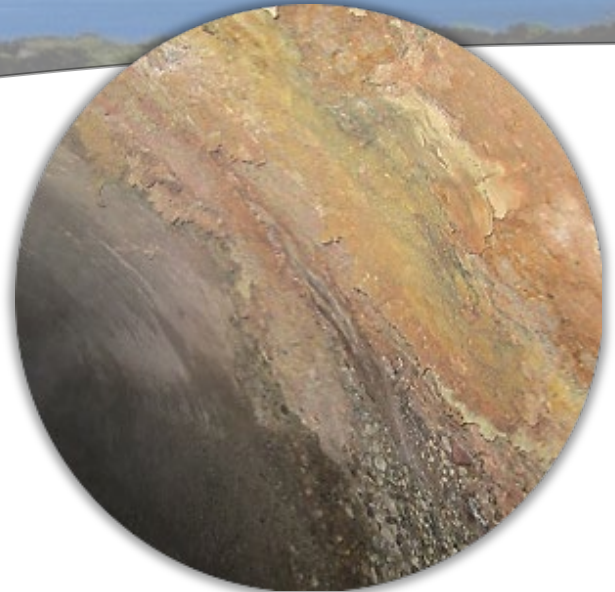
Figure A.13 Concrete Lining Deterioration within the Tecolote Tunnel

The project requires engineer evaluation of concrete deterioration. These would include accurate internal diameter measurements to estimate concrete losses, concrete core samples with compression tests and petrographic samples to determine the extent and cause of deterioration. 2012-2-Q, which recommends COMB “prepare and implement a repair plan to perform all necessary repairs to address all damaged concrete and remediate the widespread concrete deterioration in the Tecolote Tunnel to restore safe and reliable service of the facility.” The work will likely require a drone to scan the inside of the tunnel and an electric tunnel vehicle with the ability to power concrete coring tools. The work would occur during the next scheduled inspection in winter 2026-27.

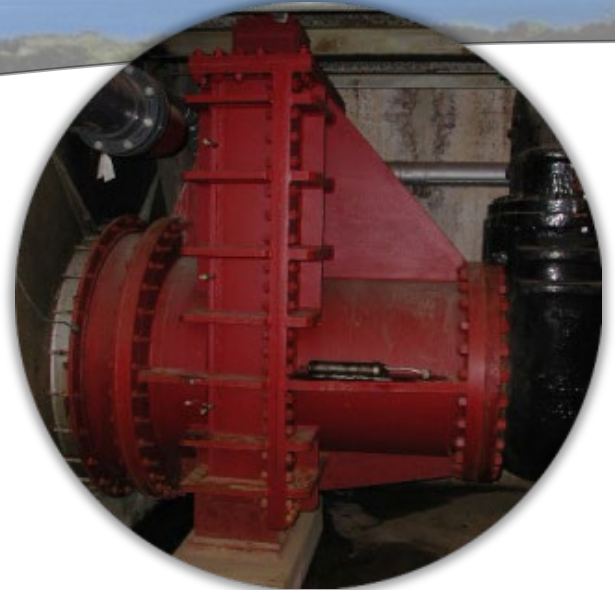
Figure A.14 North Portal Jet Flow Control Valve

This project consists of producing designs and specifications to manufacture a new valve body and to rebuild using new and previously purchased internal components. Once the jet flow valve is ready for installation, a coordinated shutdown would occur using the gate valve. The current jet flow valve would be removed from service and the new valve would be lowered by crane into the lower gallery of the North Portal through the elevator shaft for installation.

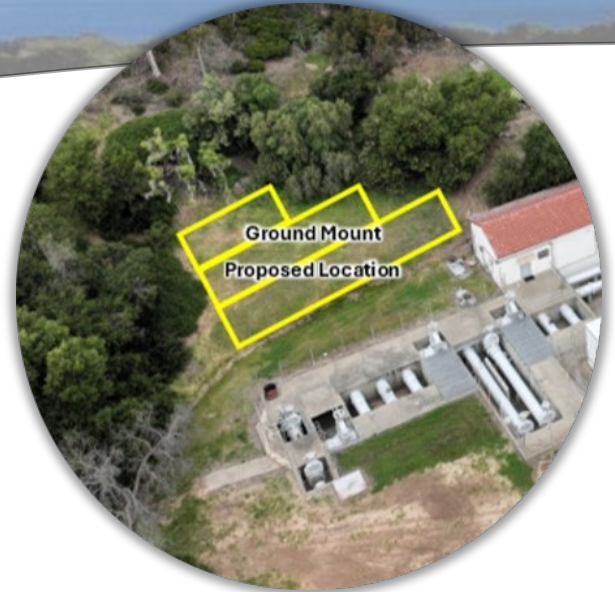
Figure A.15 Proposed Ground Mount Location West of COMB Headquarters “Chlorine Building”

In CY 2026-27, a 40kW ground-mounted photovoltaic array, EV chargers, and battery storage project at the COMB Headquarters is planned, offsetting office and new EV charging infrastructure usage. As part of the project, a new automatic transfer switch would be installed on the primary electric panel as well. The system could be expanded in the future as more electrical vehicles are added to COMB’s fleet.
