**Rehabilitate San Antonio Creek Blow-Off  
(2012-2-35)**

**Background**

The San Antonio Creek blow-off structure was constructed as an addition to the Cachuma Project facilities in 1958. It was constructed to provide a method for water release and draining of Lauro Reservoir during an Emergency Scenario. The structure's sole purpose is to respond to dam safety considerations.

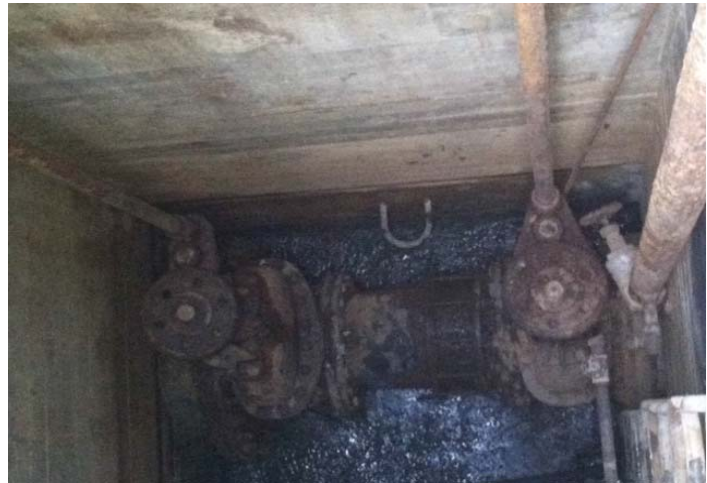
The existing structure includes a 16-inch and a 12-inch gate valve that are both frozen in place and inoperable because of age and corrosion. The inoperable condition of the valves prevents regular maintenance. The two valves serve as a lifeline control response to an emergency that would require COMB to drain or reduce the elevation at Lauro Reservoir in response to dam safety considerations.

San Antonio Creek blow-off structure is twenty-five feet deep and a quarter mile from the access road which crosses San Antonio Creek, making access difficult and potentially complicated. The 16 and 12 inch valves would be removed and replaced. The project will require a shutdown of the South Coast Conduit.
